# Assessment and Retrofit of Masonry Structures

## *Case Studies*

College of Continuing and Professional Studies  
Structural Engineering Webinar  
March 7, 2023

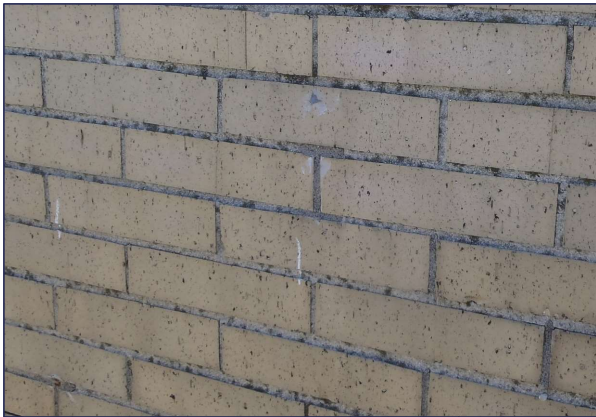
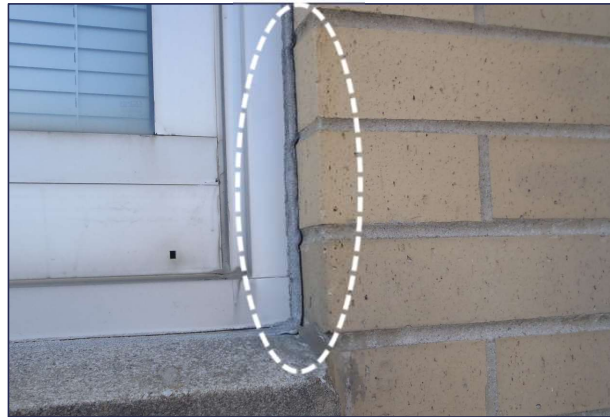
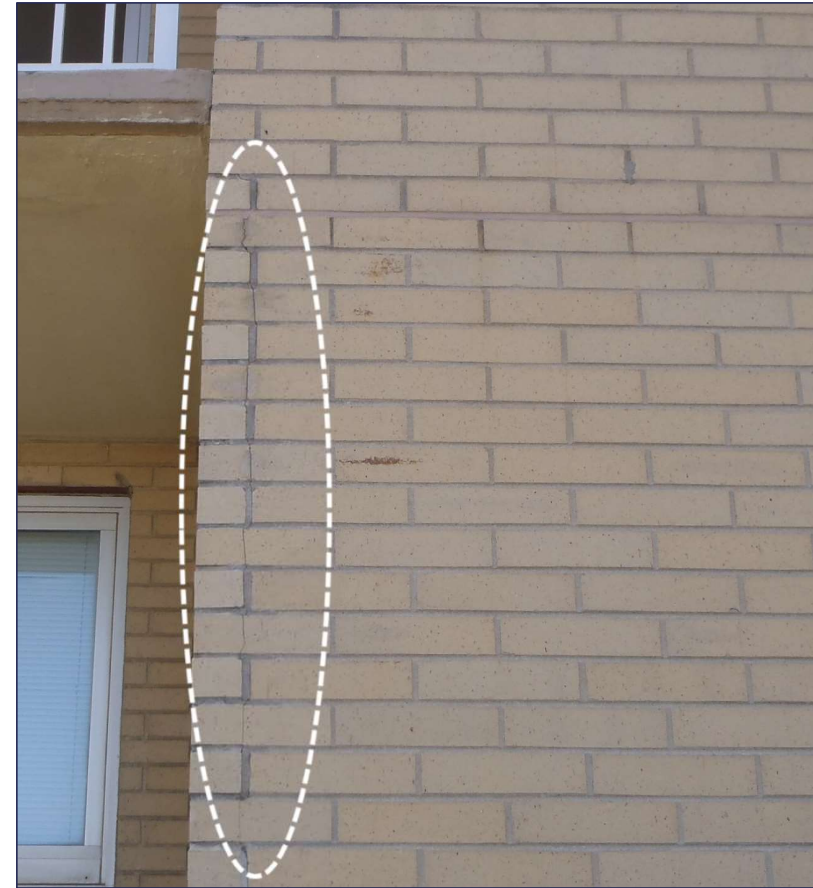
- ❑ Masonry – 50 years old, in great shape!
- ❑ Mortar – mostly OK
- ❑ Sealant failure
- ❑ Localized cracks at building corners

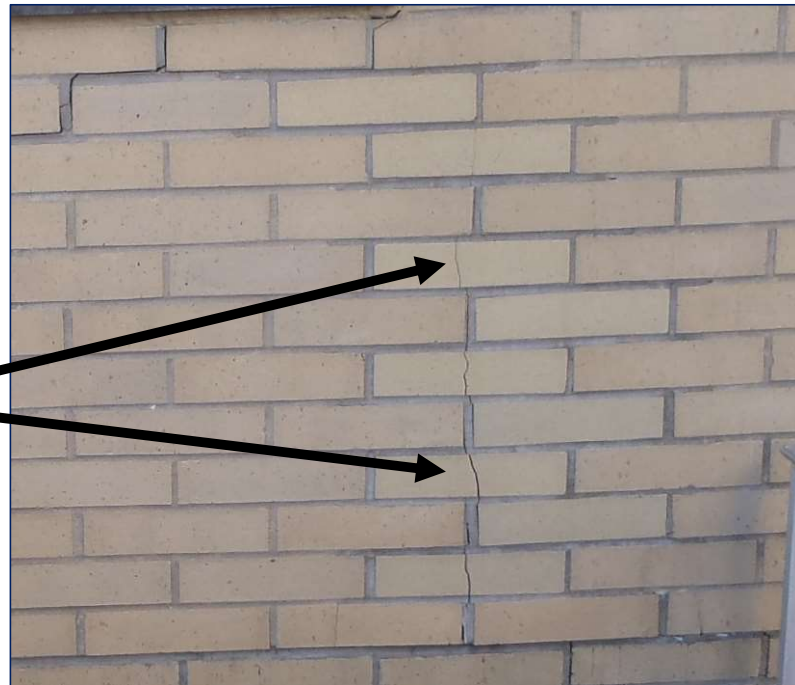
Bricks replaced –  
cracked again!

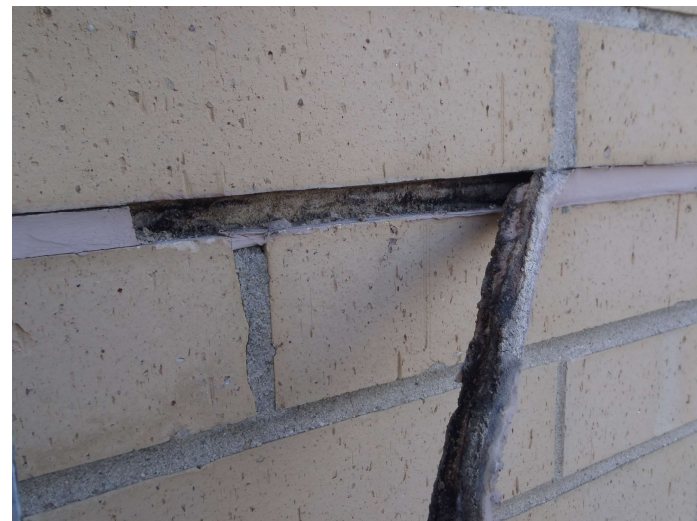
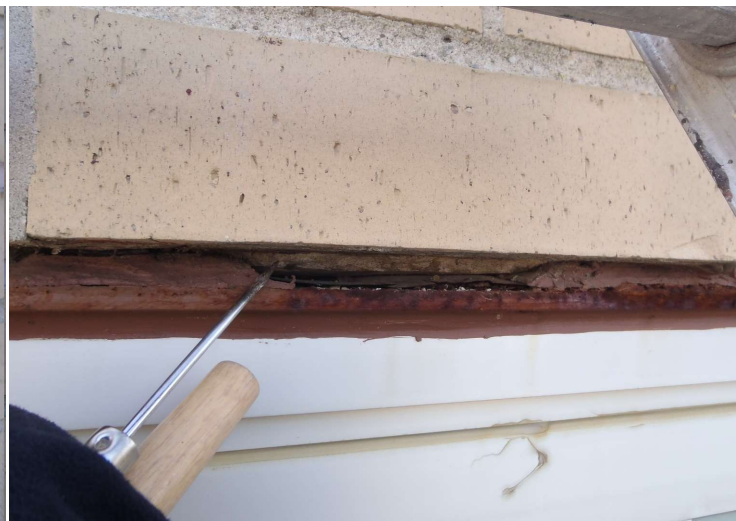
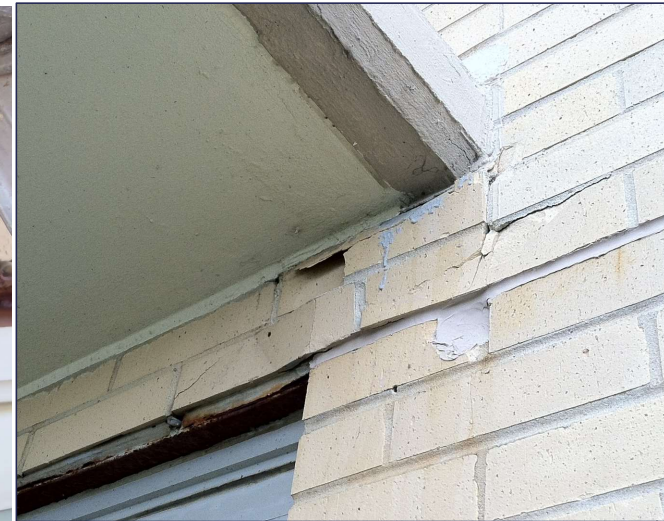
- No movement joints

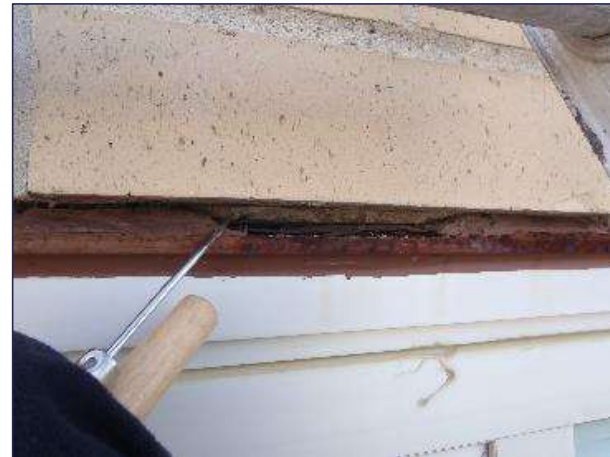
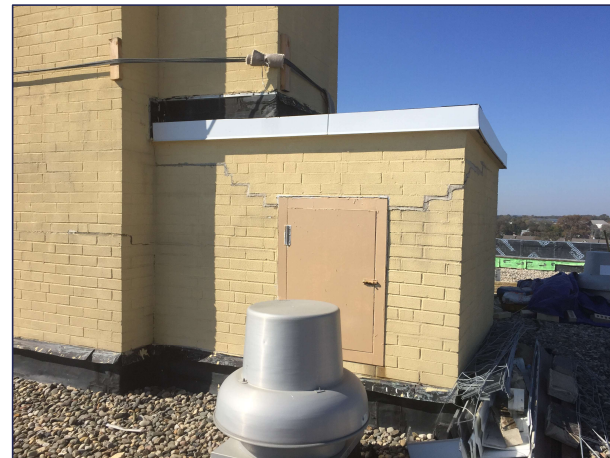
- ▣ Steel shelf angles at each floor line
- ▣ Steel corrosion
  - ▣ Oxidation byproducts occupy a larger volume than original metal
  - ▣ Expansion: up to 7x

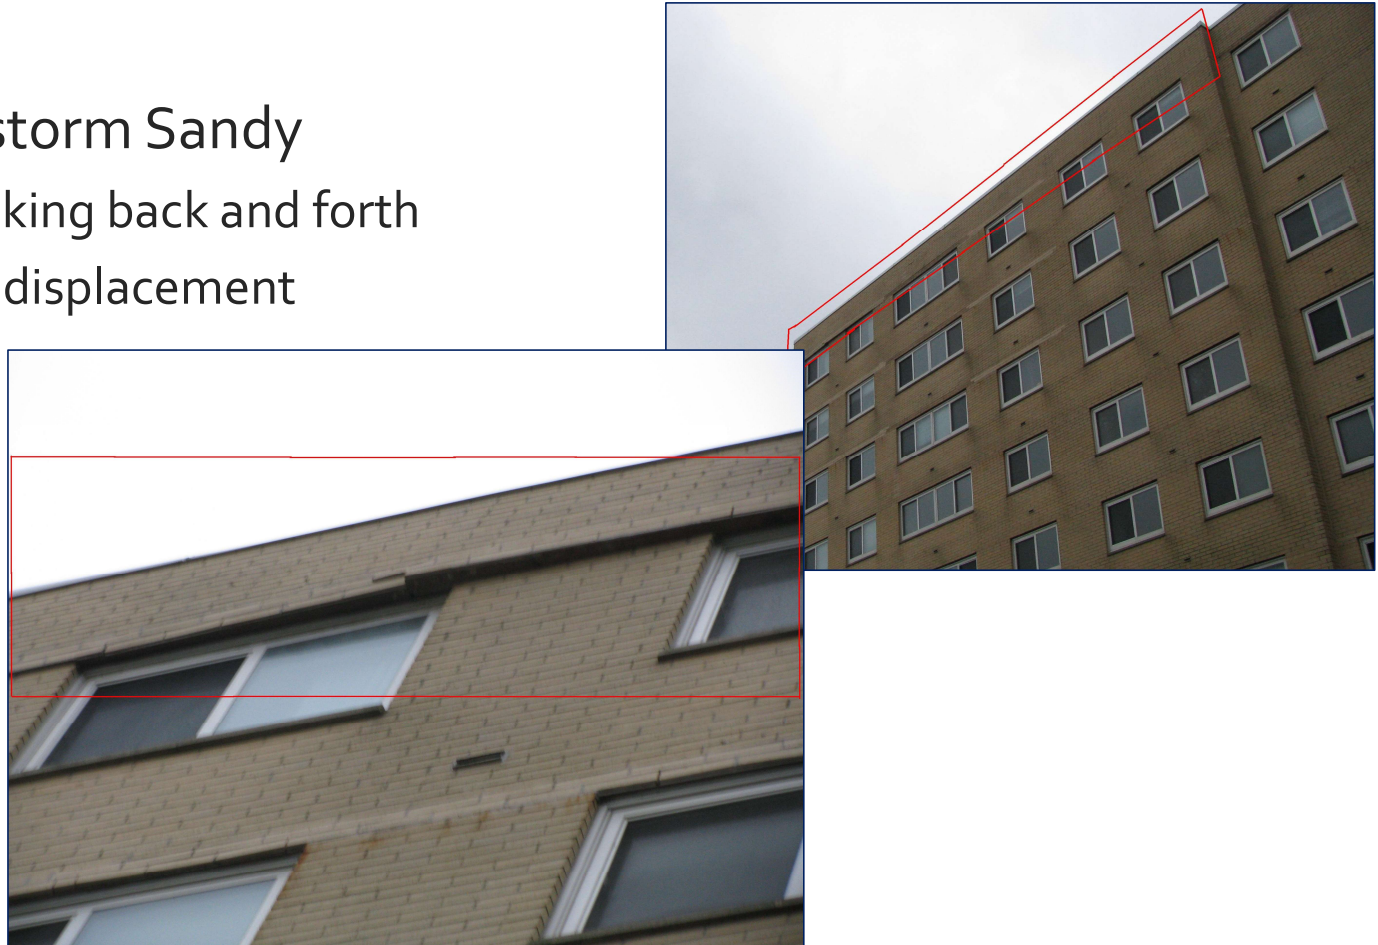
- ▣ 2014: superstorm Sandy
  - ▣ Parapet rocking back and forth
  - ▣ Permanent displacement

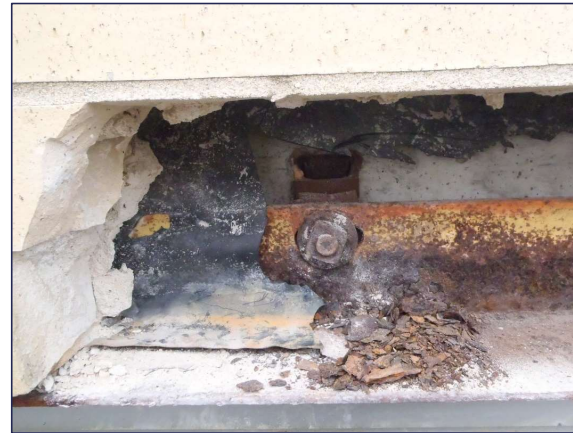
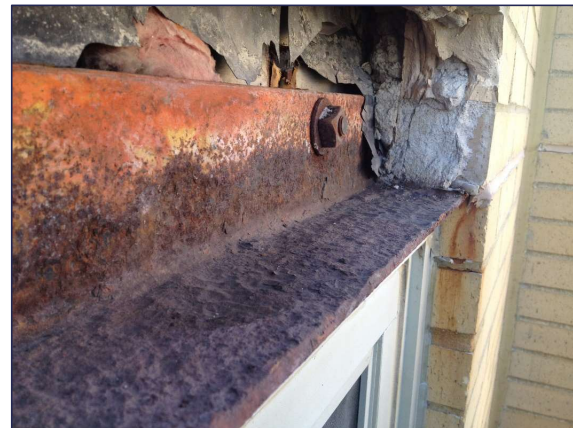
- ▣ Probe openings
- ▣ Flashing
  - ▣ PVC type
  - ▣ Still flexible!
- ▣ Shelf angle corrosion
  - ▣ Minor: visible surface oxidation
  - ▣ Moderate: surface pitting
  - ▣ Severe: flaking, section loss

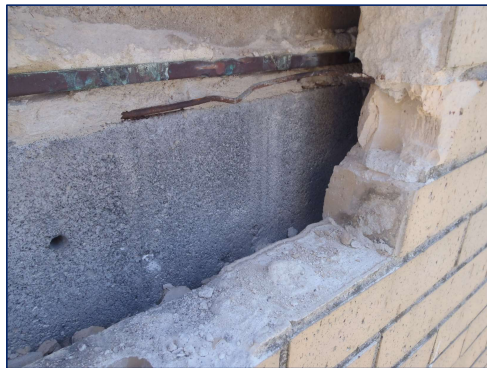
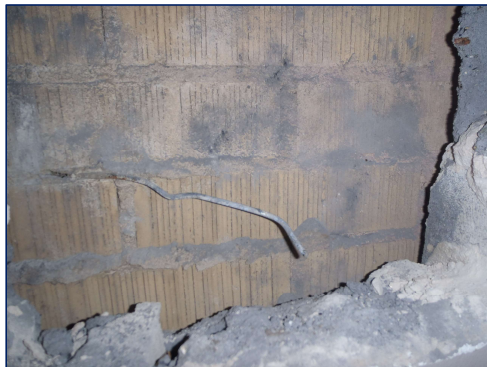
- ▣ Veneer anchors

- ▣ Minor – moderate corrosion

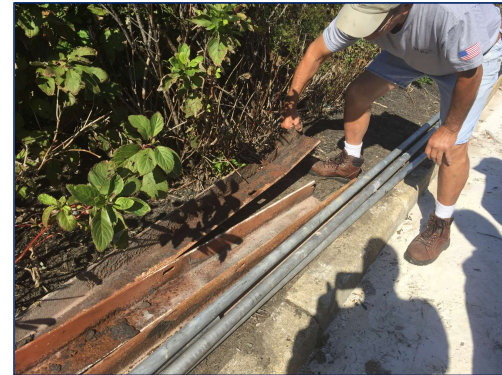
- ▣ Shelf angles

- ▣ Much worse than expected!
