# Arecibo Observatory Auxiliary Main Cable Socket Failure Investigation

## 2023 Structural Engineering Webinar Series

Jonathan C. McGormley, P.E., S.E.

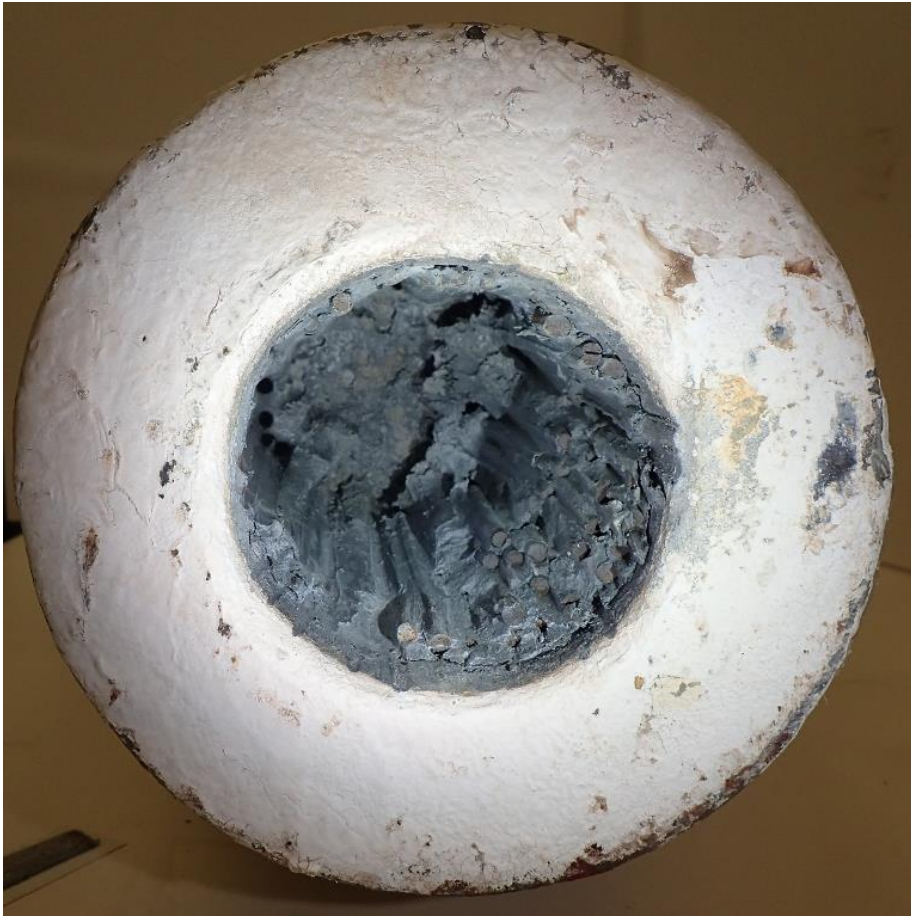
A12W AUX showing about 1 3/8-inch extension (May 2018)

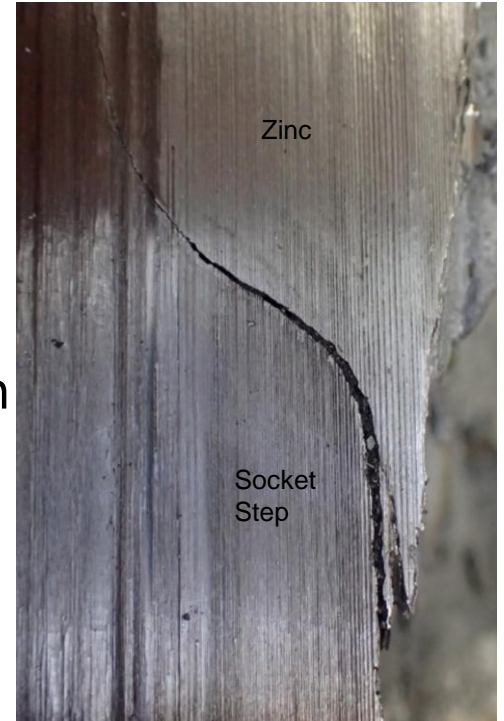
- The open socket for M4N AUX conformed to the construction documents
- There were no identified defects with the casting
- The small step at the front of the socket has been discontinued as it was attributed to excessive bending in the perimeter wires and consistent with advanced modeling results
- Sockets with steps have performed reliably

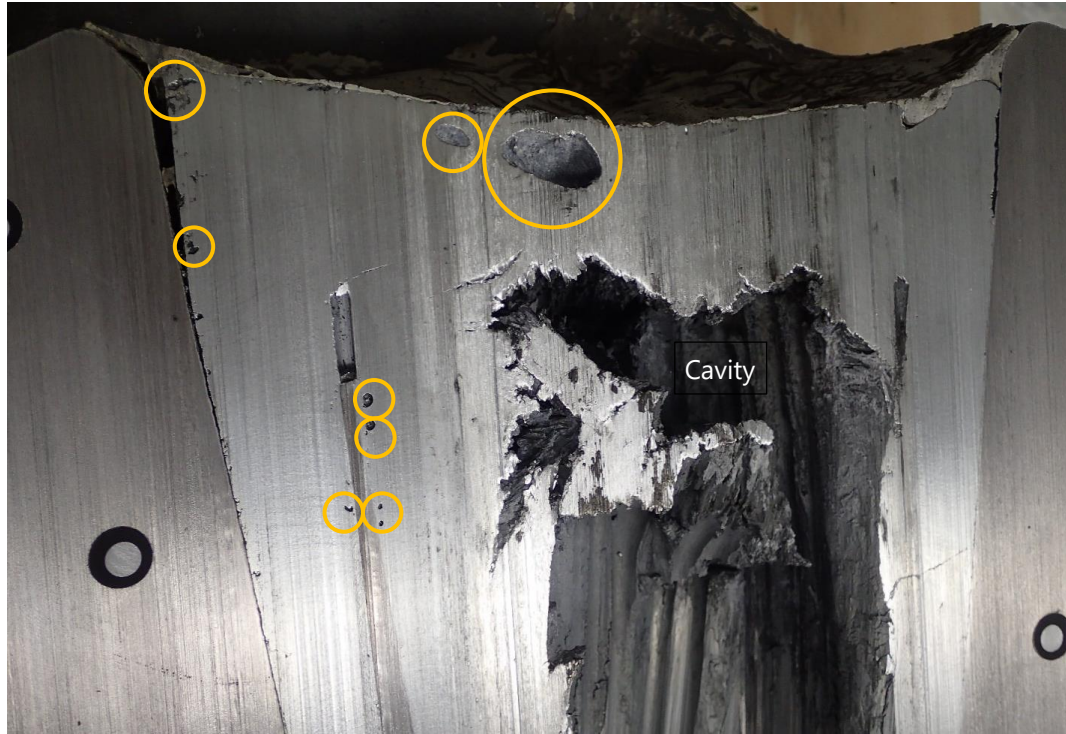
- Voids in zinc are common, particularly at the top
- Largest voids were located near the top of the socket which appears to have minimal effect on performance
- Large void near top possibly created when movement of spelter under load caused separation

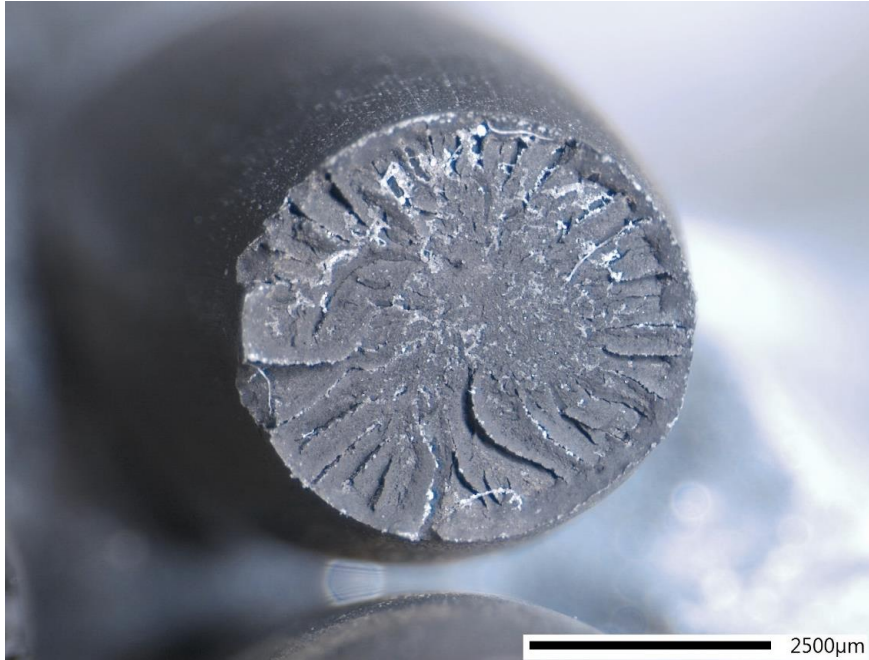
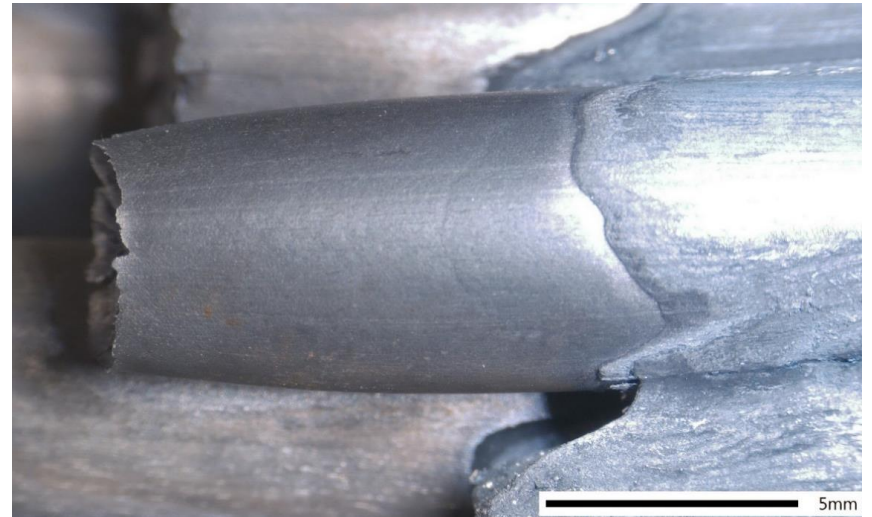
Wire EH

# Cup-Cone Fracture

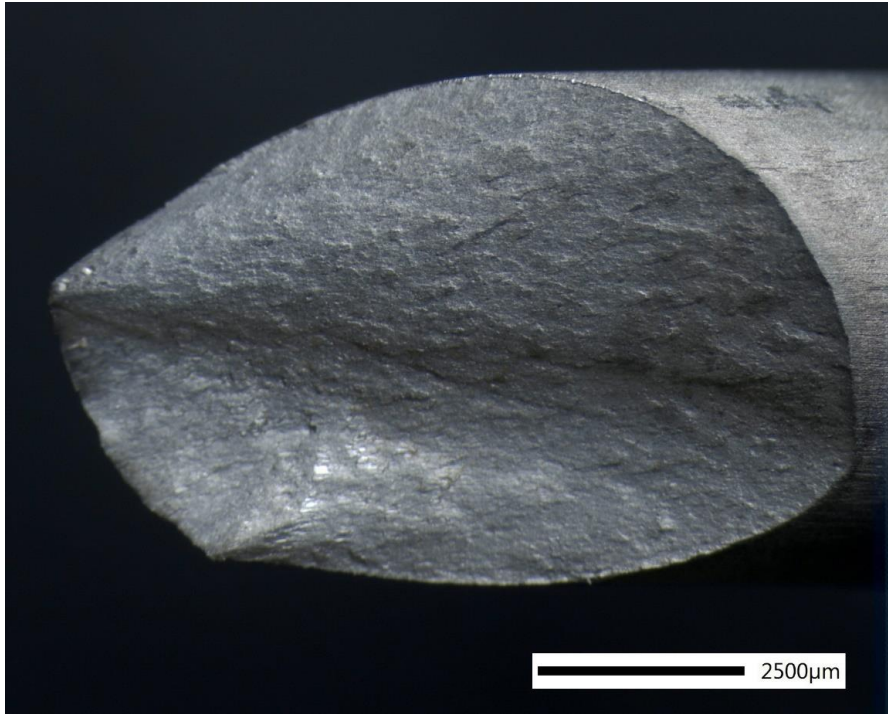
Wire G

# Slant Shear Fracture

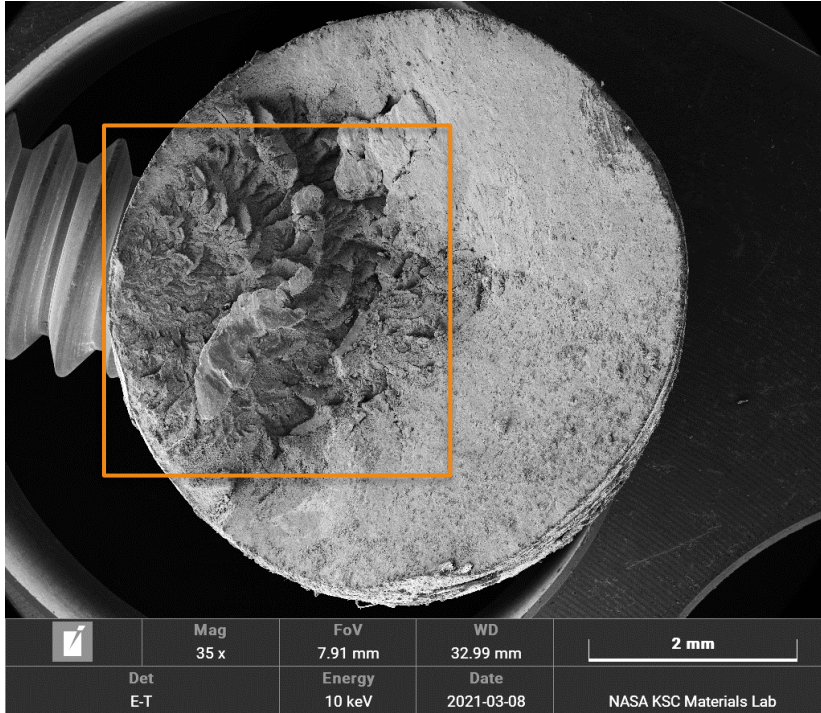
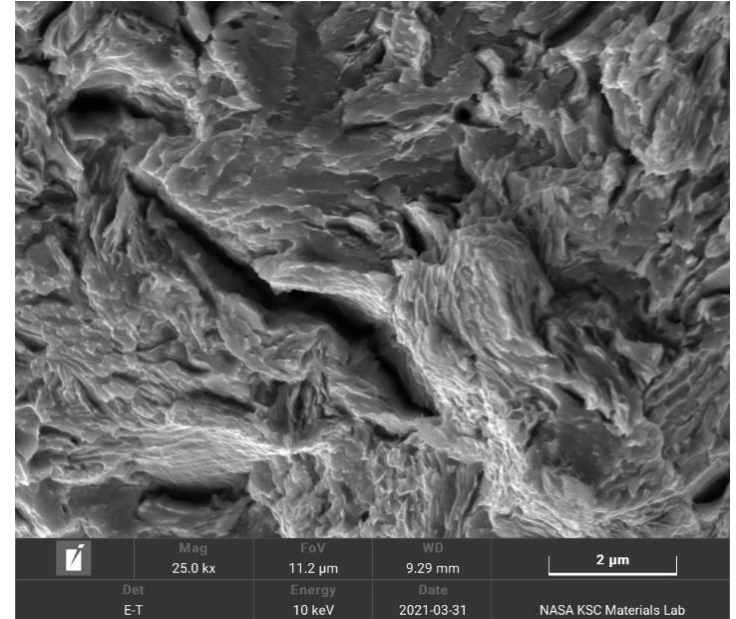
Wire AF Shown, Wire AI and Wire BA similar HAC

- Cathodic hydrogen produced as a byproduct of corrosion
- Three wire fractures associated with HAC failure

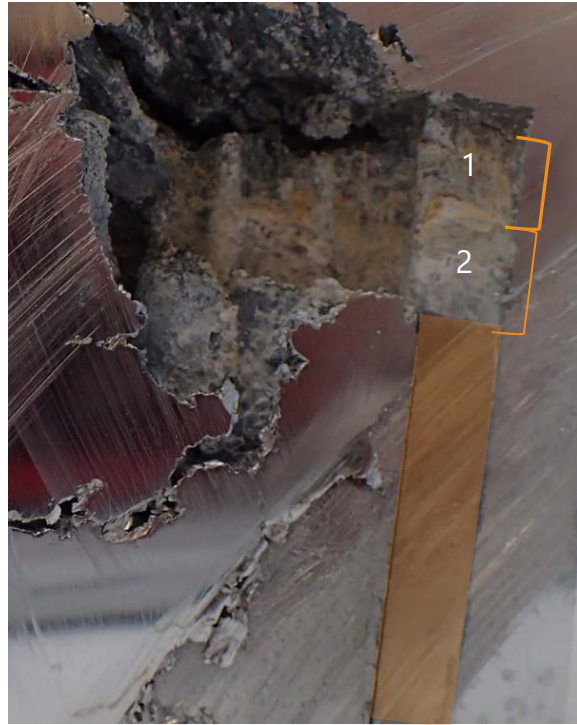
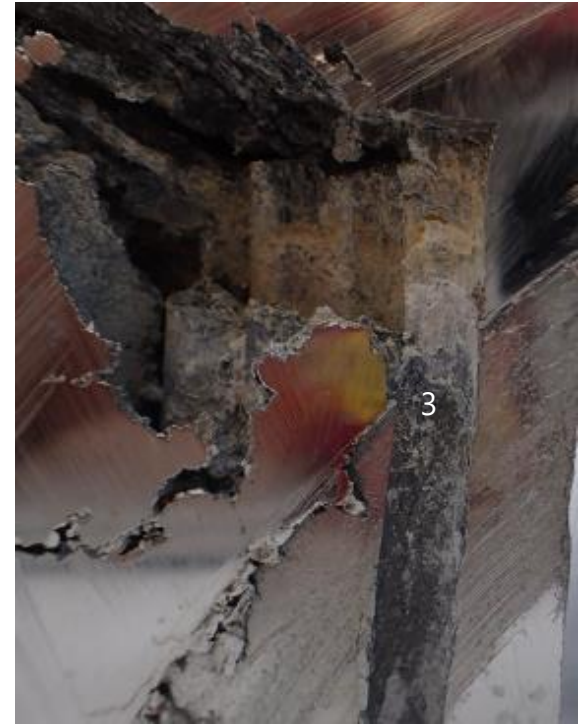
- (1) Limited zinc oxidation from slip due to proof testing and zinc seating
- (2) Presence of steel corrosion from wire end without galvanizing indicates wire in this position for long time
- (3) Second movement consistent with additional observed zinc extension
