Champlain Towers South

2023 Structural
Engineering Seminar
Series

February 21, 2023

WJE Collapse Investigation

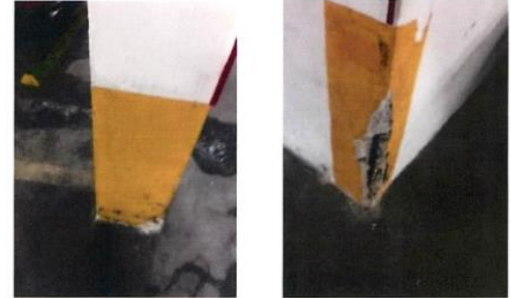
- Abundant cracking and spalling in garage with calcium carbonate leaching
- Timely repair recommended following ICRI recommendations
- Previous repairs failing due to poor workmanship
- Recommend entrance/pool decks slabs showing distress be removed in their entirety and replaced

Figure J1: Typical cracking and spalling at parking garage columns

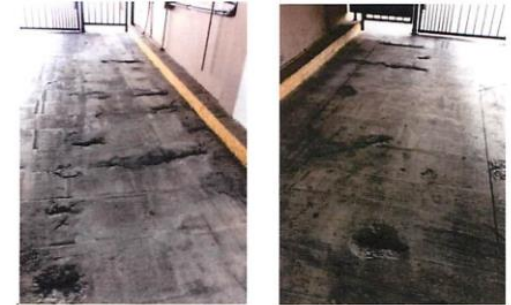
Figure J2: Spalling with exposed steel reinforcement at topside of garage deck.

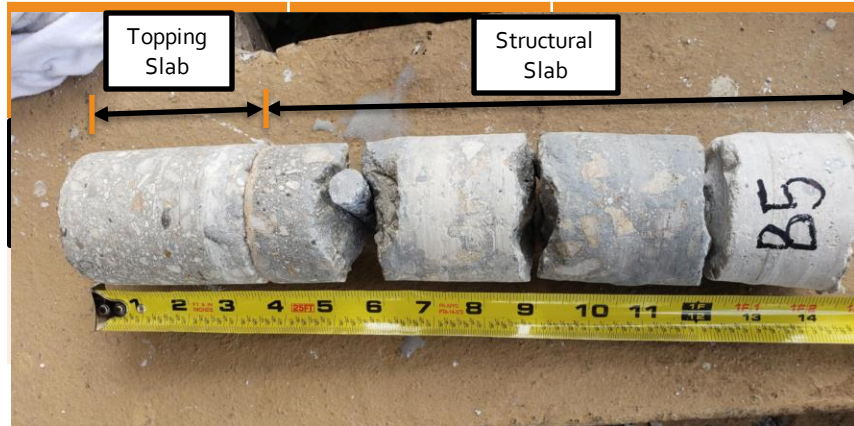
Parking Deck

NOT included in the original structural drawings

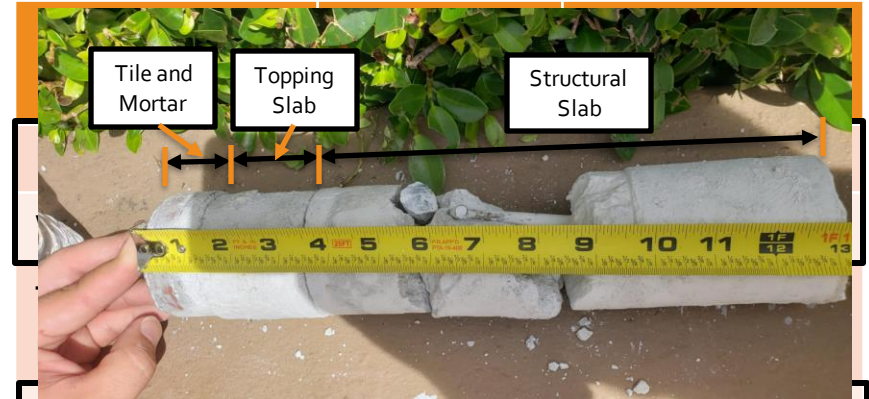
Pool Deck

Concrete	2.1	<i>Varies, not shown in plan</i>
Topping		
Structural Slab	9.5	9.5

*submittal not available, assumed to be as specified

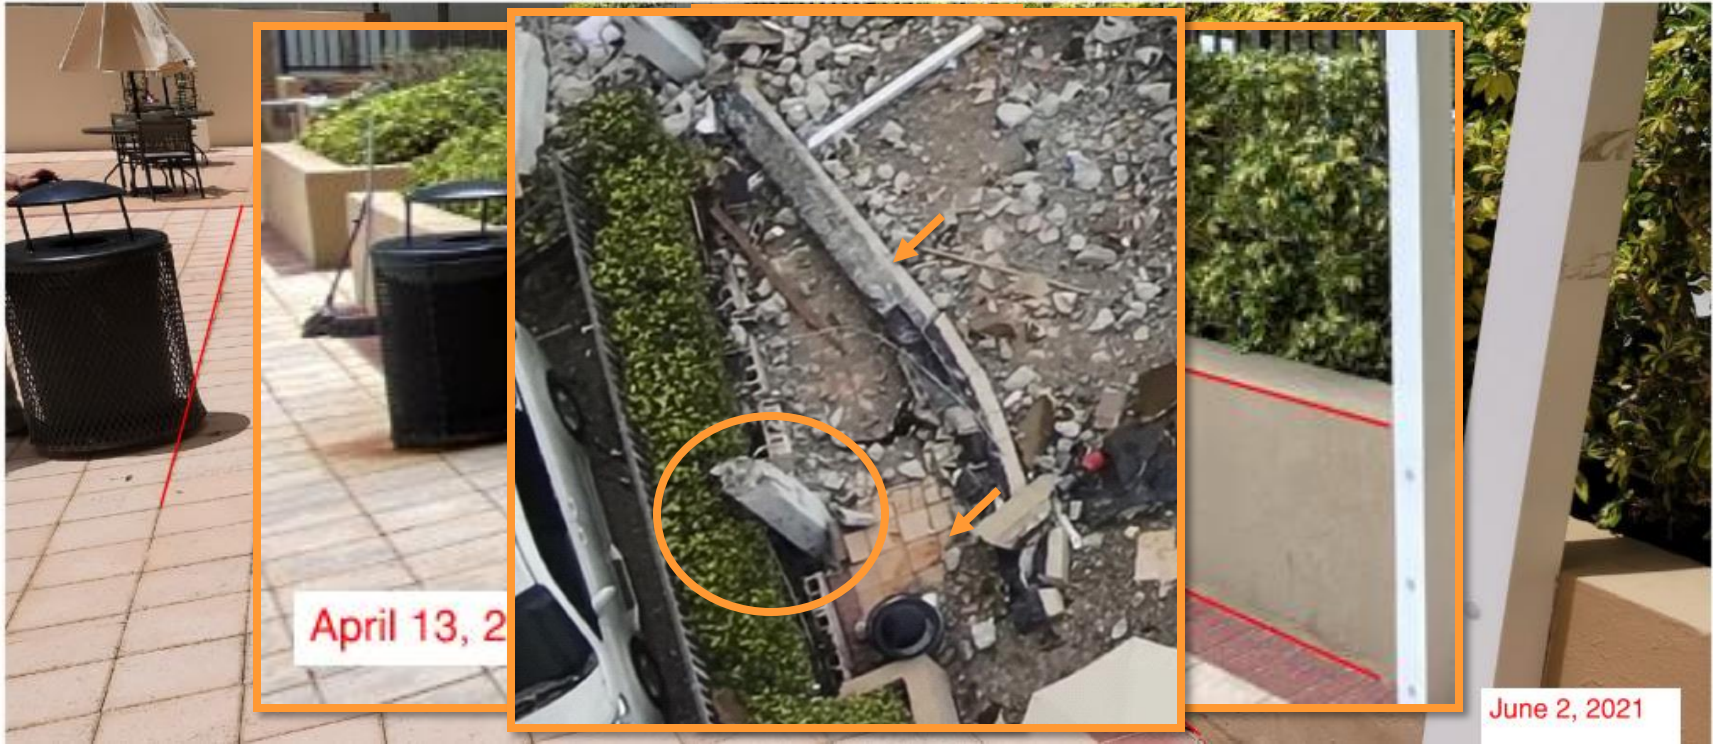
K13.1 Slab/Planter Distress - June 2, 2021

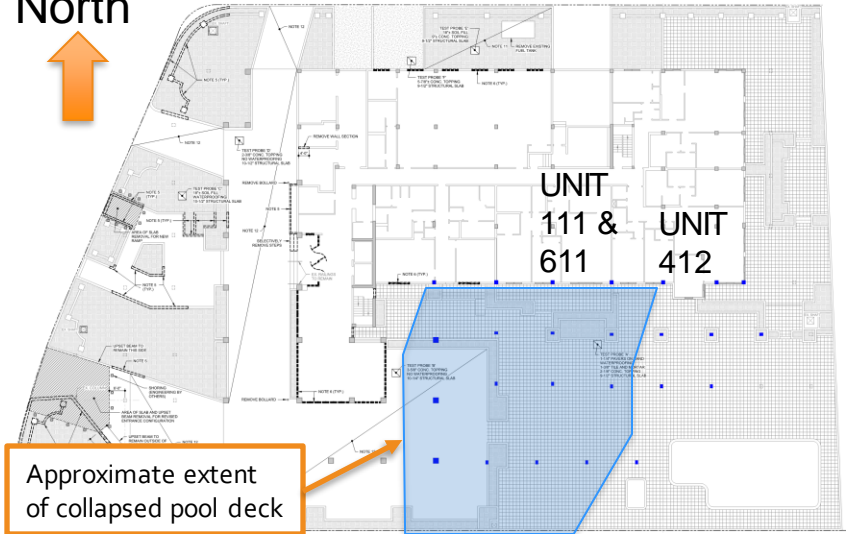
Approximate extent of collapsed pool deck

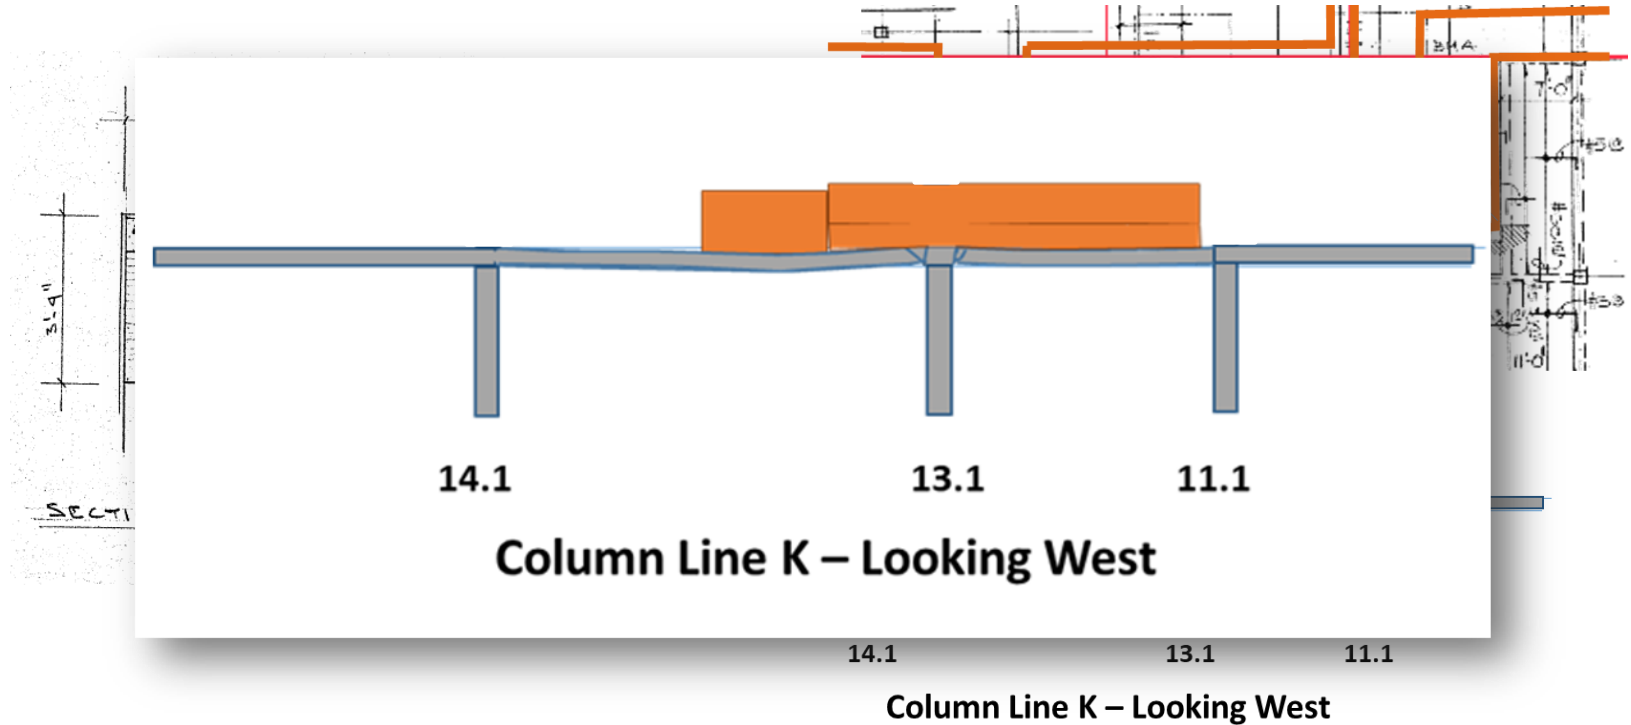
K/13.1 Likely Slab Distress Mechanism

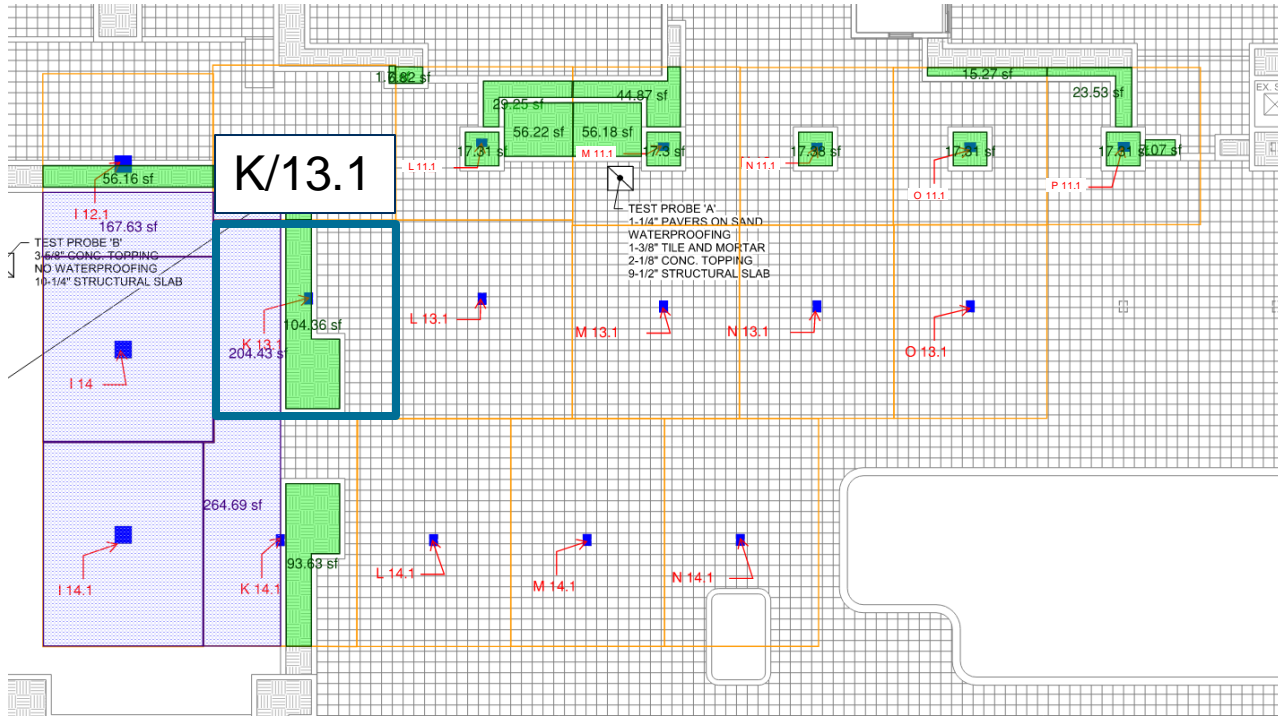
Pool Deck – At Collapse

Pool Deck Punching Shear (K 13.1)

Column Number	K 13.1
Size (in x in)	16x12
Nominal f'_c (psi)	4000
Clear Cover (in)	0.75
Factored Load (kip)	266
Reduced Nominal Capacity (kip)	155
Demand to Capacity Ratio	1.72

Column Number	K 13.1
Size (in x in)	16x12
Estimated f'_c (psi)	5000
Clear Cover (in)	2.13
Estimated Load (D) (kip)	128
Nominal Capacity (kip)	113
Demand to Capacity Ratio	1.13
