# Lessons from Failures for Structural Engineers

**David B. Peraza, PE**  
dperaza@exponent.com

**Exponent®**

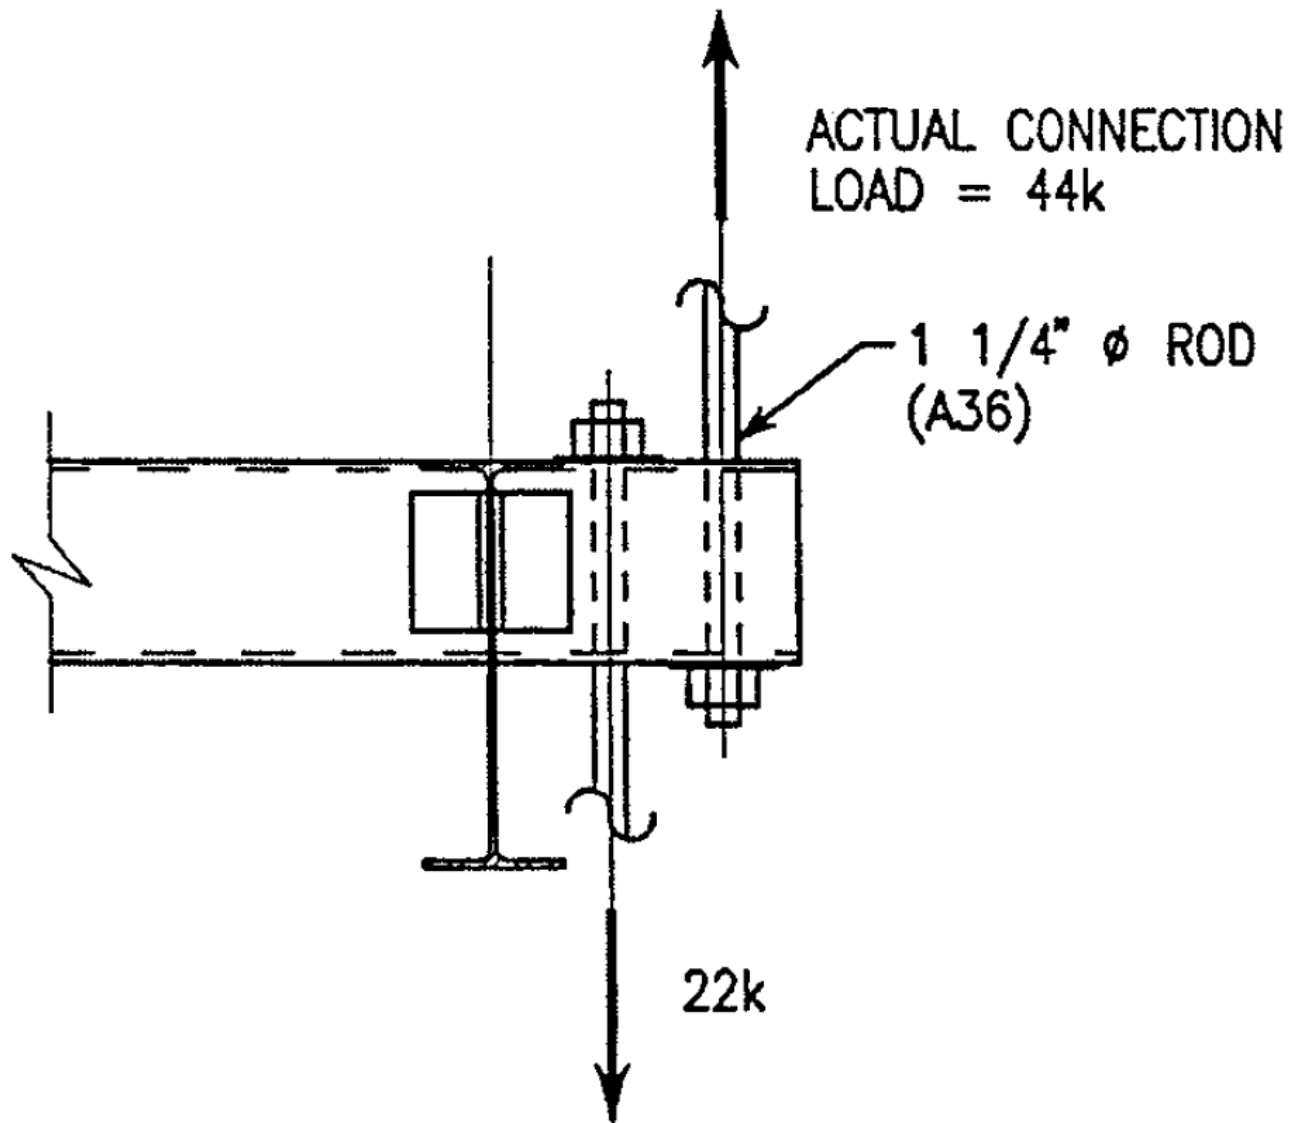
# As-Built

- Using original detail, connection strength was 60% of that required by code
- The as-built detail doubled the load on the nut
- Quality and workmanship not an issue

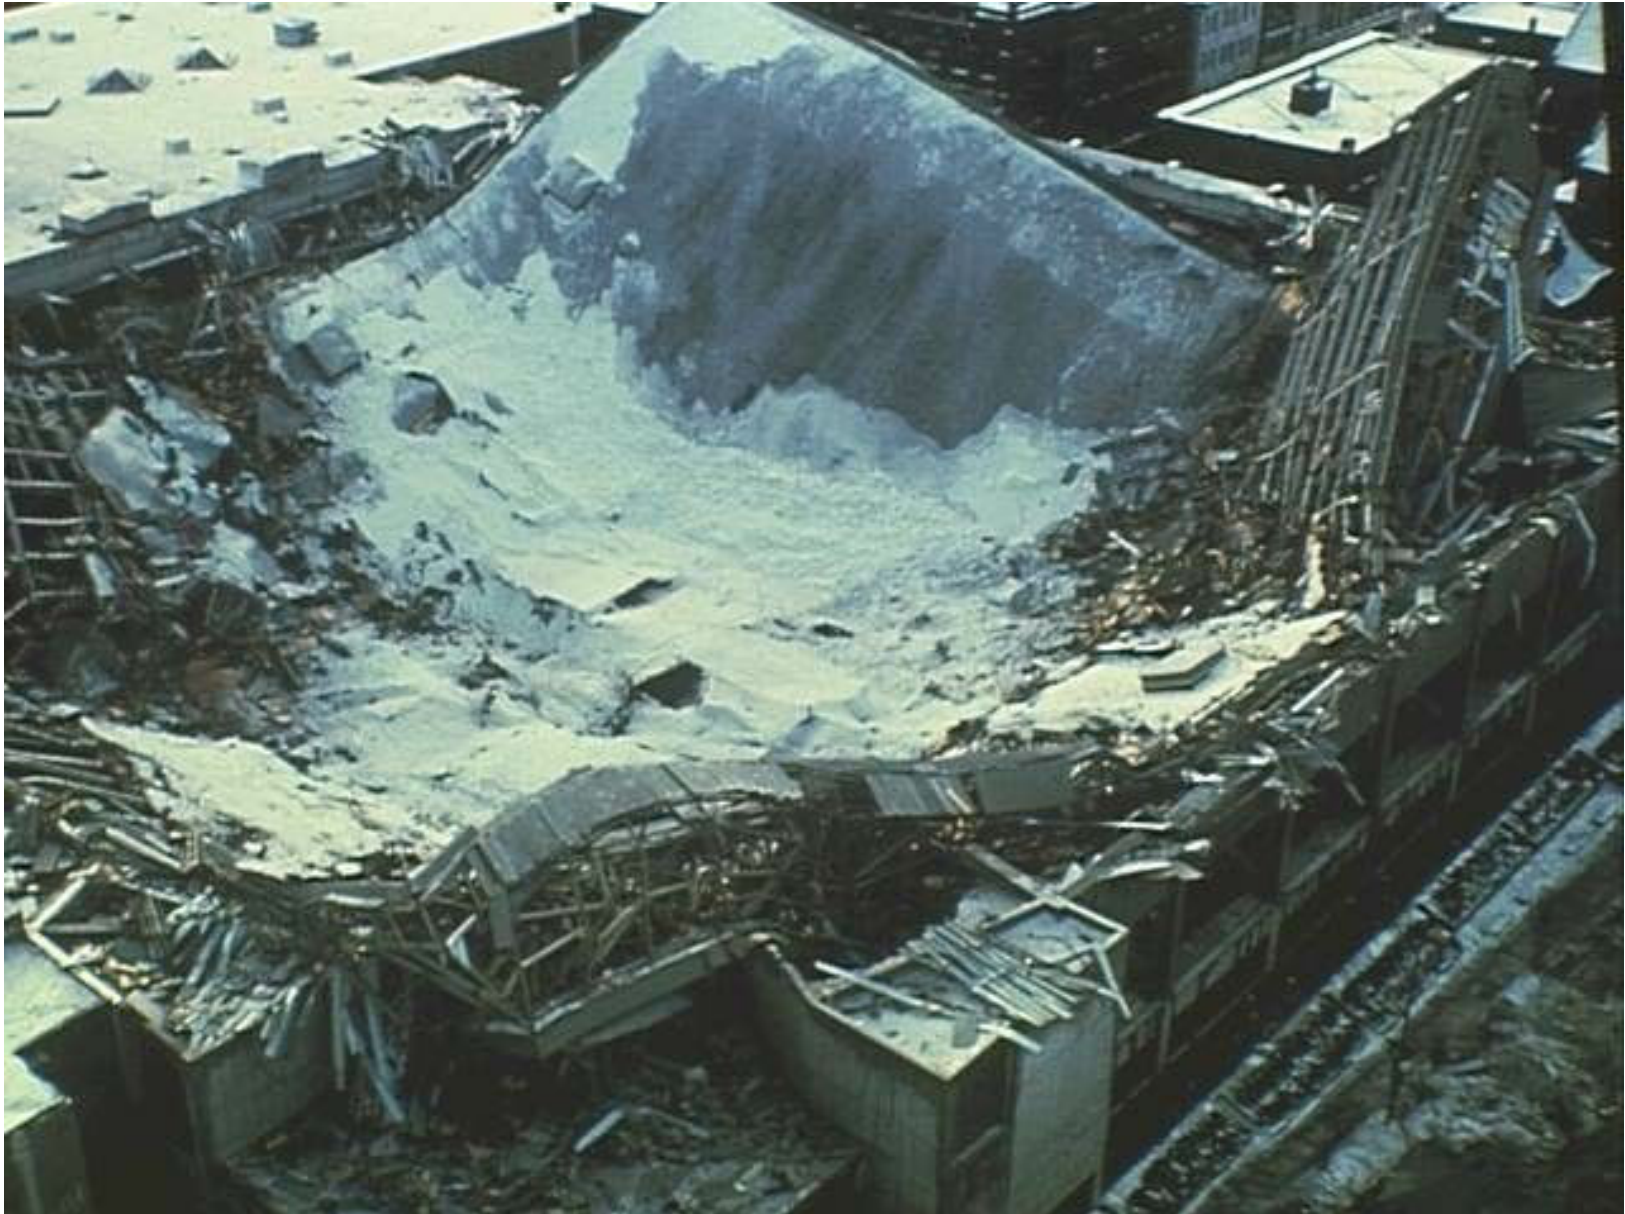
# Five Years Later...Collapse

- Snow on roof was 15-18 psf <sup>1</sup>
- Largest load roof had experienced
- Design based on full braces at midpoints
- Actual ultimate live load capacity was 15-20 psf <sup>2</sup>
- Actual dead load was 21% larger than design dead load (roofing, steel framing weight)

- **Caused by Design error**
  - Buckling (wrong unbraced length, soft braces)
  - Did not recognize bending

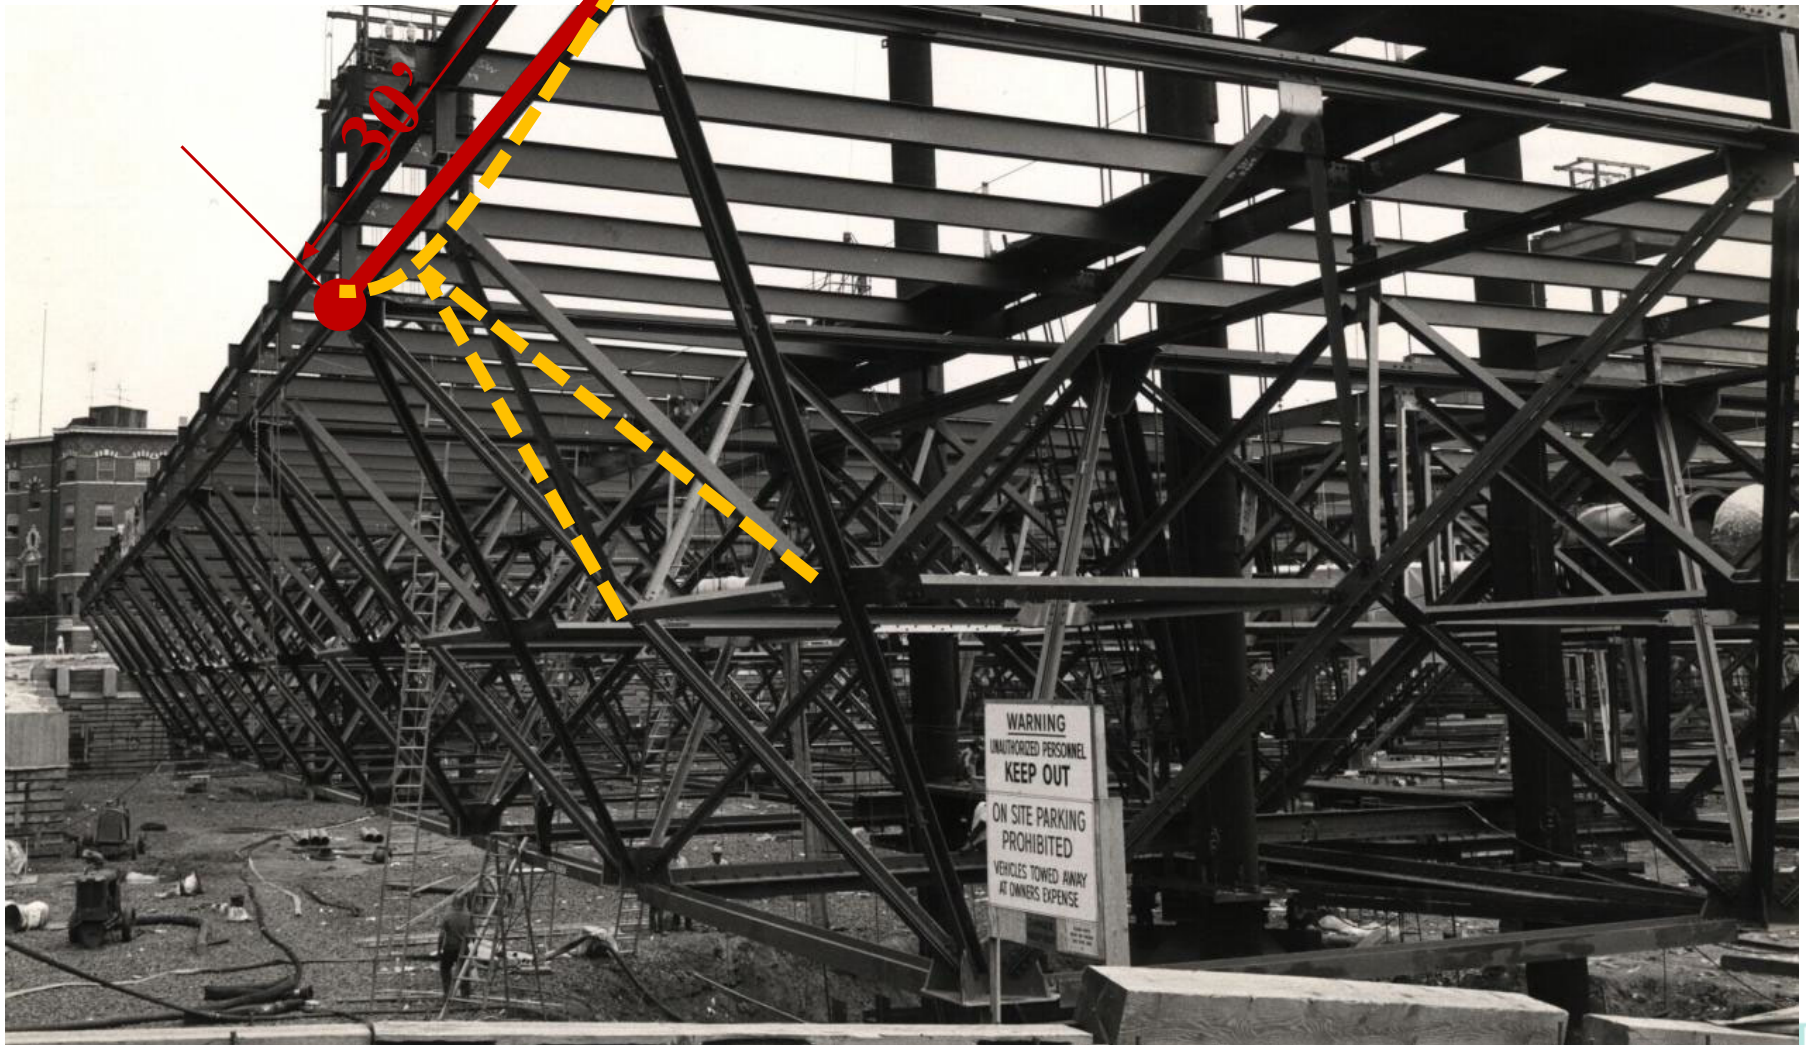
# Reality

- Unbraced length 2X assumption
- Bending

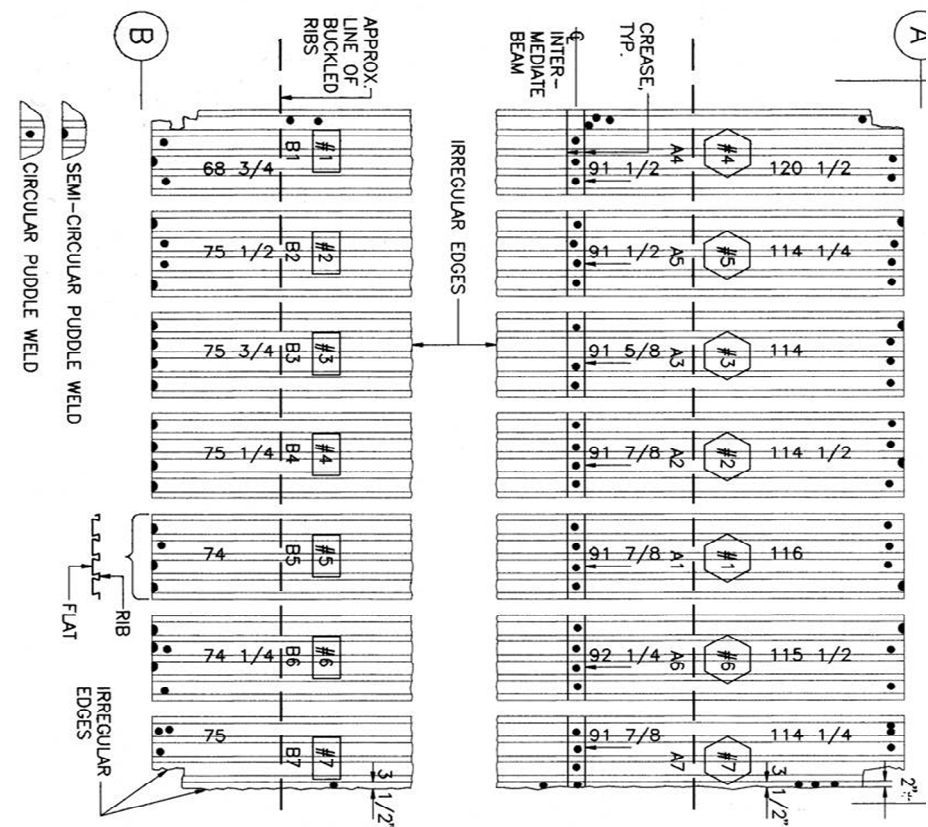
- Buckled ribs at midspan
- Crease at intermediate beam
- “Half moon” puddle welds
- No sidelap connections
- Few side welds
- No puddle weld washers

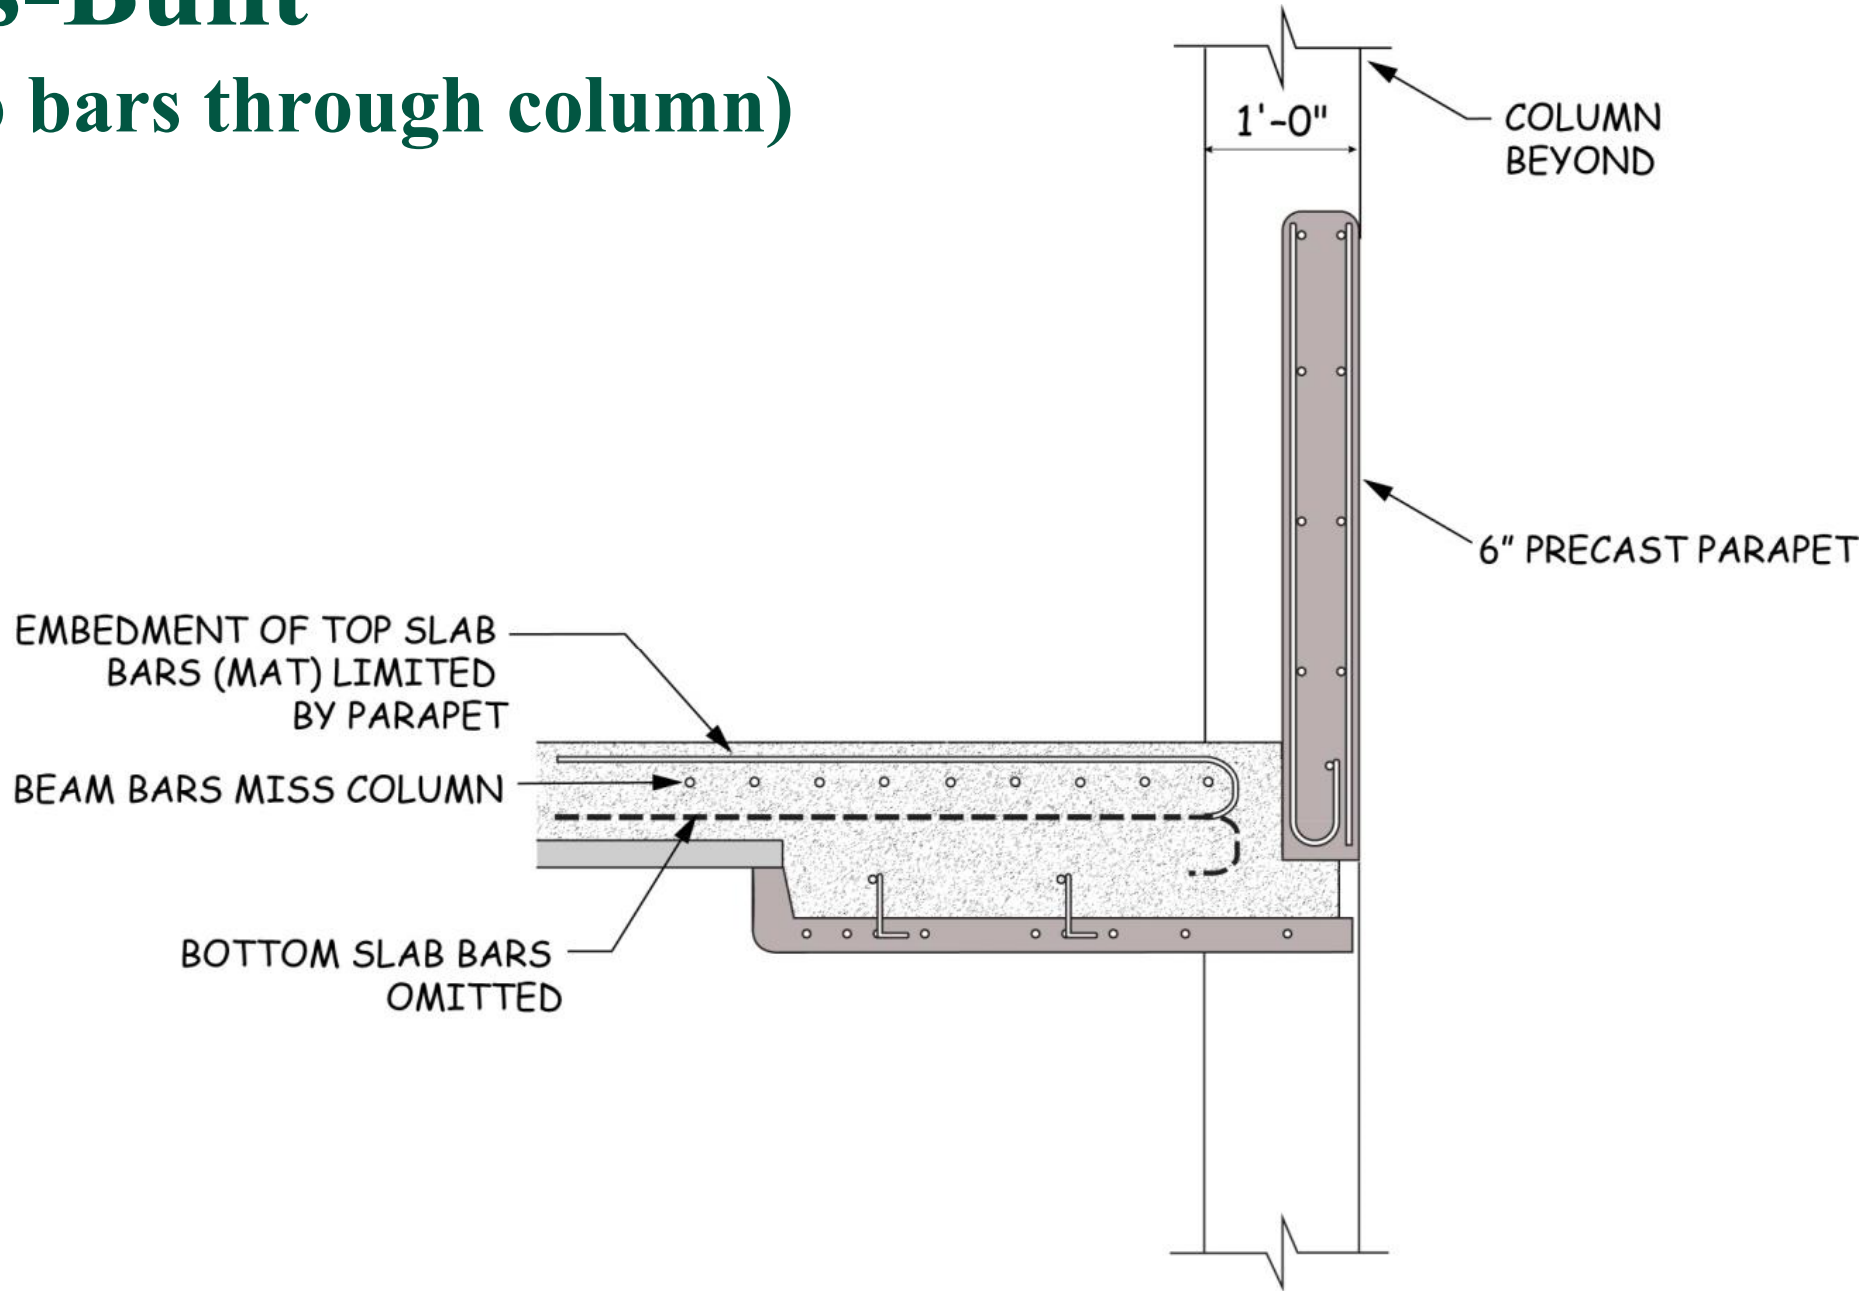
# As-Built (no bars through column)

- Inadequate punching shear strength
- Inadequate slab-to-column connections

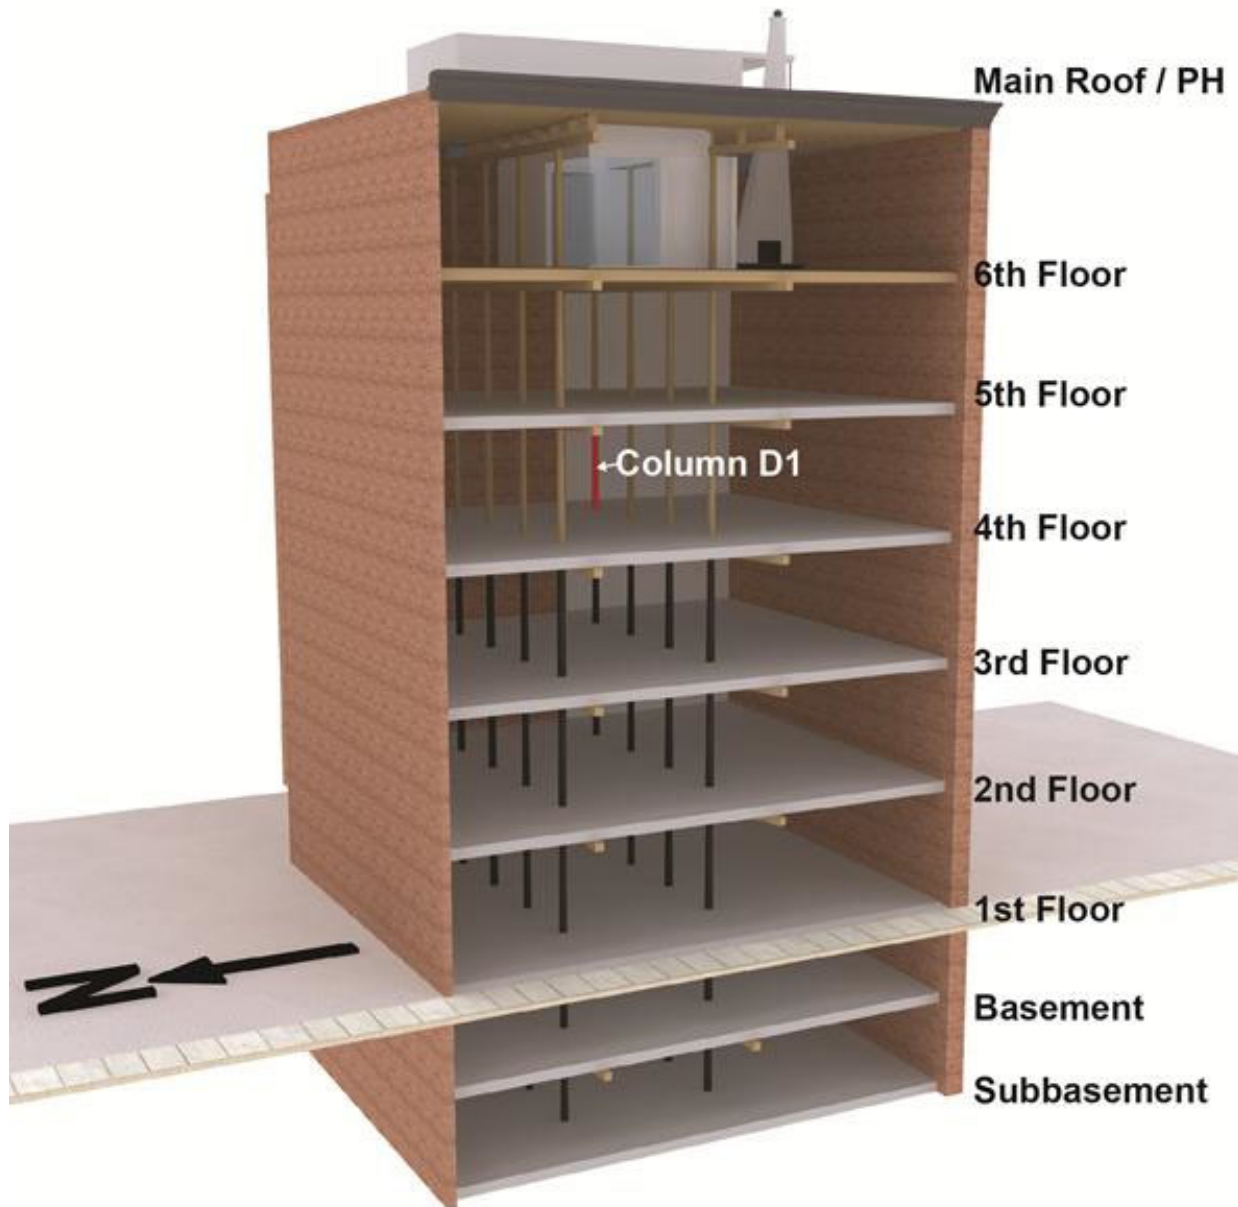
# Cross-Section

- Severely overstressed in crushing
- 79% on 4<sup>th</sup> floor
- #2 Dense Southern Yellow Pine

- Checked columns on 4<sup>th</sup> floor as if they were cast iron
- Used wrong diameter (actual area is 60% of BH area)
- Didn't recognize taper or crushing
- Didn't have columns graded

- Immediately restrict loading
- Remove penthouse
- Design new support system for penthouse that bypasses columns

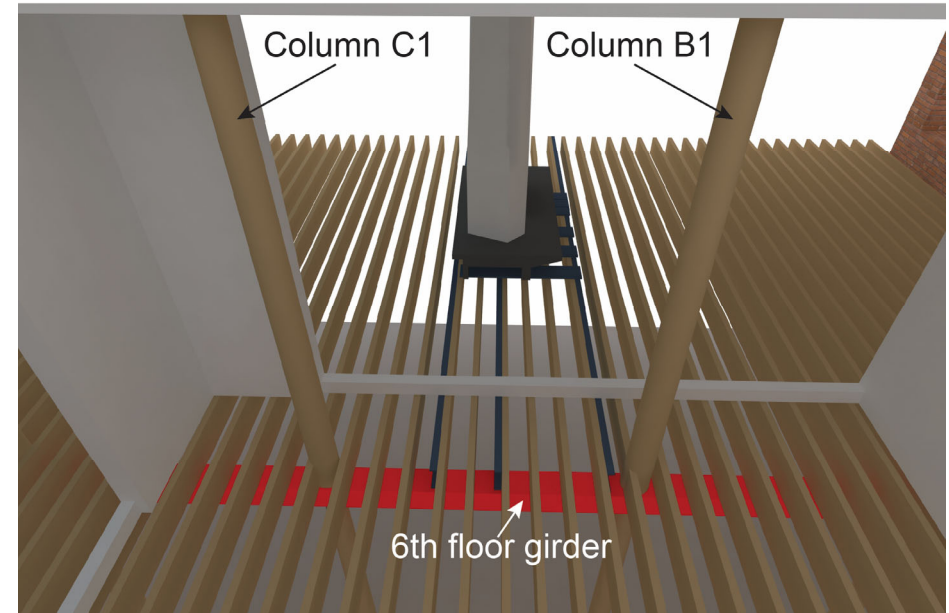
- Fireplace girder overstressed 65% in shear
- Others overstressed 23%

- Collapse of girder and fireplace
- Overstress of other girders

- Remove fireplace
- Reinforce girders to safely support courtyard loads

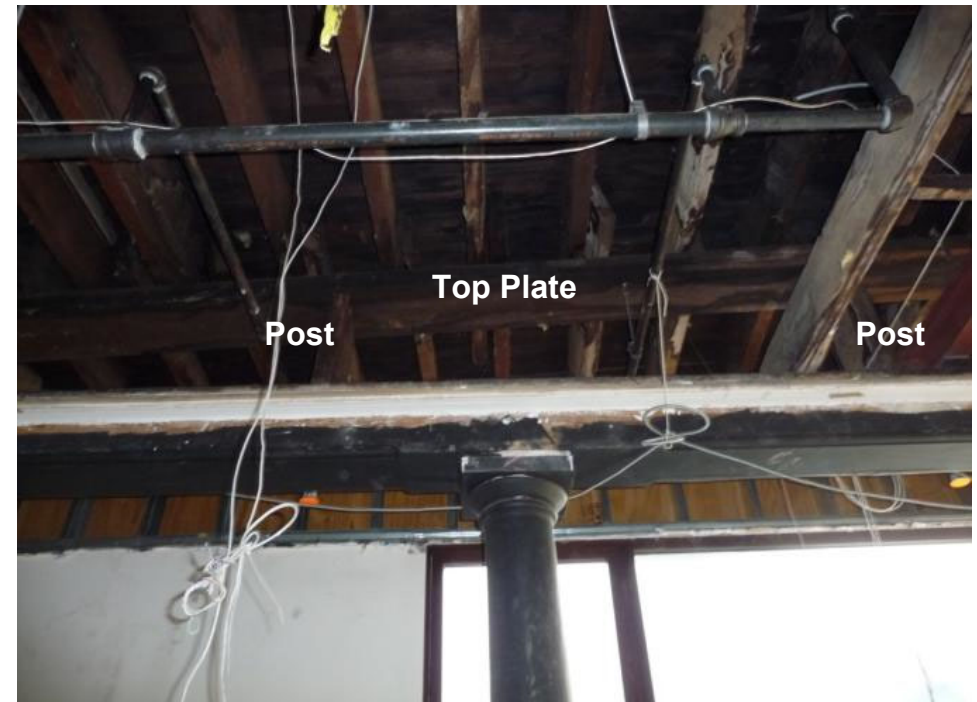
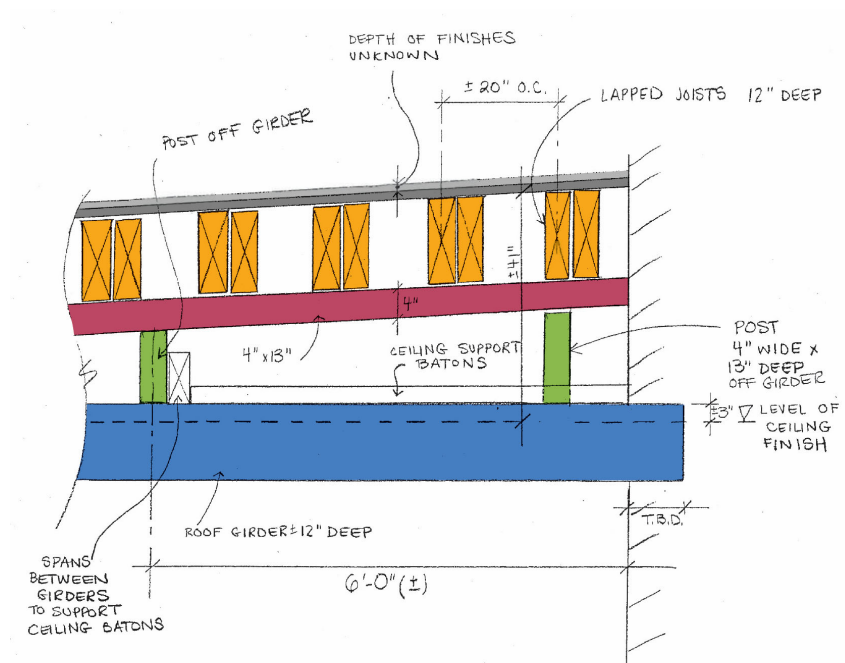
- Widely spaced posts
- Both girder lines
- Overstressed in bending and shear ~100%

- Condition forgotten on south
- Did not recognize on north
- Did not issue repair sketch for either girder line

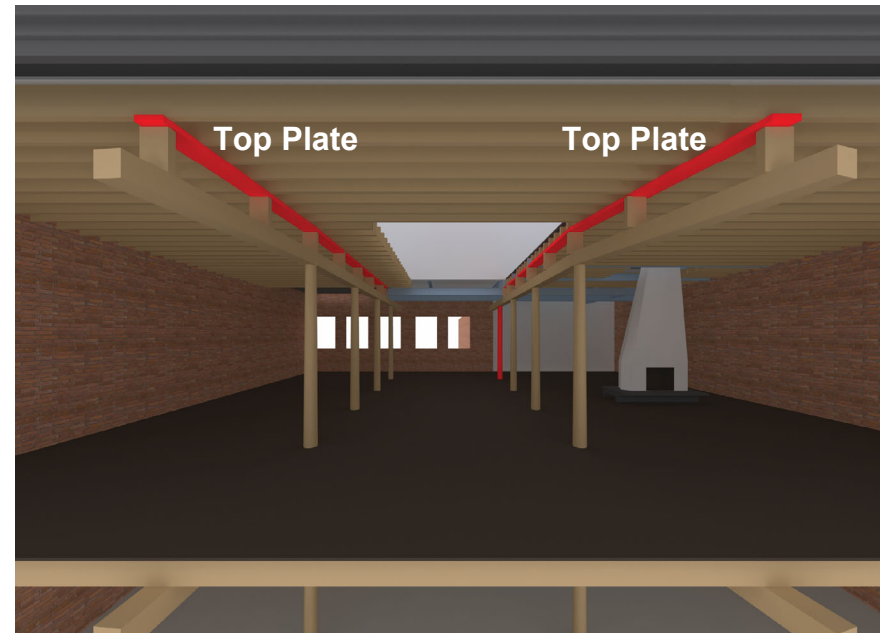
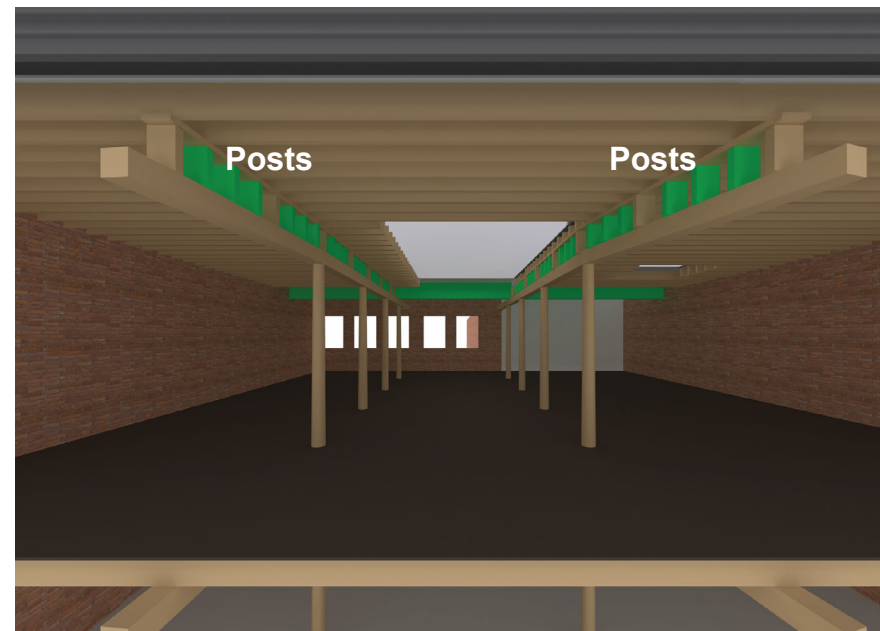
- **Potential Consequences**
  - Partial collapse of roof
- **Remedy**
  - Add posts
  - (Requires ceiling removal)

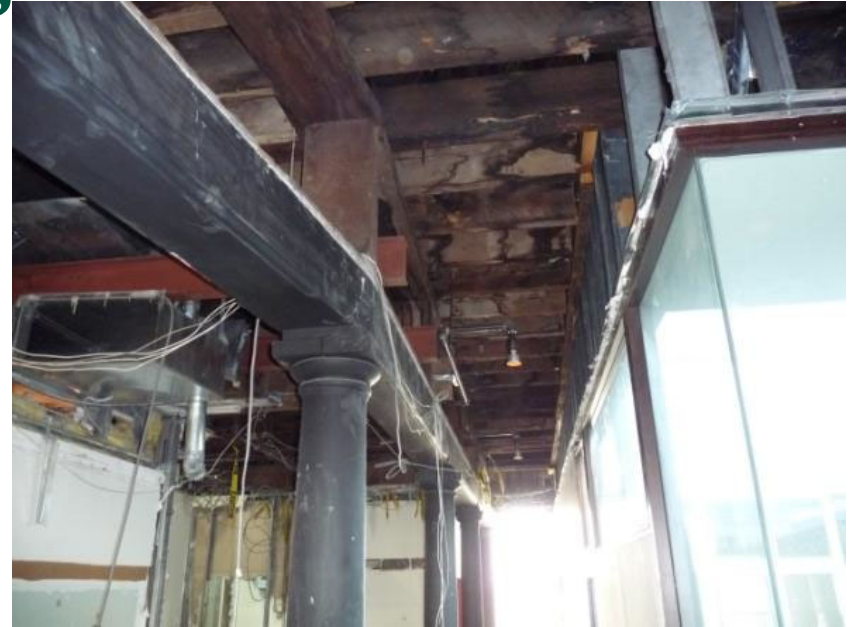
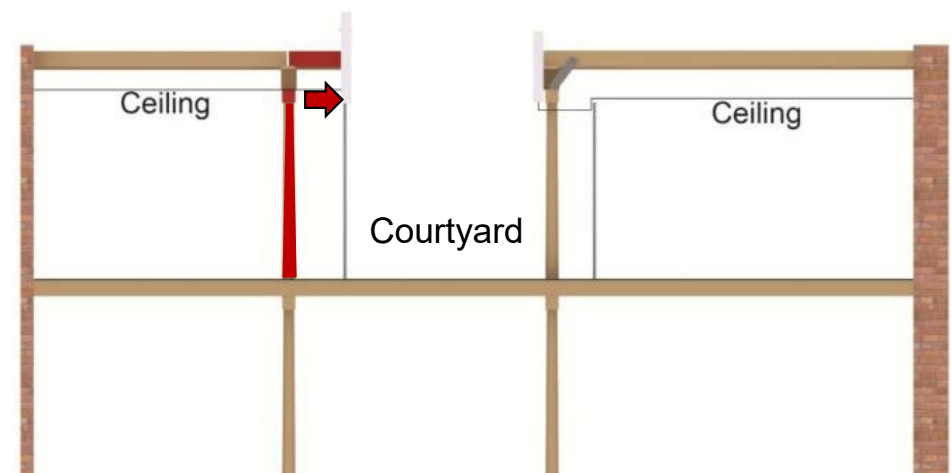
- Column line became unbraced when ceiling joists removed
- Roof loads and parapet weight on courtyard glass
- No bracing for wind loads at top of glass

- Did not recognize conditions

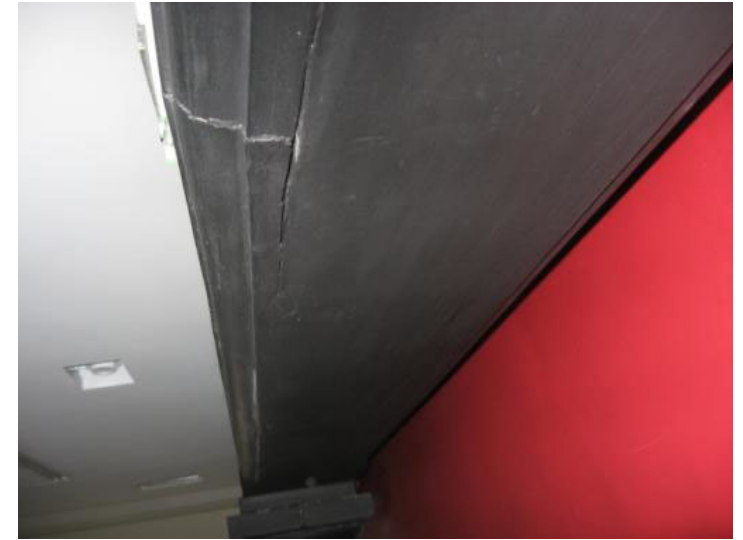
- Buckling of column line
- Damage to courtyard glass wall

- Install knee braces
- Cantilever joists
- Brace storefront to girder (after removing ceiling)
