# Arecibo Observatory Auxiliary Main Cable Socket Failure Investigation

## 2023 Structural Engineering Webinar Series

Jonathan C. McGormley, P.E., S.E.

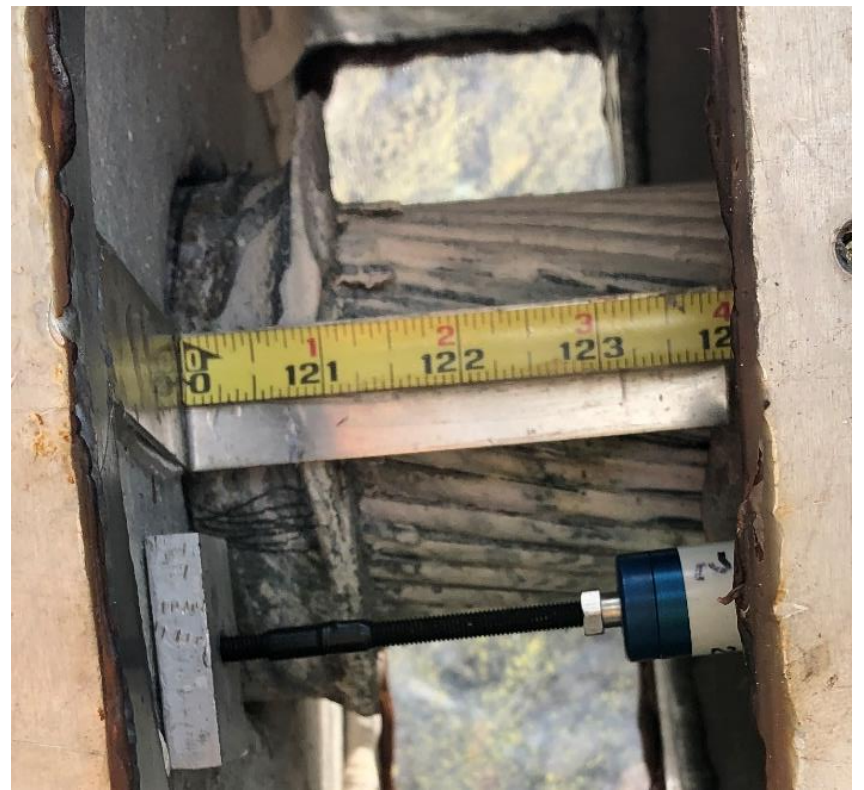
A12W AUX showing about 1 3/8-inch extension (May 2018)
