Champlain Towers South

2023 Structural
Engineering Seminar
Series

February 21, 2023

WJE Collapse Investigation

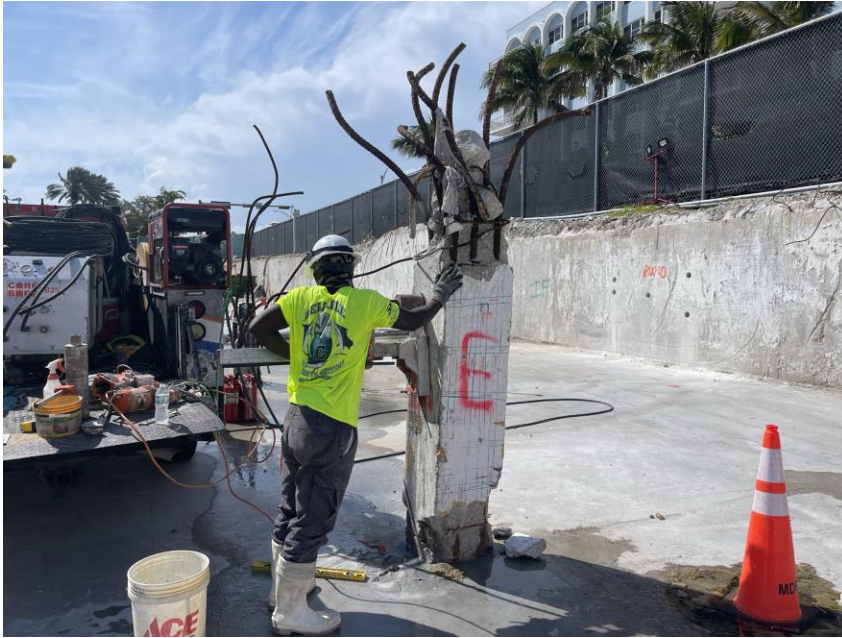
Concrete core collected from a column

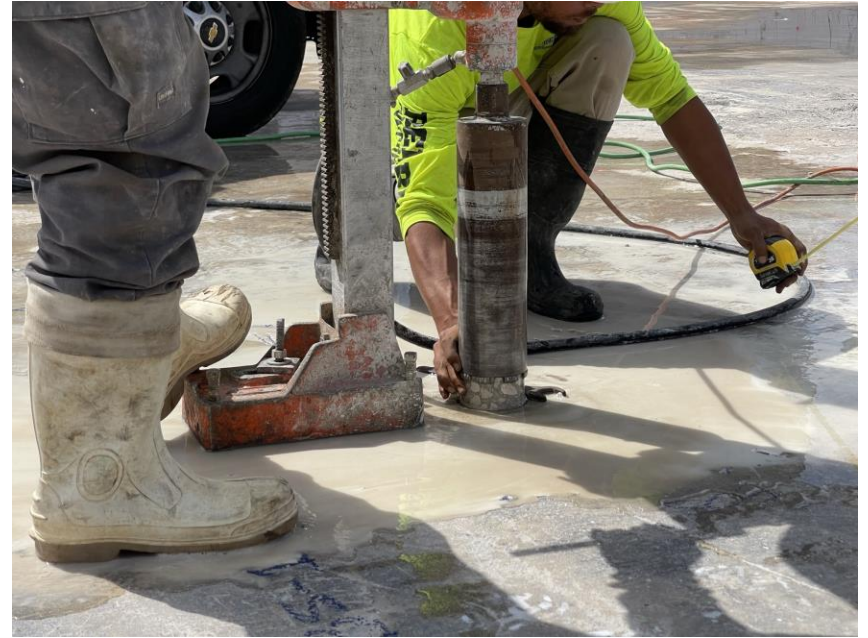
Concrete core collected from the basement slab

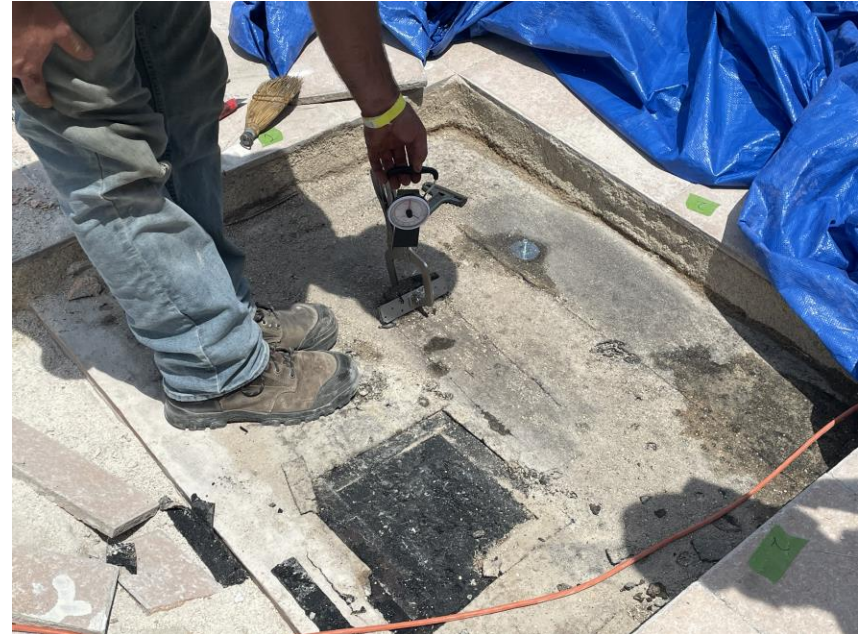
Waterproofing testing at the pool deck
