# Lessons from Failures for Structural Engineers

**David B. Peraza, PE**  
dperaza@exponent.com

**Exponent®**

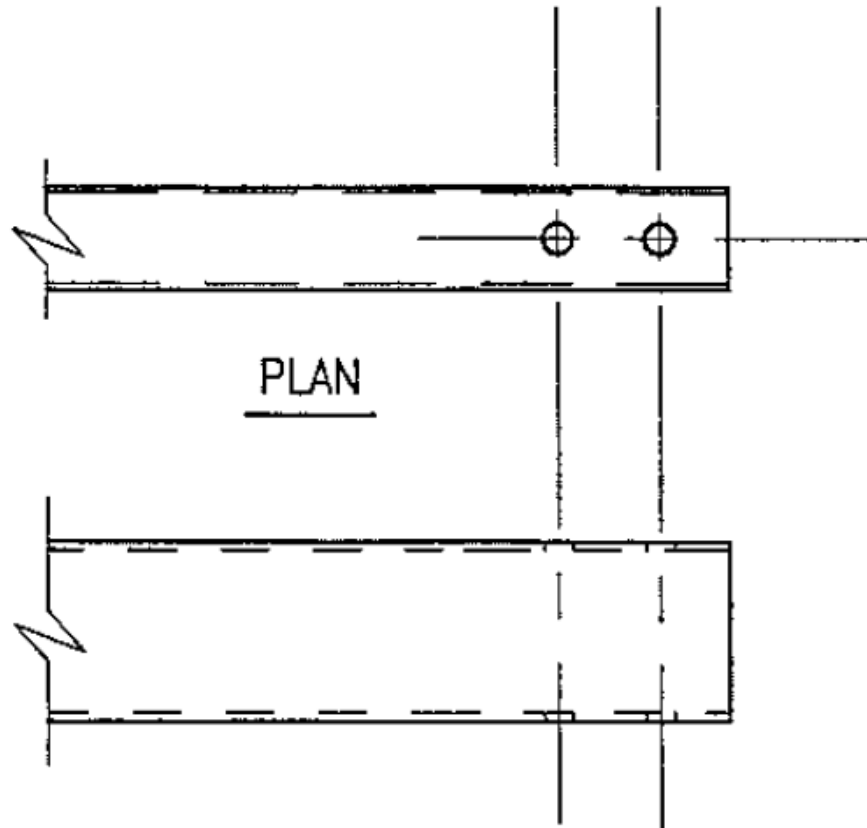
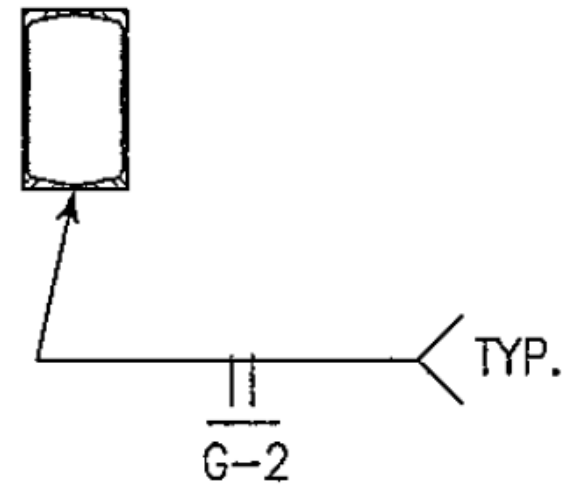
# As-Detailed

- Using original detail, connection strength was 60% of that required by code
- The as-built detail doubled the load on the nut
- Quality and workmanship not an issue

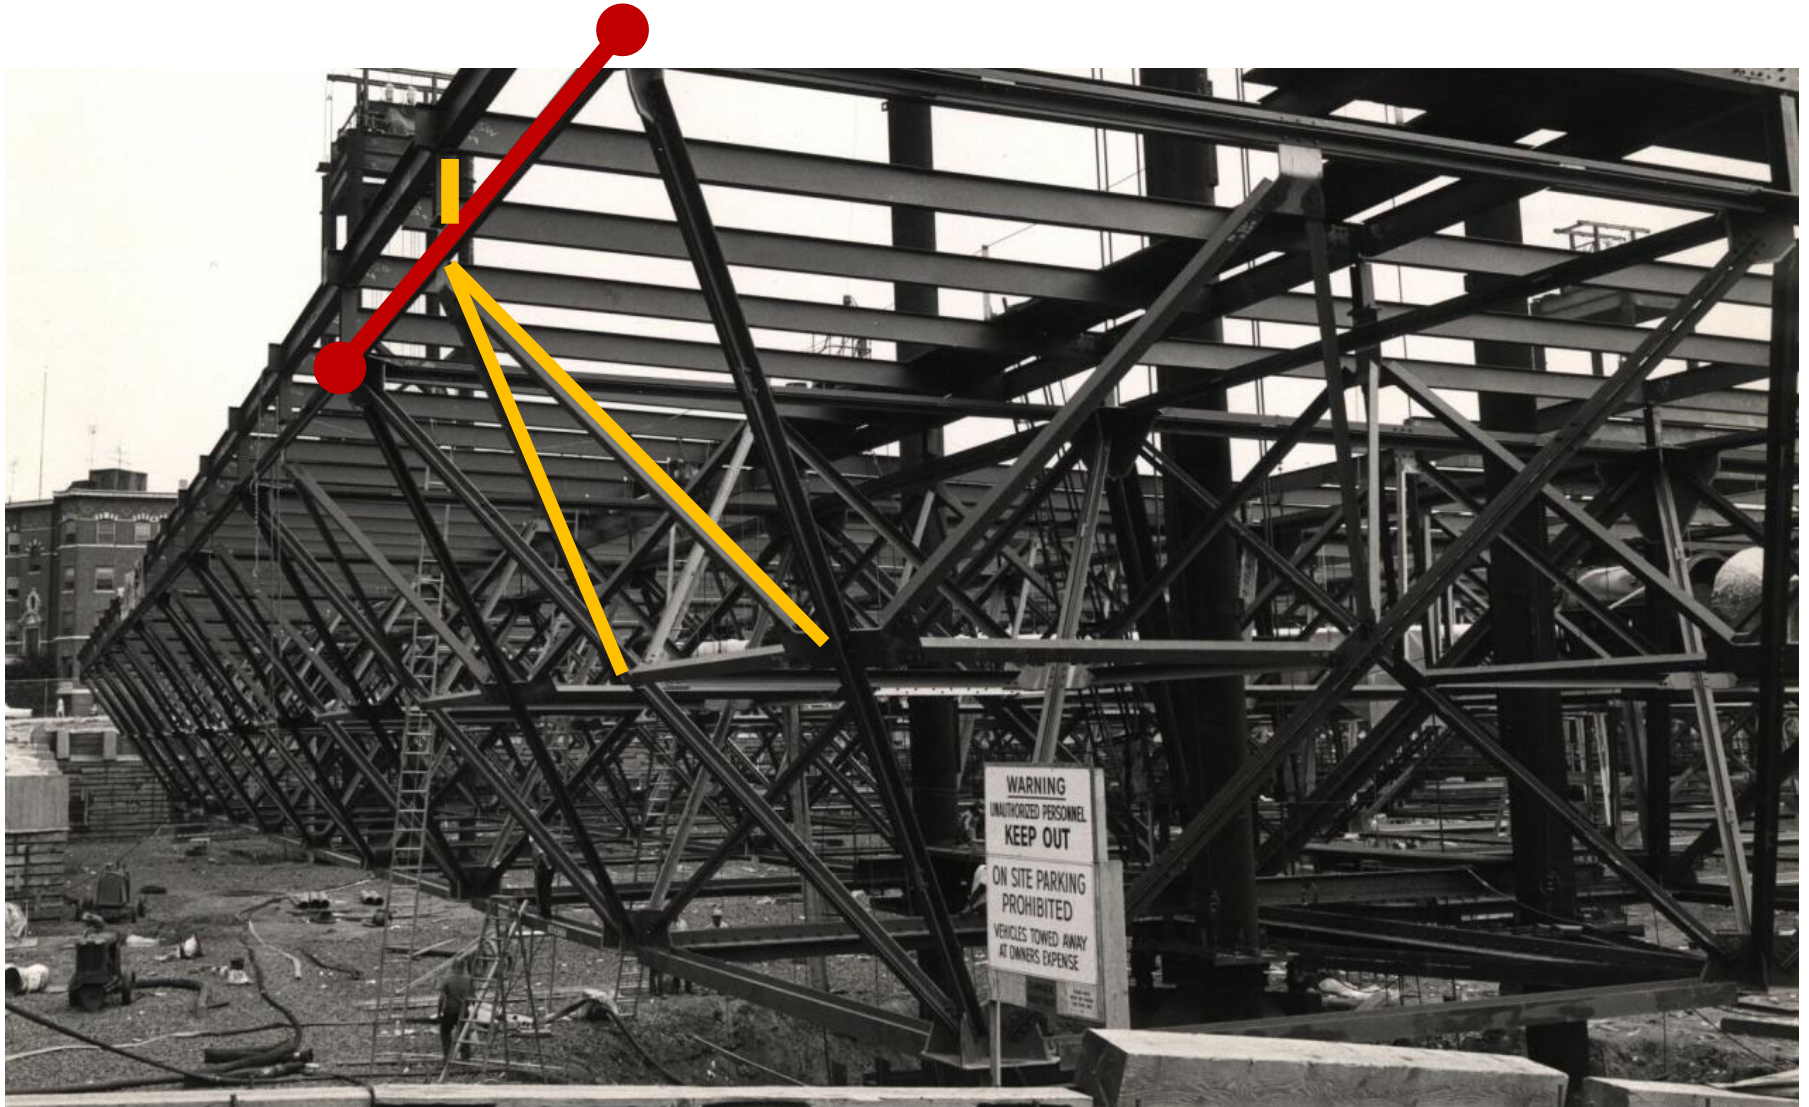
# Unbraced Length? Bending?

- Braced at midpoint
- No Bending

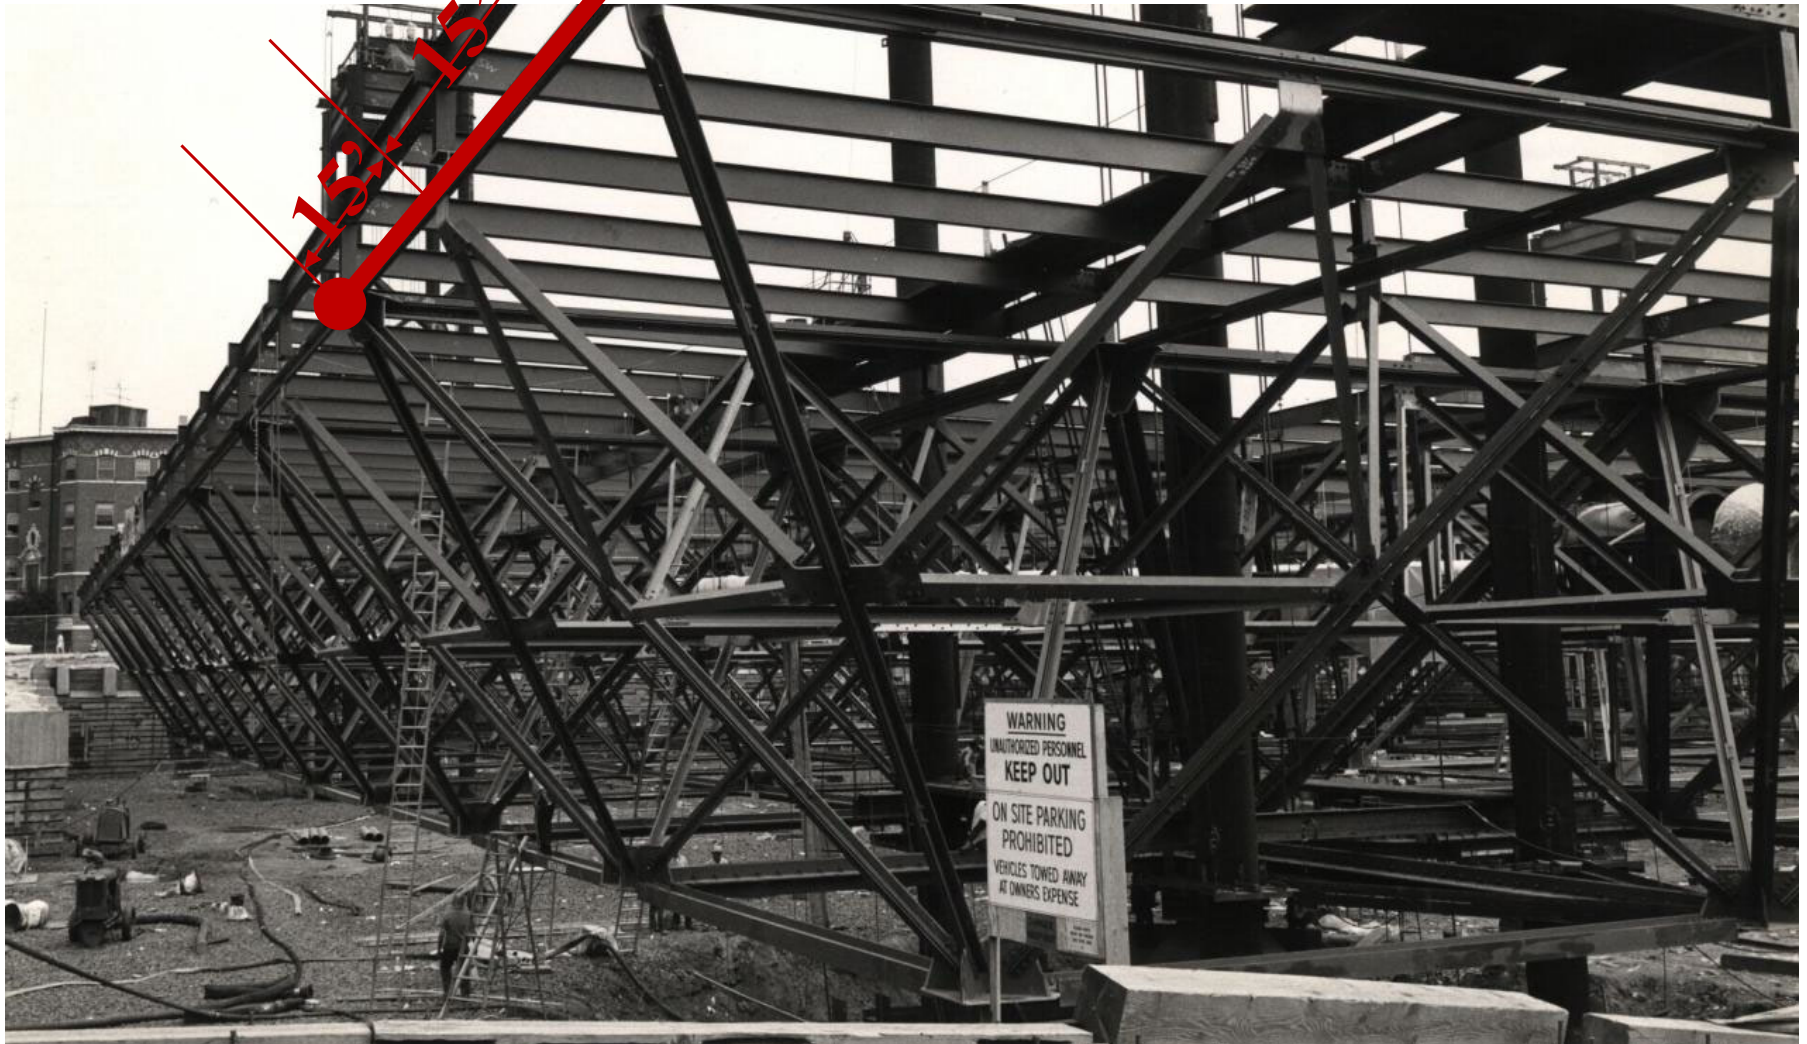
# Reality

- Unbraced length 2X assumption
- Bending

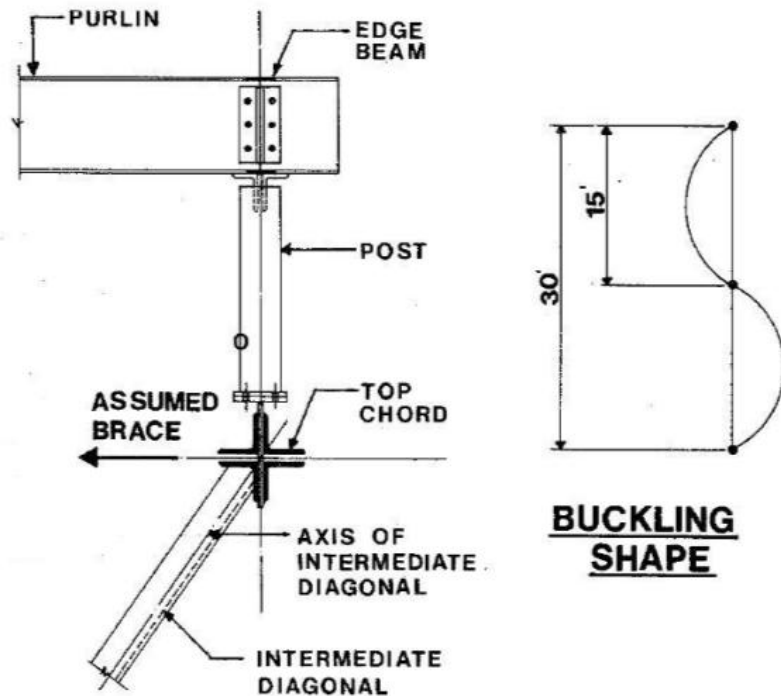
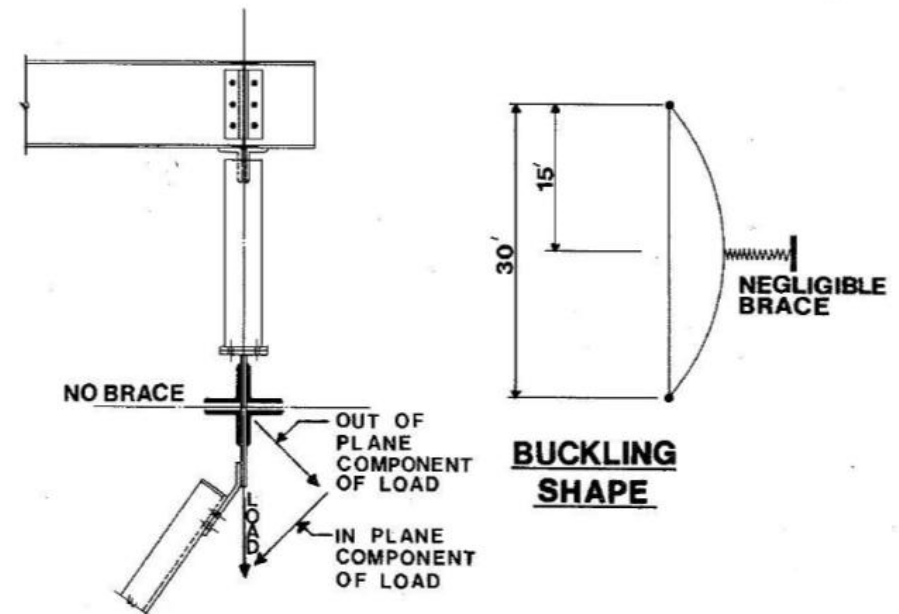
# Perimeter—with Post

Overstress: 857%

- **Design Assumption**

- 160 kip allowable compression
- No Moment

- **Actual**

- 15 kip allowable compression
- Moment

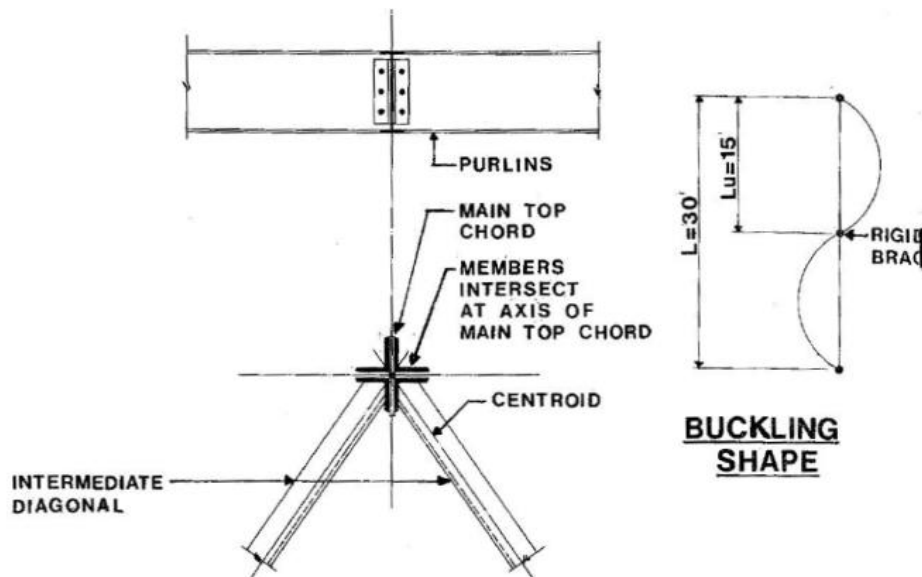
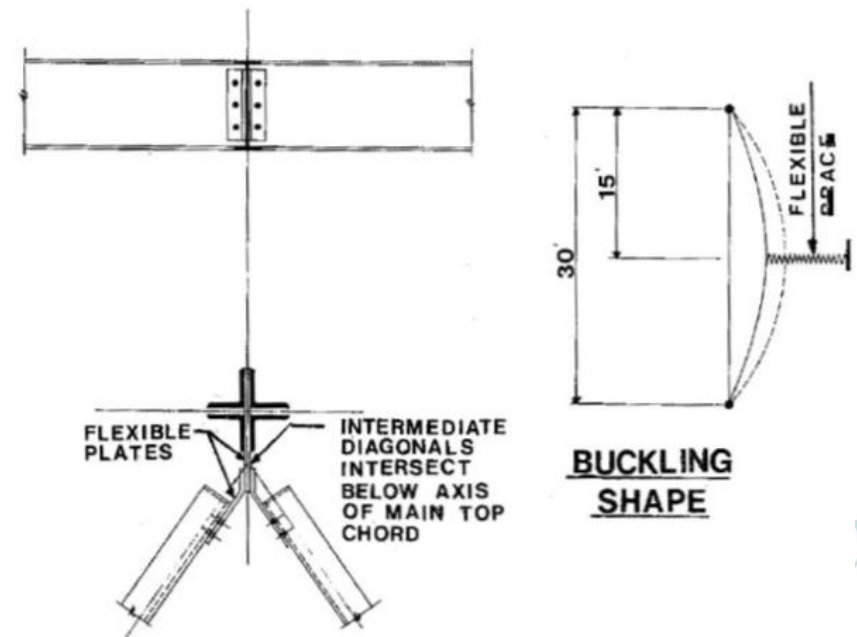
# Interior—No Post

## Overstress: 107%

- Design Assumption
  - 635 kips allowable Compression

### ◆ Actual

- 362 kips allowable compression

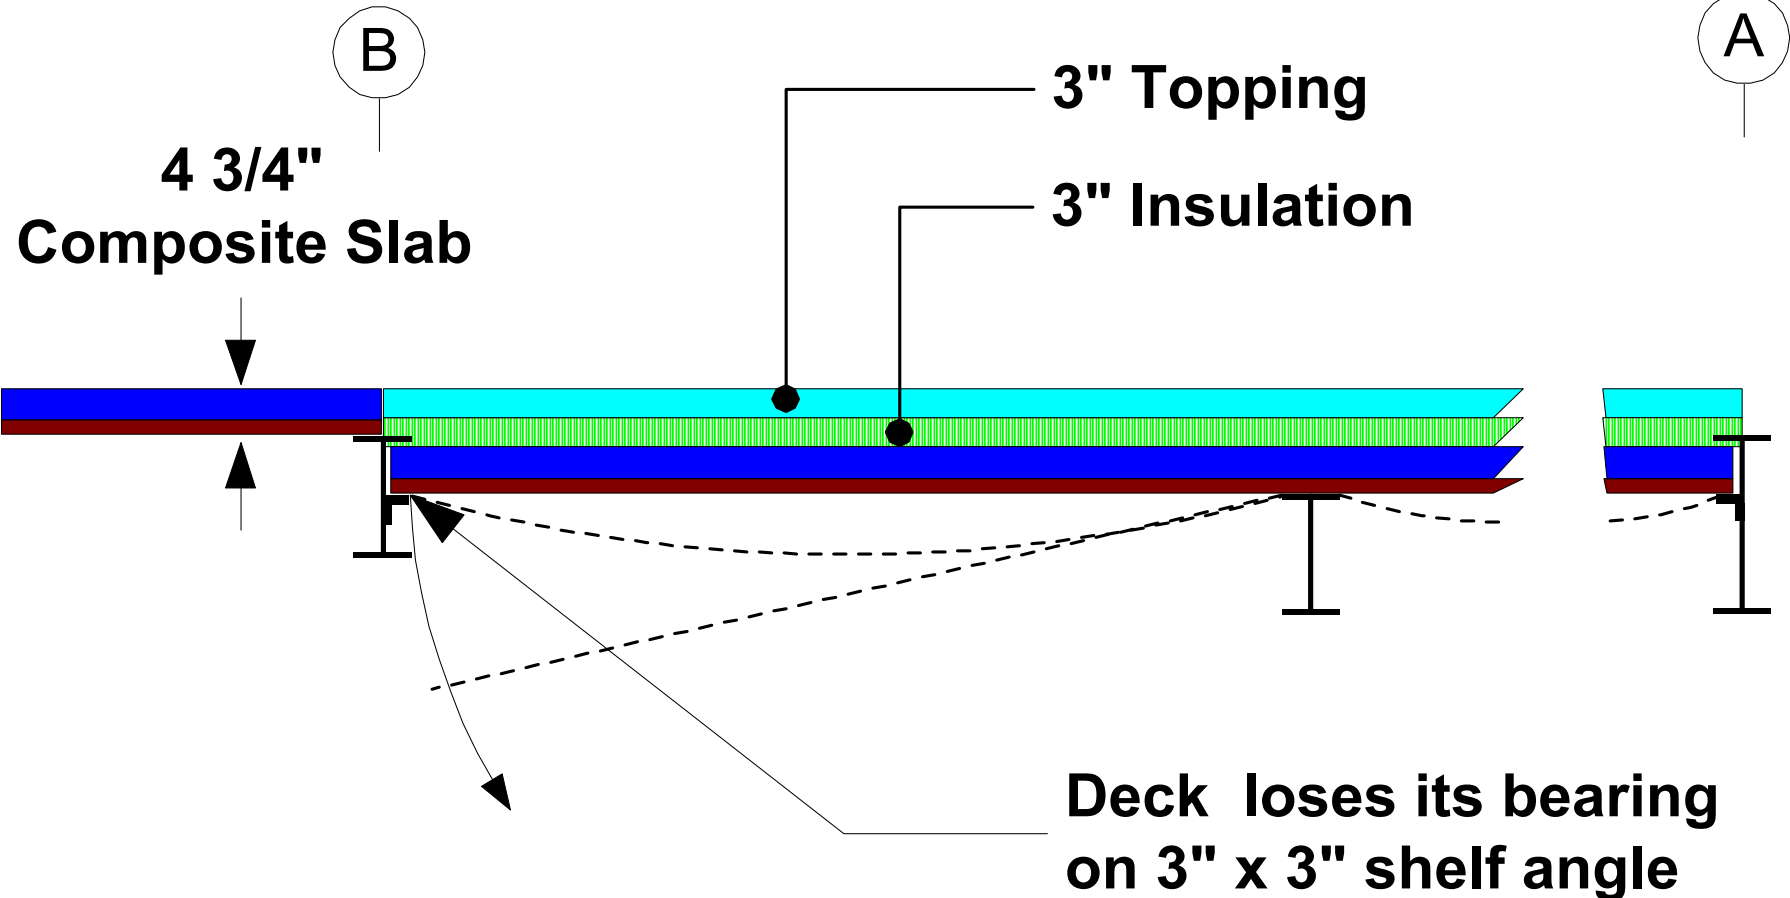
# Collapse Mechanism

- Added weight of concrete

- Premature loading of uncured composite slab

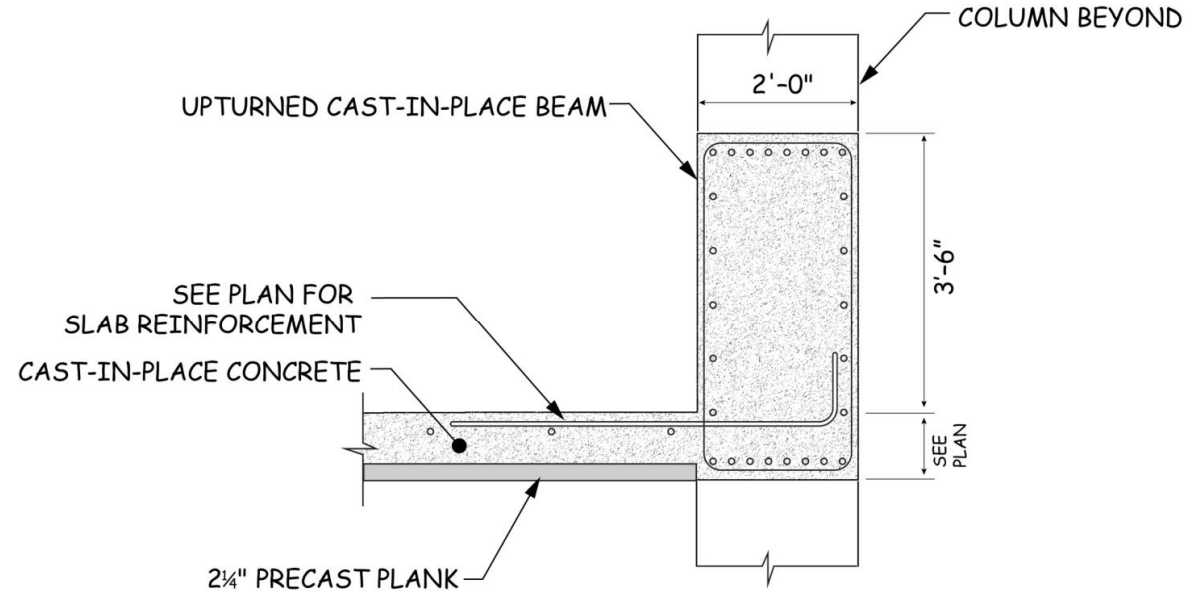
## Original Design

- Narrow beam
- Wide column
- Concentric load

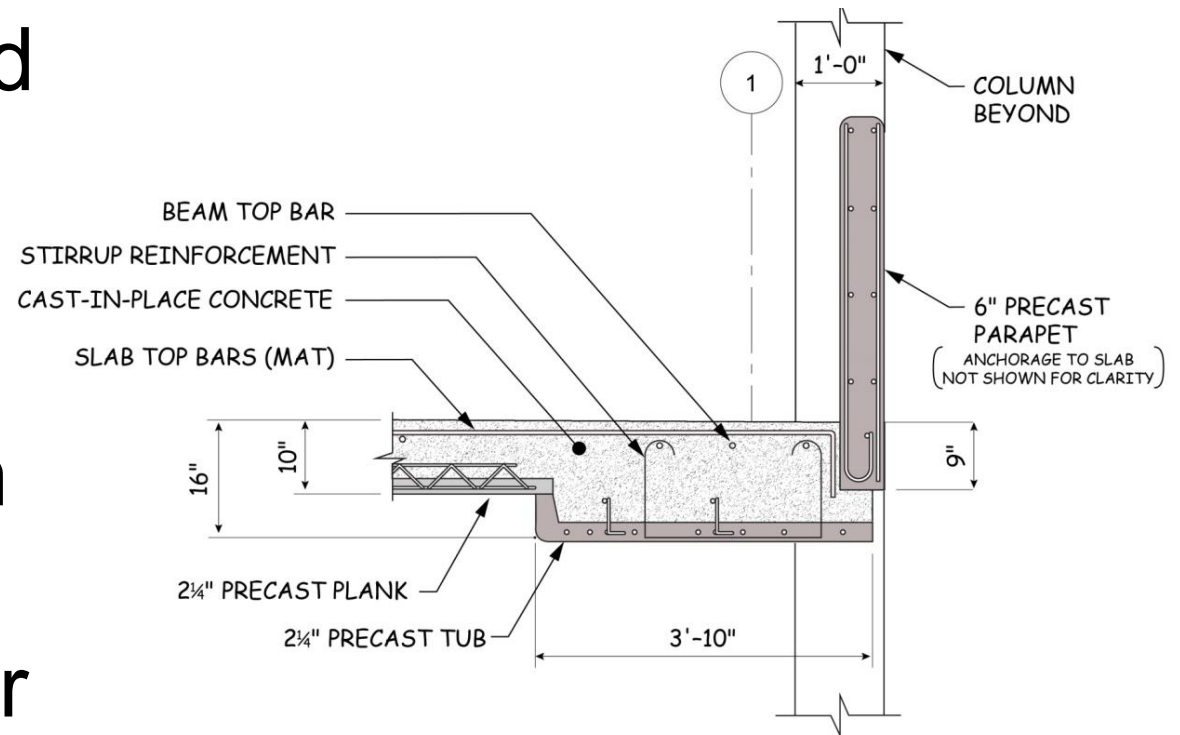
## Revised Design

- Wide beam
- Narrow column
- Eccentric load
- Punching shear

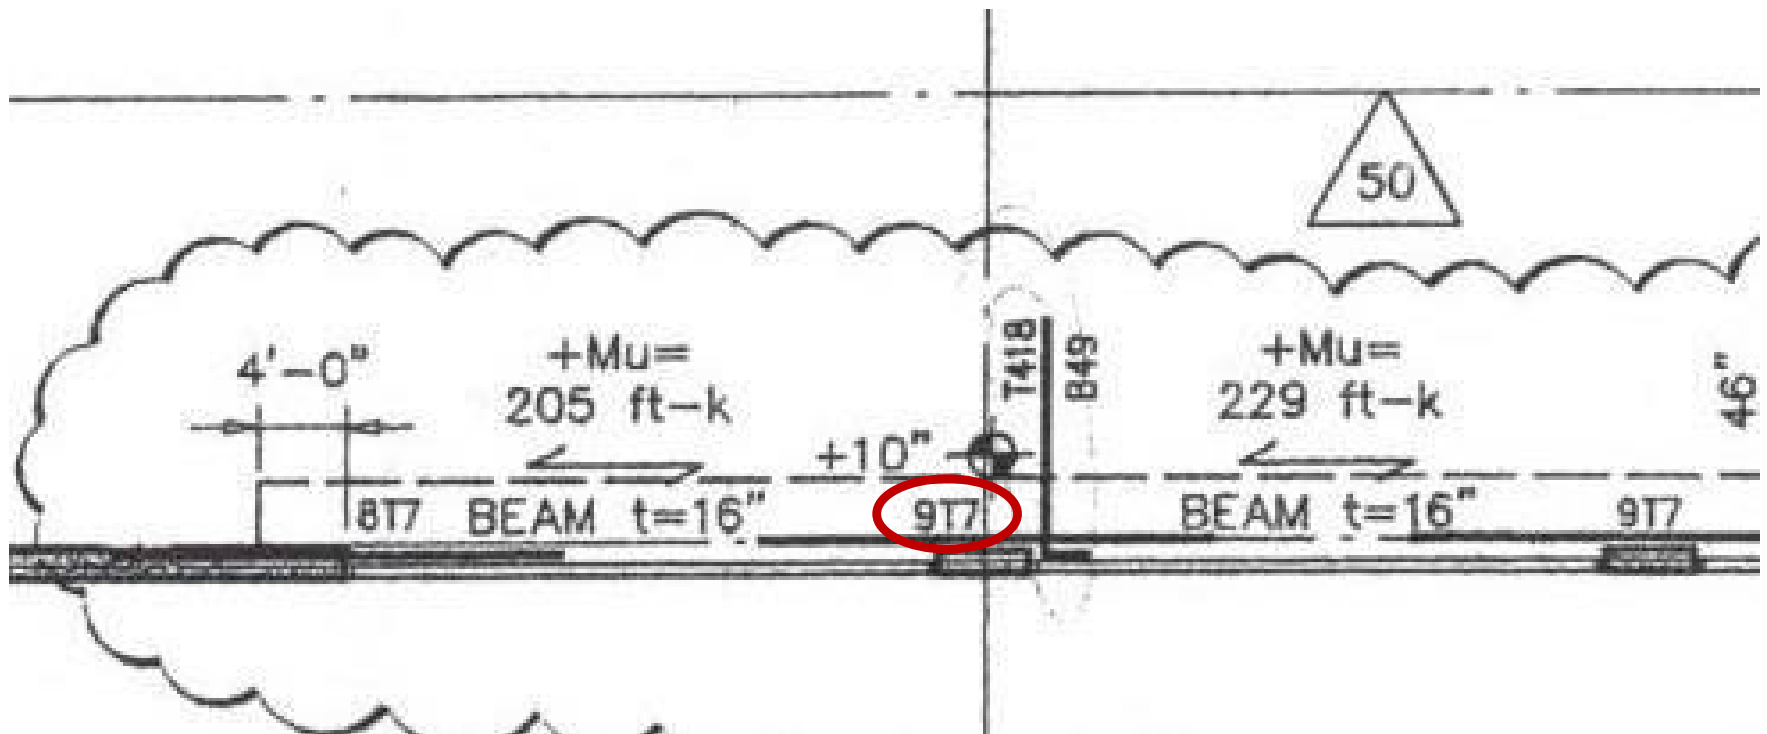
# Design Drawings—Beam Bars

- Info provided to EOR by Precast Engineer
- Nine #7 bars Top, typical
- Diagrammatically shown next to column

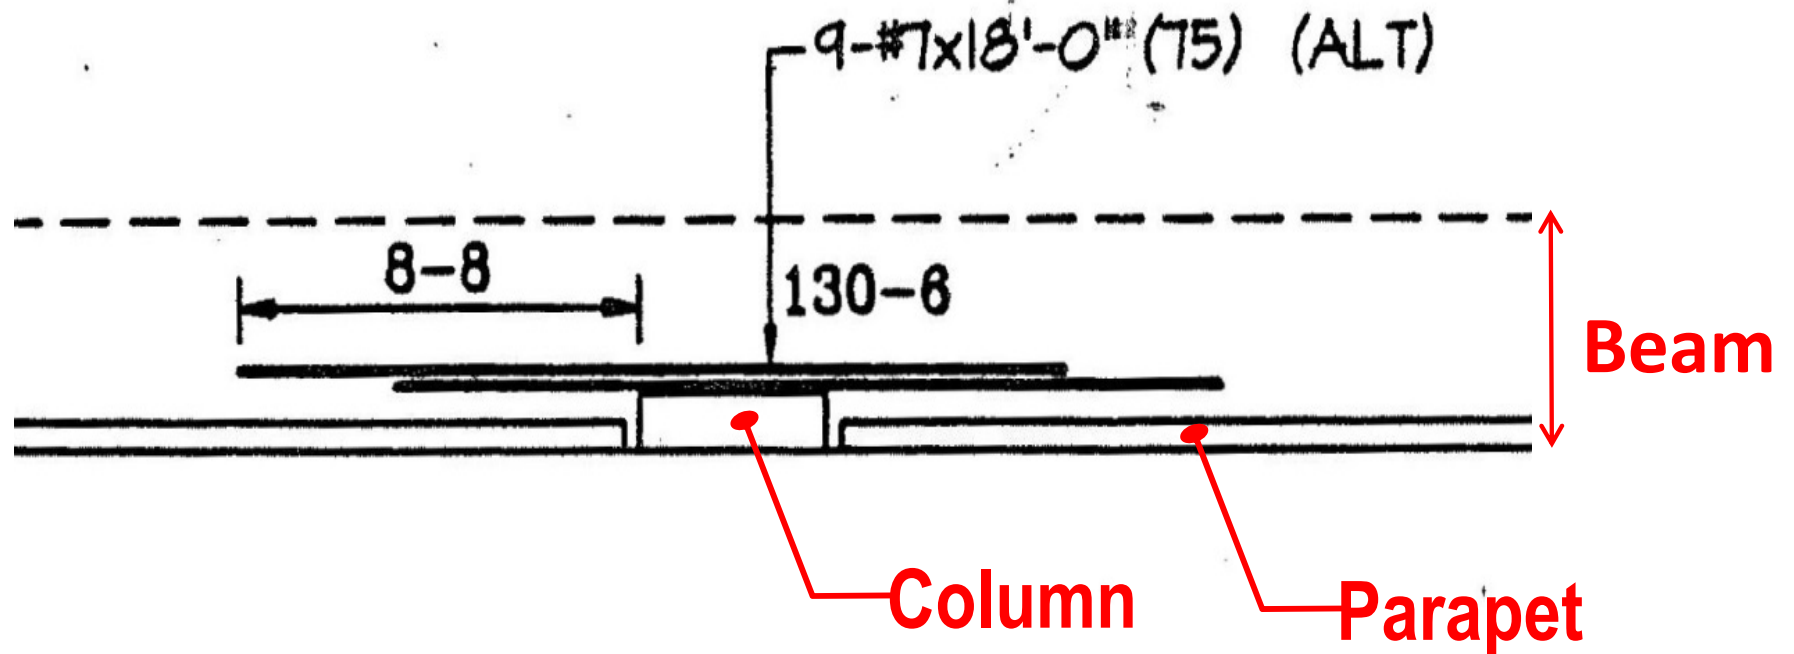
# Shop Drawings—Beam Bars

Shown diagrammatically next to columns

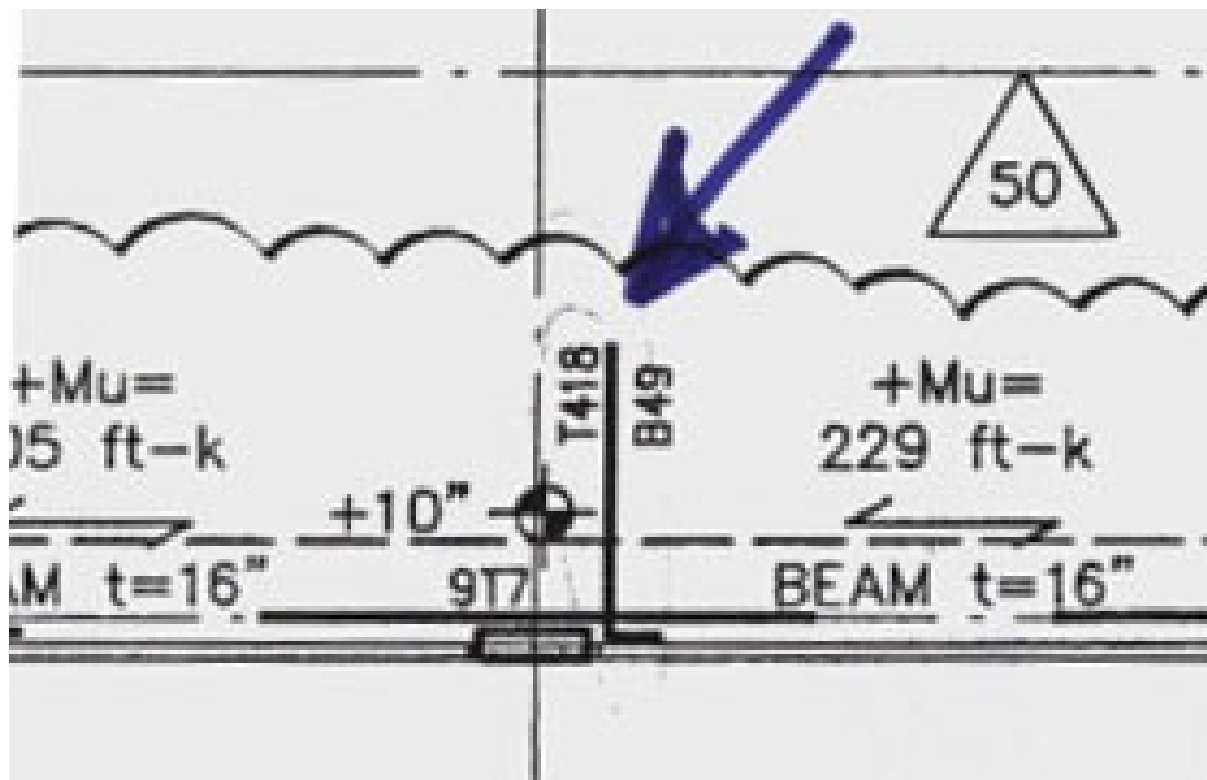
# Design Drawings—Slab Bars

- Design provided to EOR by Precast Engineer
- T418 (#4 top at 18", hooked)
- B49 (#4 bottom at 9", hooked)

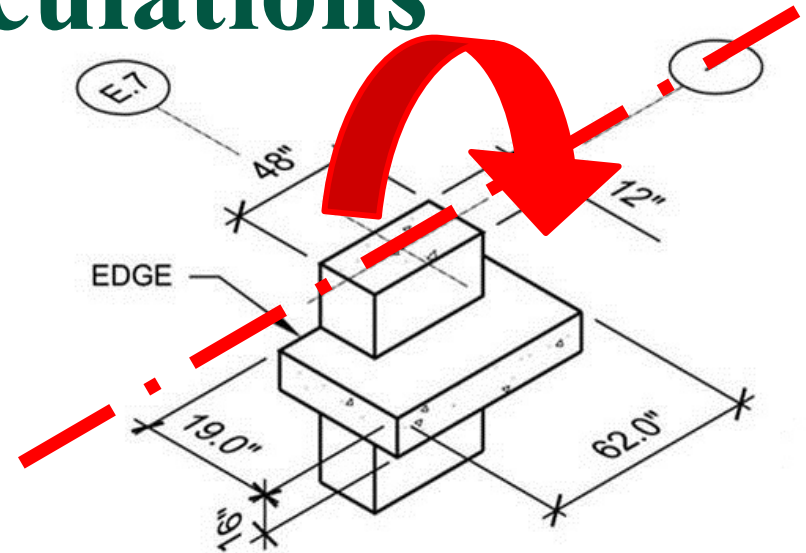
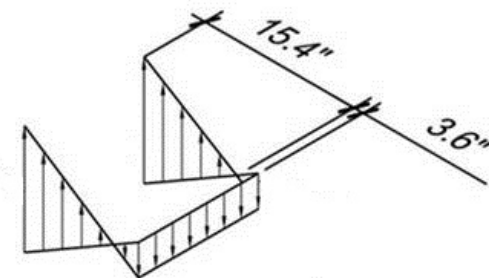
# Punching Shear Calculations

- By Precaster
- Inadequate
- Ignored unbalanced moment
- Significant overload
- Provided to EOR
- Not checked by EOR

- Inadequate punching shear strength
- Inadequate slab-to-column connections

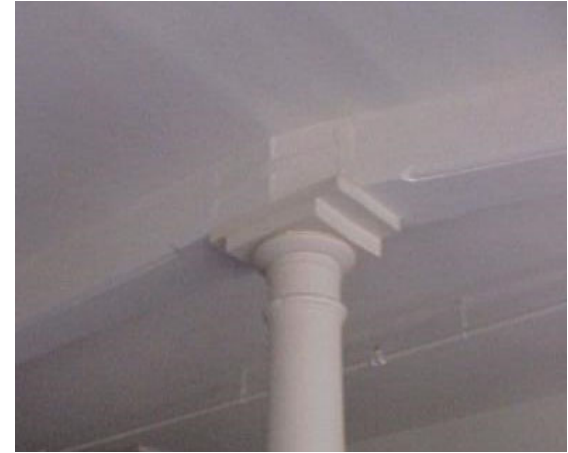
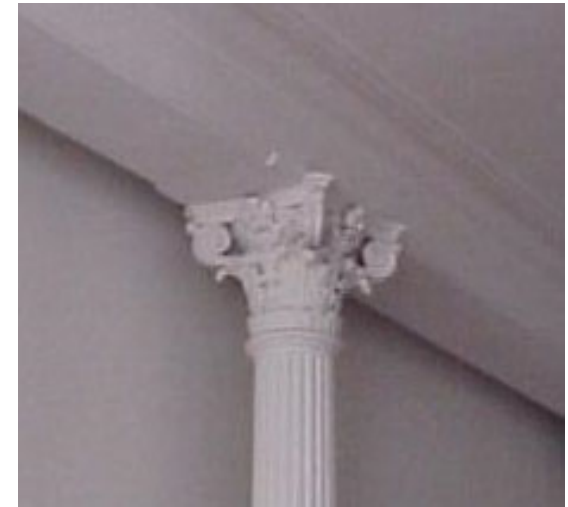
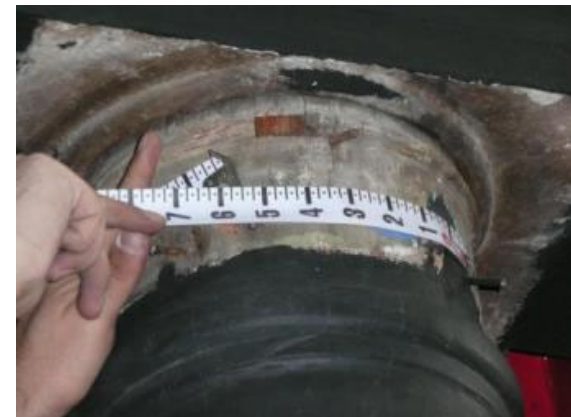
# Column Overload

- Severely overstressed in crushing
- 79% on 4<sup>th</sup> floor
- #2 Dense Southern Yellow Pine

- Checked columns on 4<sup>th</sup> floor as if they were cast iron
- Used wrong diameter (actual area is 60% of BH area)
- Didn't recognize taper or crushing
- Didn't have columns graded

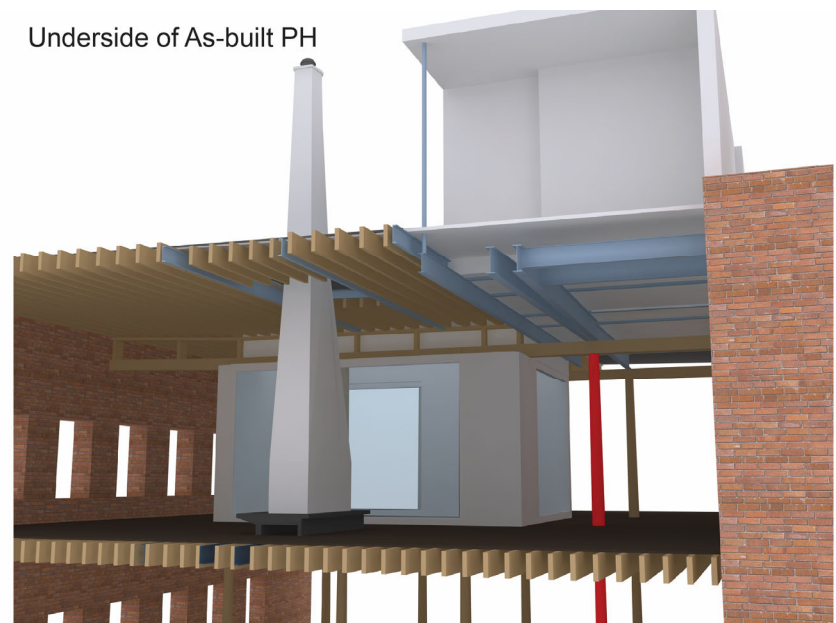
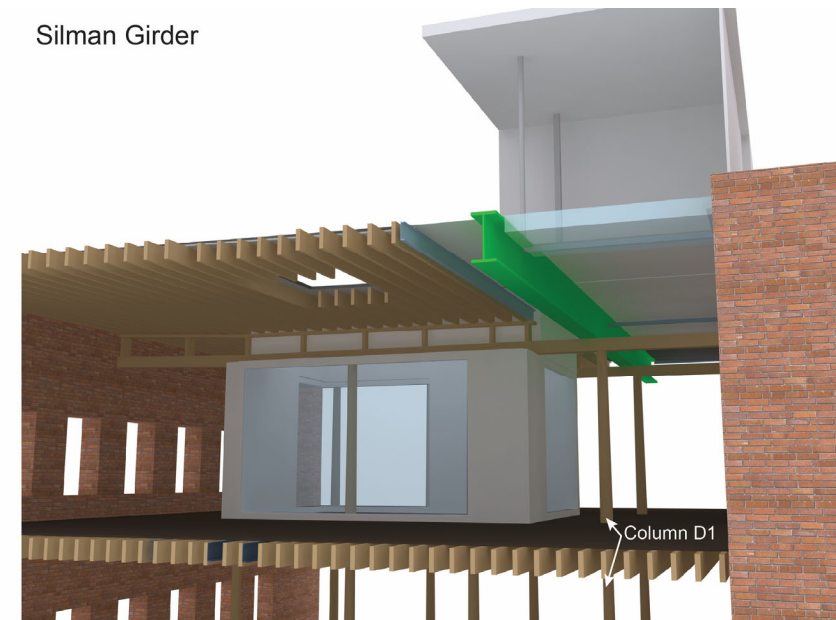
# Column Overload

- Collapse of multiple levels
- Sudden and catastrophic

- Immediately restrict loading
- Remove penthouse
- Design new support system for penthouse that bypasses columns

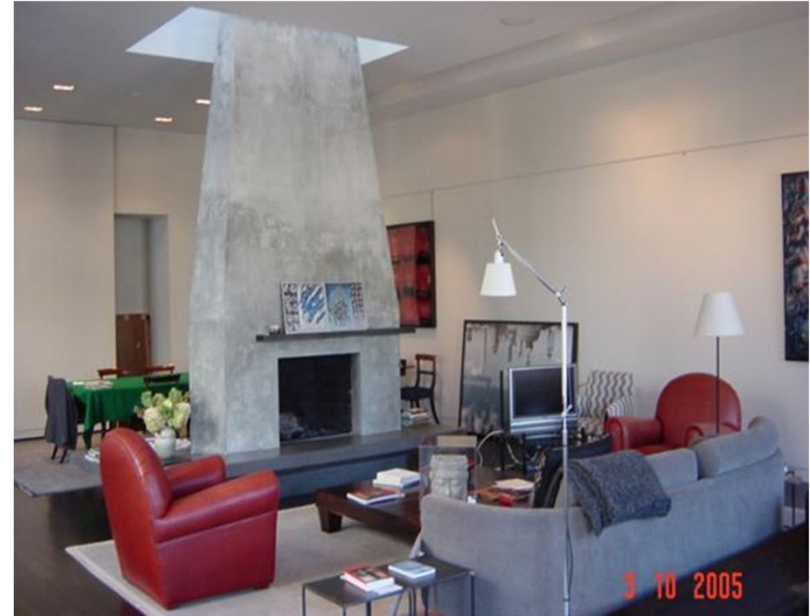
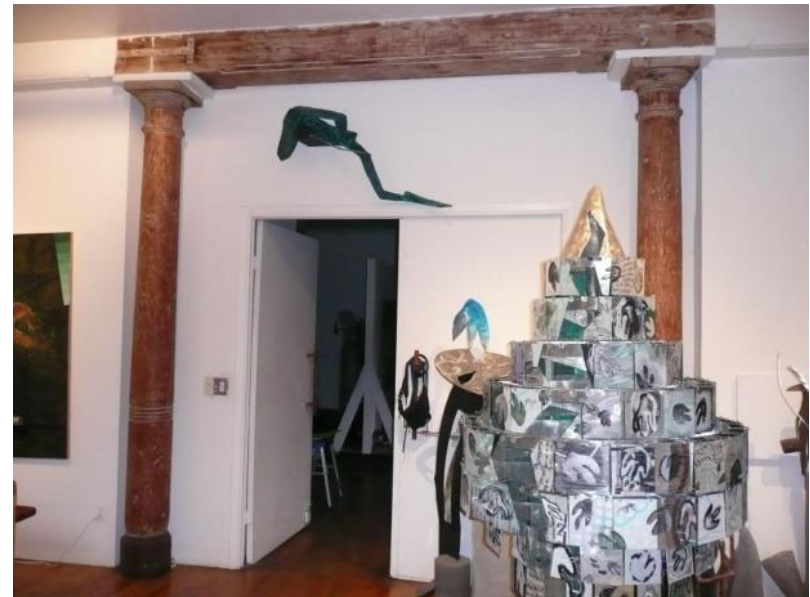
# Wood Girder Supporting Fireplace

- Fireplace girder overstressed 65% in shear
- Others overstressed 23%

- Erroneous shear calculations
- Omitted loads
- Neglected 2-span

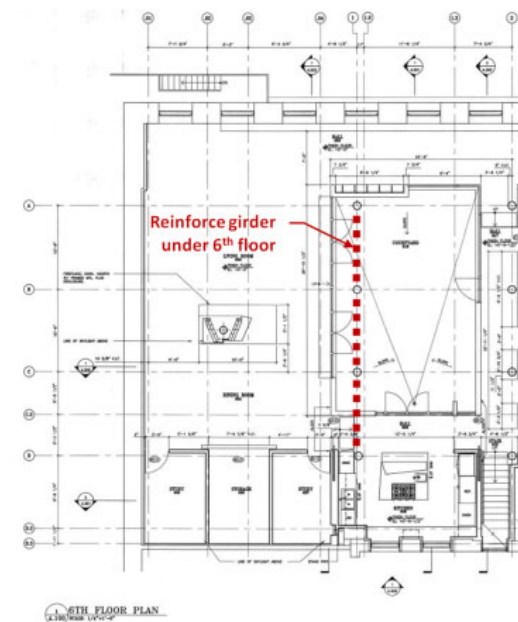
# Wood Girder Supporting Fireplace

- Collapse of girder and fireplace
- Overstress of other girders

- Remove fireplace
- Reinforce girders to safely support courtyard loads

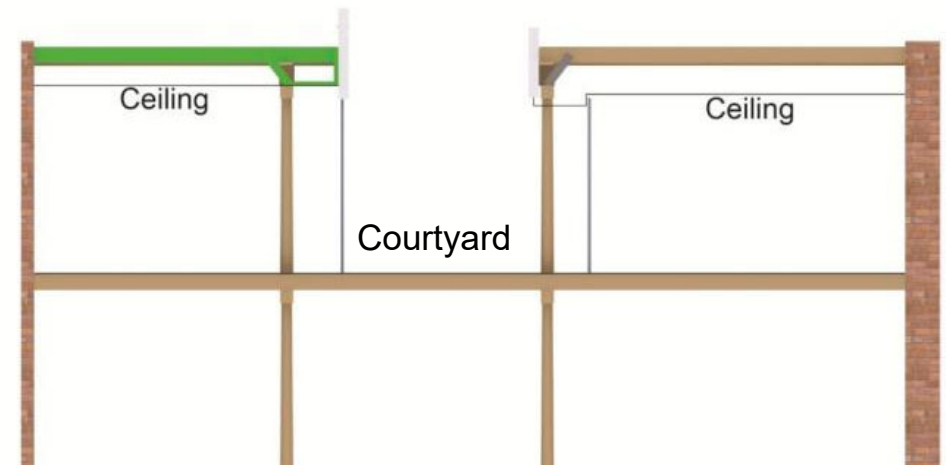
# Column Line Bracing

- Buckling of column line
- Damage to courtyard glass wall

- Install knee braces
- Cantilever joists
- Brace storefront to girder (after removing ceiling)
