Large Challenges of a Small Project

Dave Logan, P.E.¹

INTRODUCTION

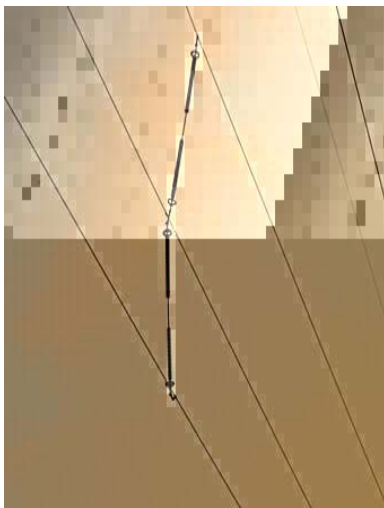
The other two products were rigid connection interphase spacers (Fig. 1) designed specifically for that purpose. However, one of the vendors offered no testing and a rather limited warranty, while the other performed significant levels of testing to confirm durability of their product and provided an extensive warranty.

Fig. 1 – Interphase Spacer

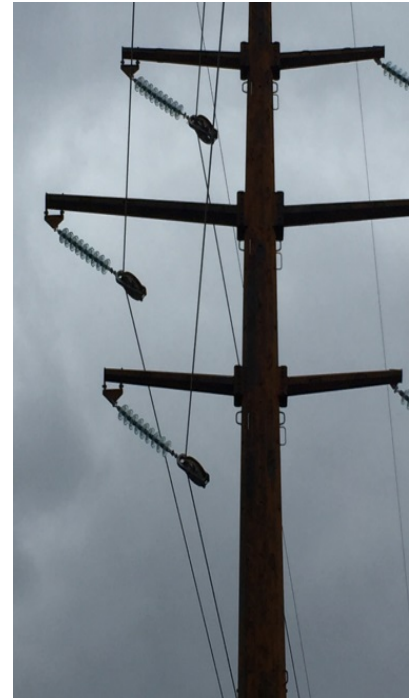
Fig. 2 – Pole Top Configuration

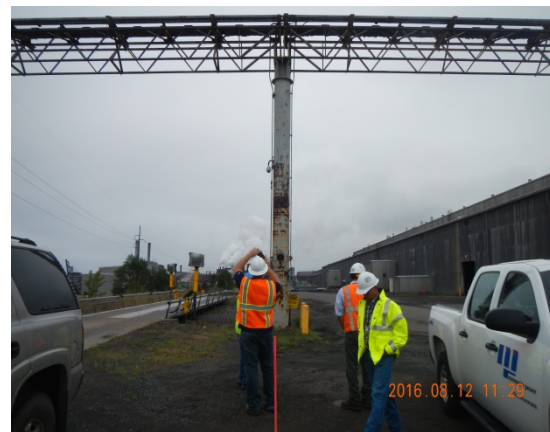
The line crossed over pipe bridges (Fig. 3). The bridges were tall enough to maintain reasonable clearance to the large equipment and rail cars that frequent the property and are accessible to workers for maintenance purposes. Because the bridges were accessible, clearance to them for new design was 19.5 feet. Because of the height of the pipe bridges and required clearance to the bridges, conductor height crossing over them was as much as 60 feet above ground.

Fig. 3 – Pipe Bridge

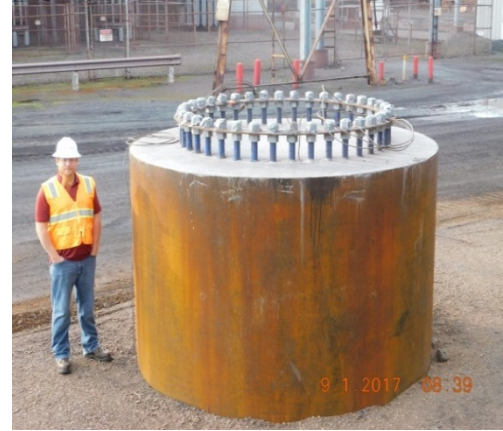
Fig. 4 – Foundation at STR 617

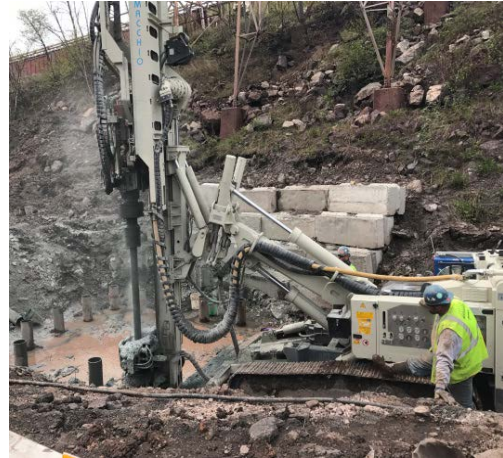
A foundation contractor was brought on for support during foundation design to aid in foundation type selection. Micropiles were selected as the preferred alternative to drilled pier. Following structure design, each location was reviewed for suitability of a drilled pier foundation. Locations where drilled pier foundations could be supported in the soil above the rock, or where one full pier diameter long rock socket was sufficient, drilled piers were selected except where access was an issue. At all other locations, micropile foundations were used (Fig. 5).

Fig. 5 – Micropile Drill Rig

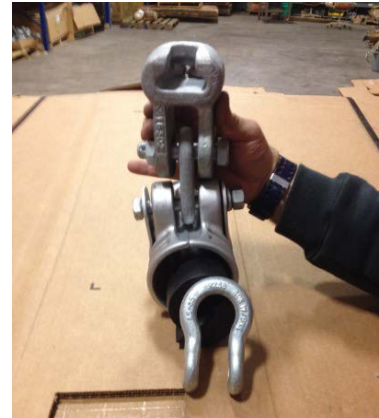
The result was that the socket-eye used to connect the link to the AGS unit was incompatible with the hardware that had been acquired for suspension wire attachment, and compatible hardware was not a common stock item. Line construction had already started and the construction window was very small, so ordering specialty hardware was not an option without causing significant delays. The design team worked with Minnesota Power standard material stores to come up with a solution that would not require specialized material. This means that maintenance and restoration activities can be performed using common stock items without having to stock a specialized item for a small application in the Minnesota Power system. The final assembly is shown to the right.(Fig. 6).

Fig. 6 – AGS Solution

Because of the span lengths, AGS units were selected for tangent suspension insulator wire attachment to prevent damage to the conductor. The hardware specified was compatible with ANSI 52-5 ball-and-socket hardware. However, much of the material for the project had been specified prior to the final decision to coordinate insulators with the Great Northern project, which used larger capacity suspension insulators having ANSI 52-8 ball-and-socket connection.

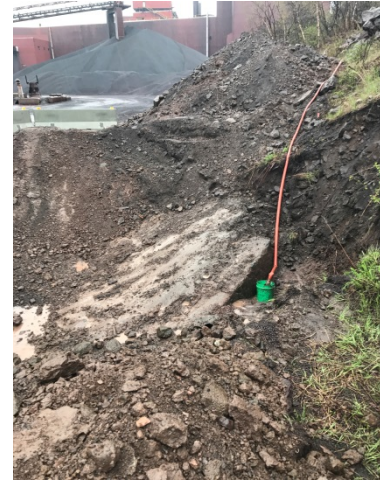
Subsurface conditions at the project site varied greatly. The boring taken for STR 617 indicated rock at 9 feet below grade (Fig. 8). The micropile foundation was designed to ensure that the pad of the pile cap was fully below grade. This was critical at this location as the structure was already impinging on the roadway. When the excavation began at this location, the contractor encountered bedrock immediately below the pavement. A large amount of rock had to be removed to accommodate the pad below grade. The disparity between the installed pile cap elevation and the top of rock elevation was as much as 4 feet.

Fig. 8 – Shallow Rock at STR 617

The micropile drill rig was used to drill a series of holes in the rock to allow the rock to be hammered out and a larger excavator had to be brought in to remove the rock.

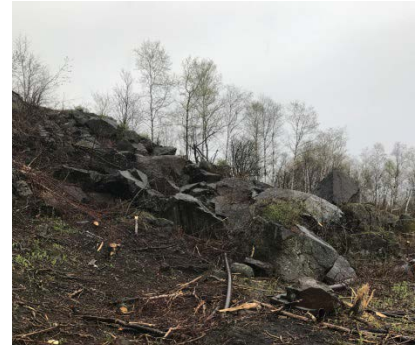
Structure 6A was originally spotted at the base of a hill. At some time in the past, large boulders had been pushed down the hill and now reside where structure 6A was originally spotted (Fig. 9). The boulders in question were roughly the size of a pickup. The mass of the boulders was not obvious in the LiDAR or aerial imagery.

Fig. 9 – Boulder at STR 6A

To complicate the issue, a 2-inch PVC natural gas line was located fairly close to structure 6A. Moving the boulders introduced risk of accidentally crushing the gas line. Instead of risking damage to the gas line and delay to mobilize additional equipment, 6A was moved to the southeast. This relocation placed the structure closer to the gas line. The micropile cap was raised so the pile cap loading on the soil would not affect the gas line. The contractor installed temporary sheet piling between the foundation excavation and the gas line to prevent damage to the line during construction.
