Structural Engineering
Webinar Series

Brittle Fracture: Another View

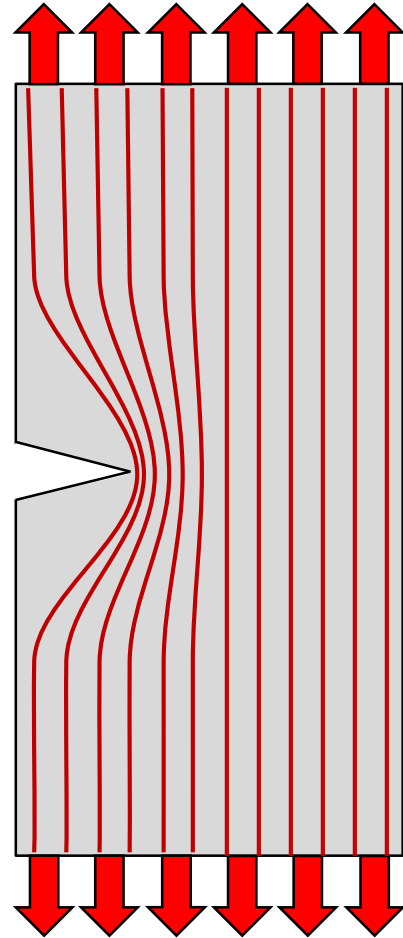
Two things:

- $A_{\text{net}} < A_{\text{gross}}$
- Stress is not uniform

...However, the chief effect of the notch is not in introducing a stress concentration but in producing a triaxial state of stress at the notch.

In summary, a notch increases the tendency for brittle fracture in four important ways:

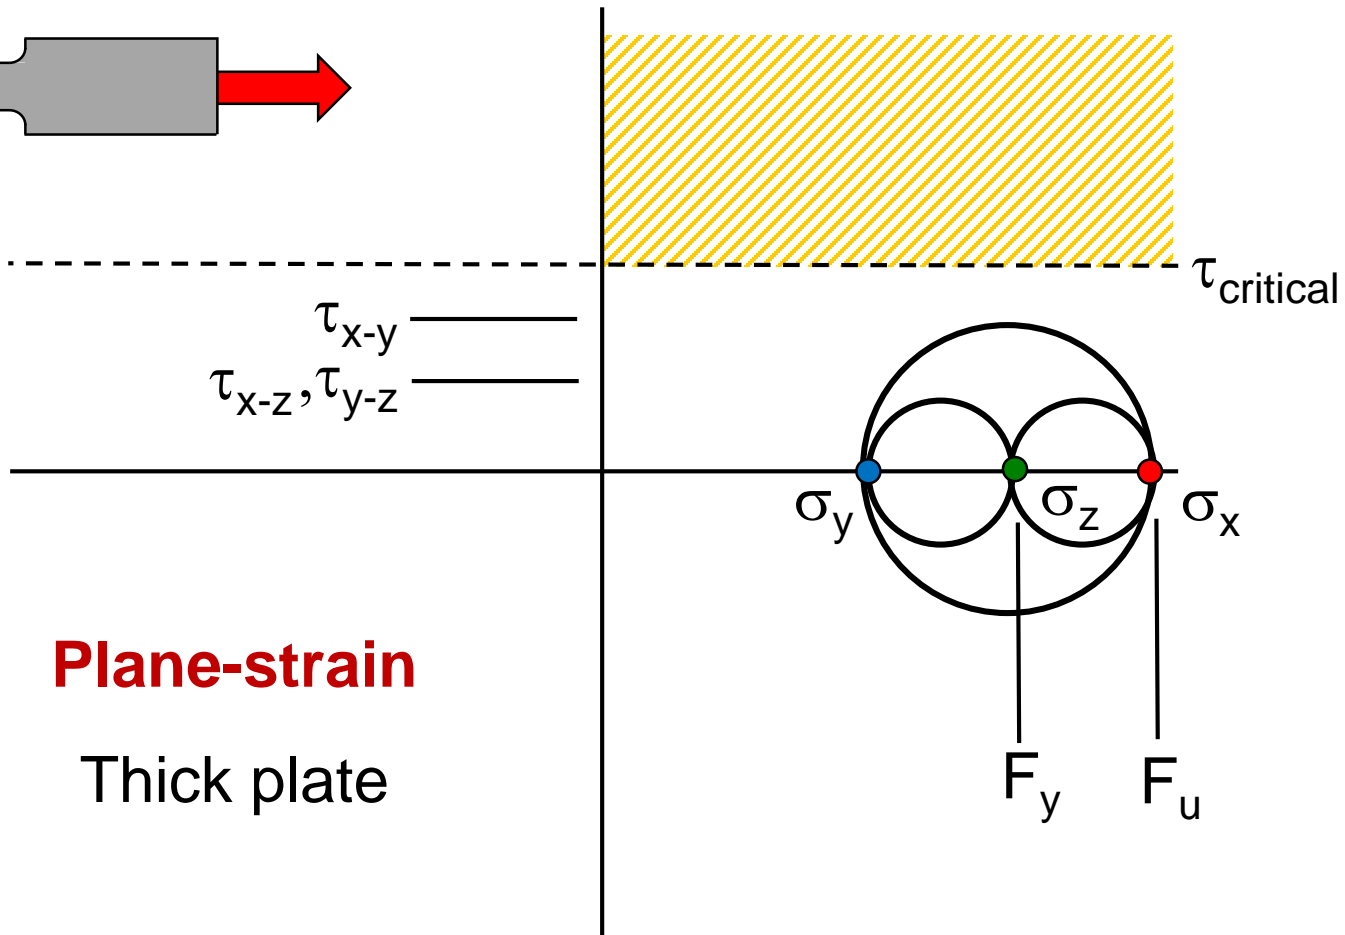
Plane-strain

Thick plate

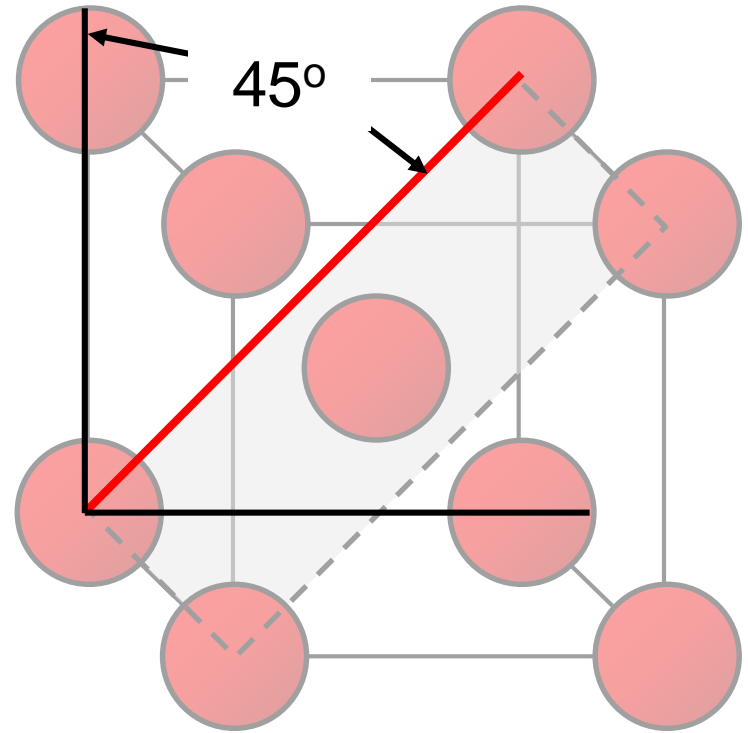
Body Centered Cubic (BCC)

Shear Planes

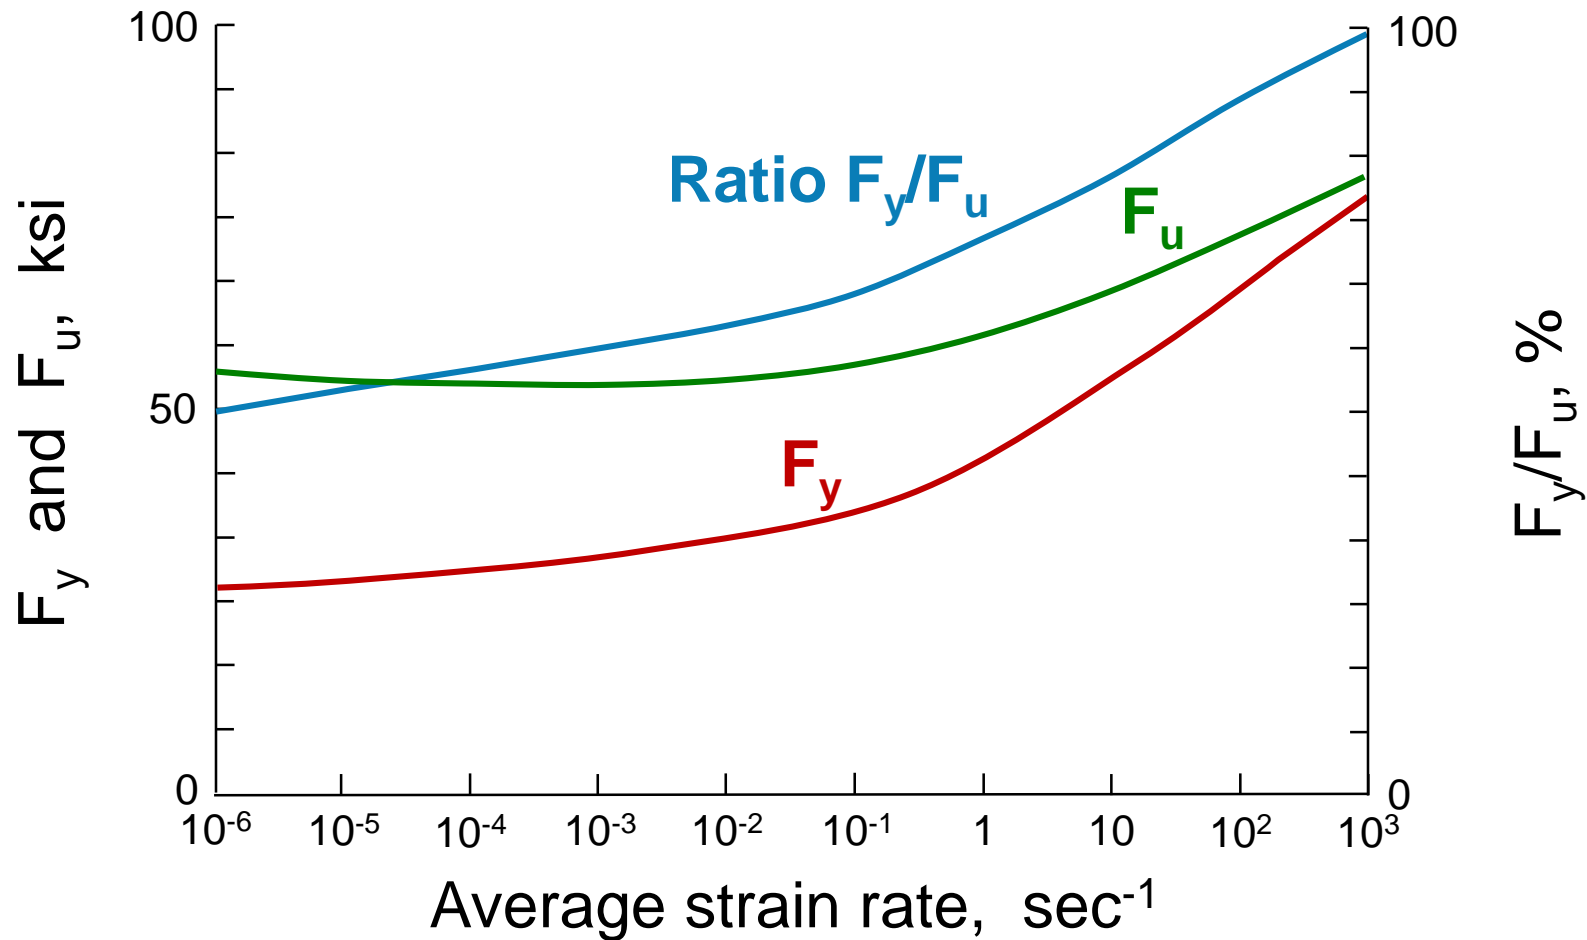
Adapted from Manjoine

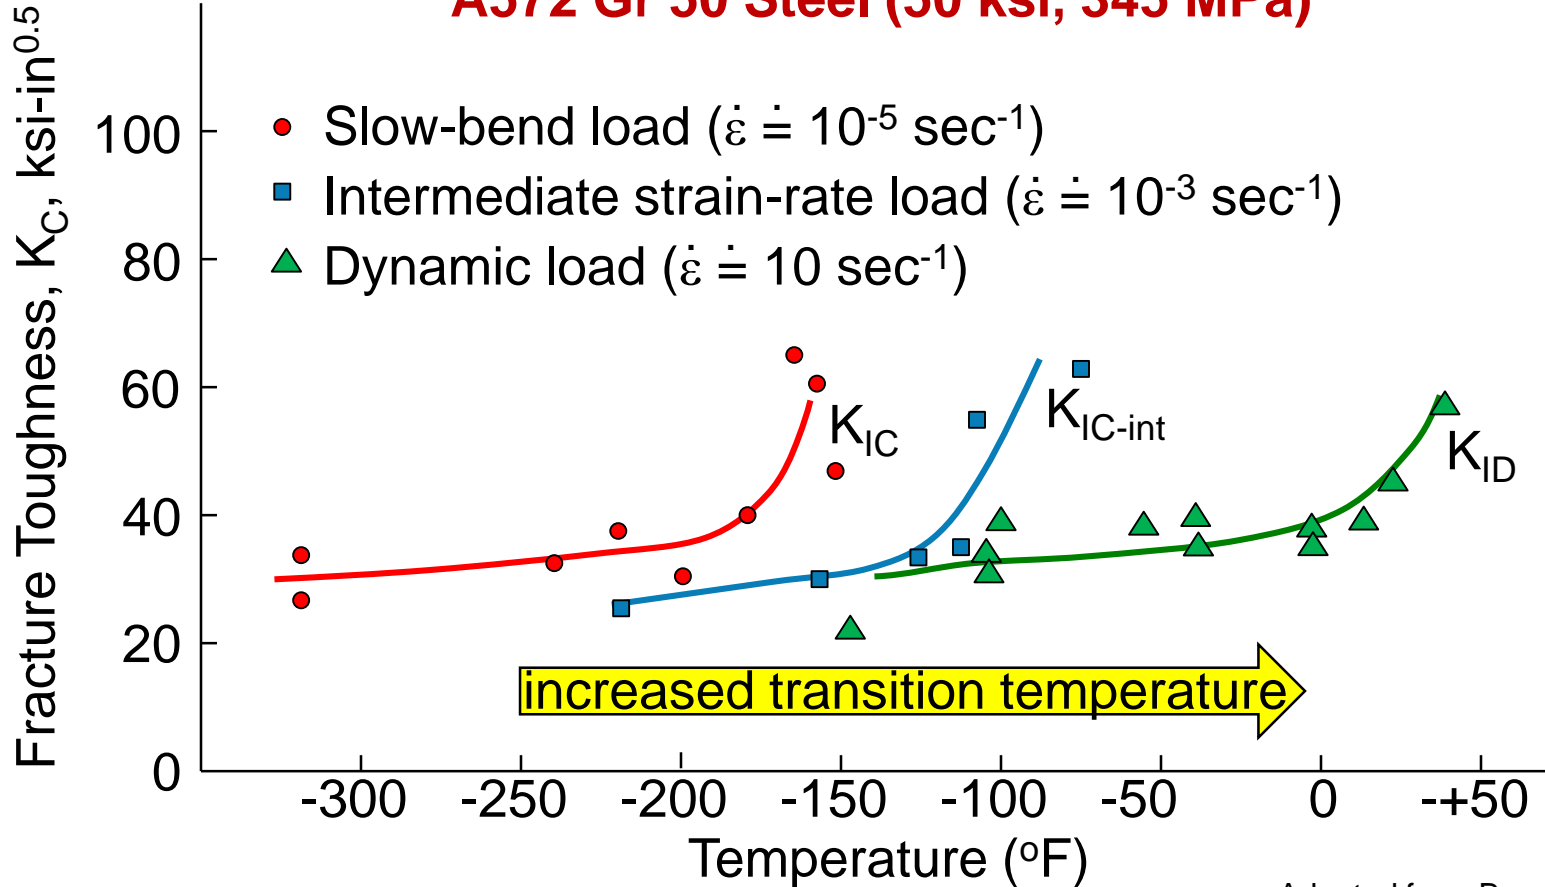
A572 Gr 50 Steel (50 ksi, 345 MPa)

The changes produced by the introduction of a notch have important consequences in the fracture process. For example, the presence of a notch will increase appreciably the ductile/brittle transition temperature of a steel.

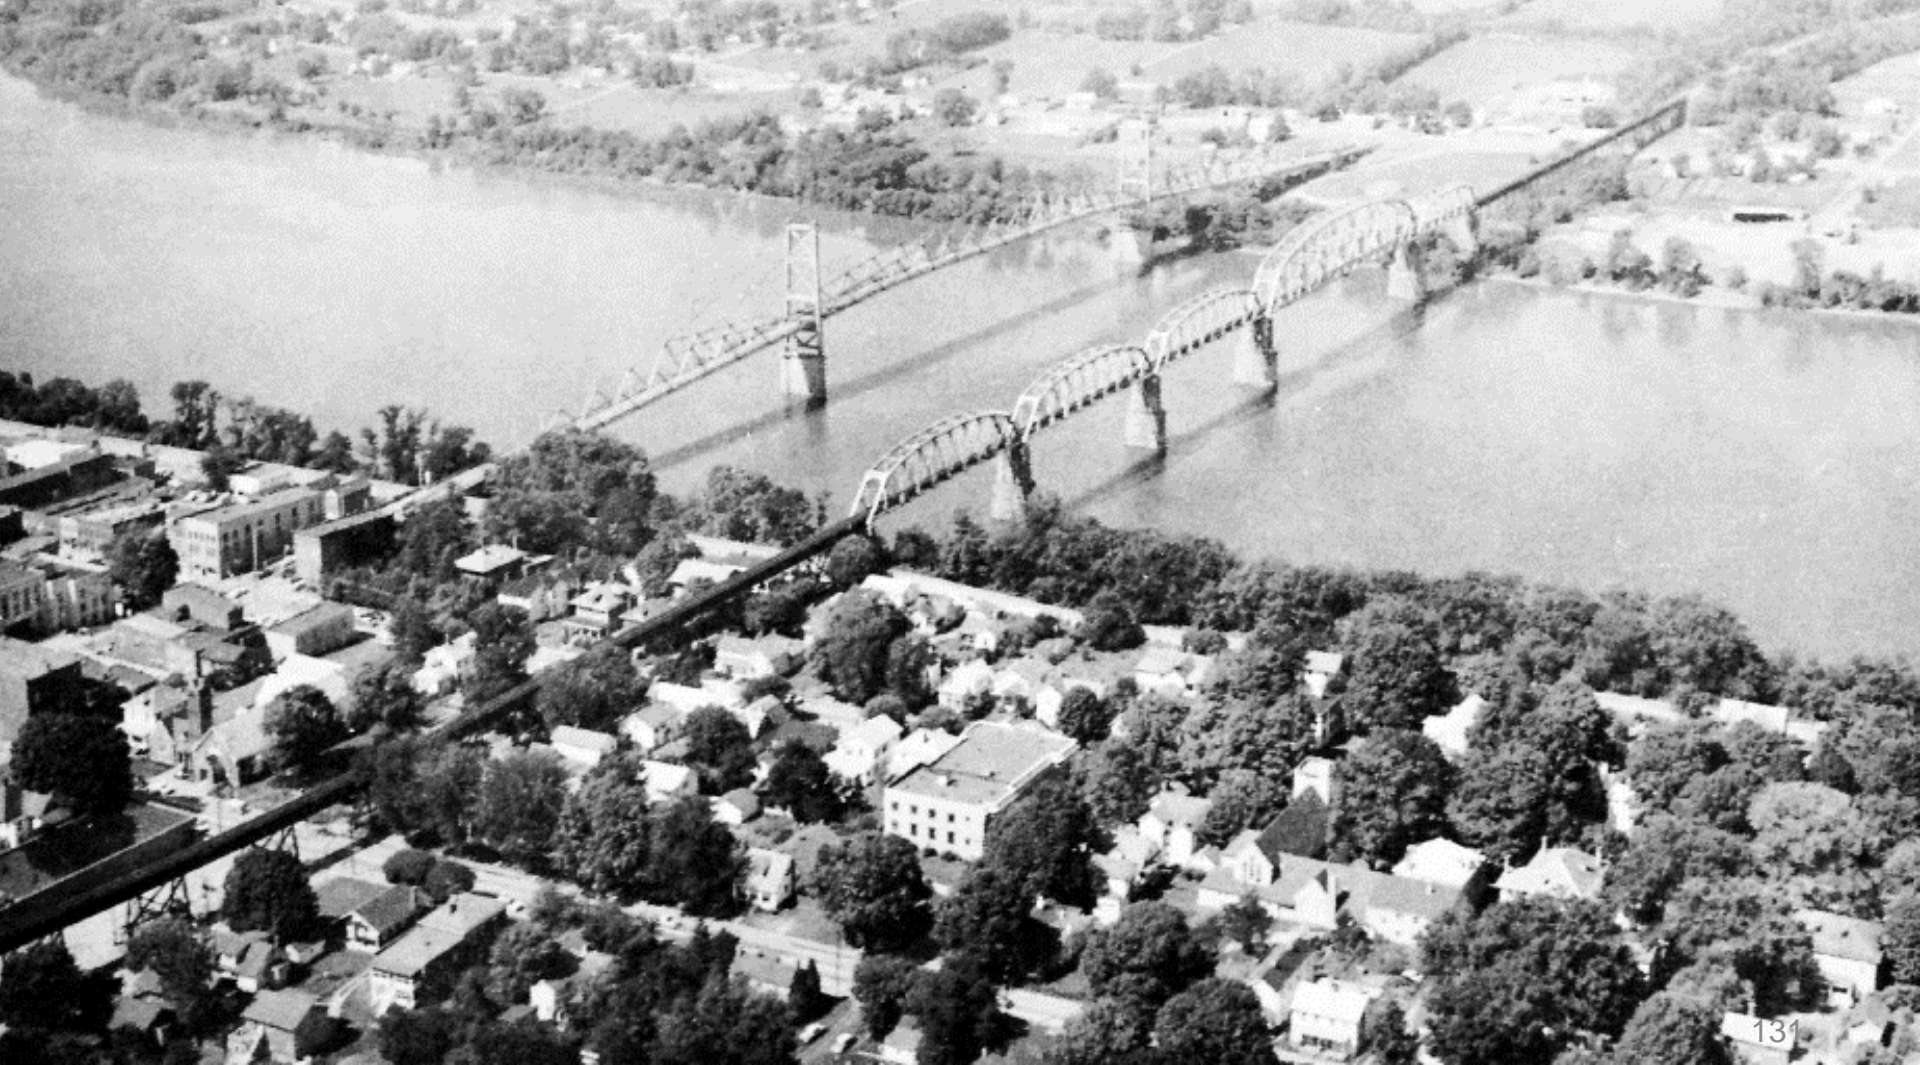
Silver Bridge Summary

- Opened to traffic May 1928
- Collapsed December 1967
- Eyebar suspension bridge
- 30 °F at time of collapse

- Total length: 1756 feet
- Main span: 700 feet
- River width: 1240 feet

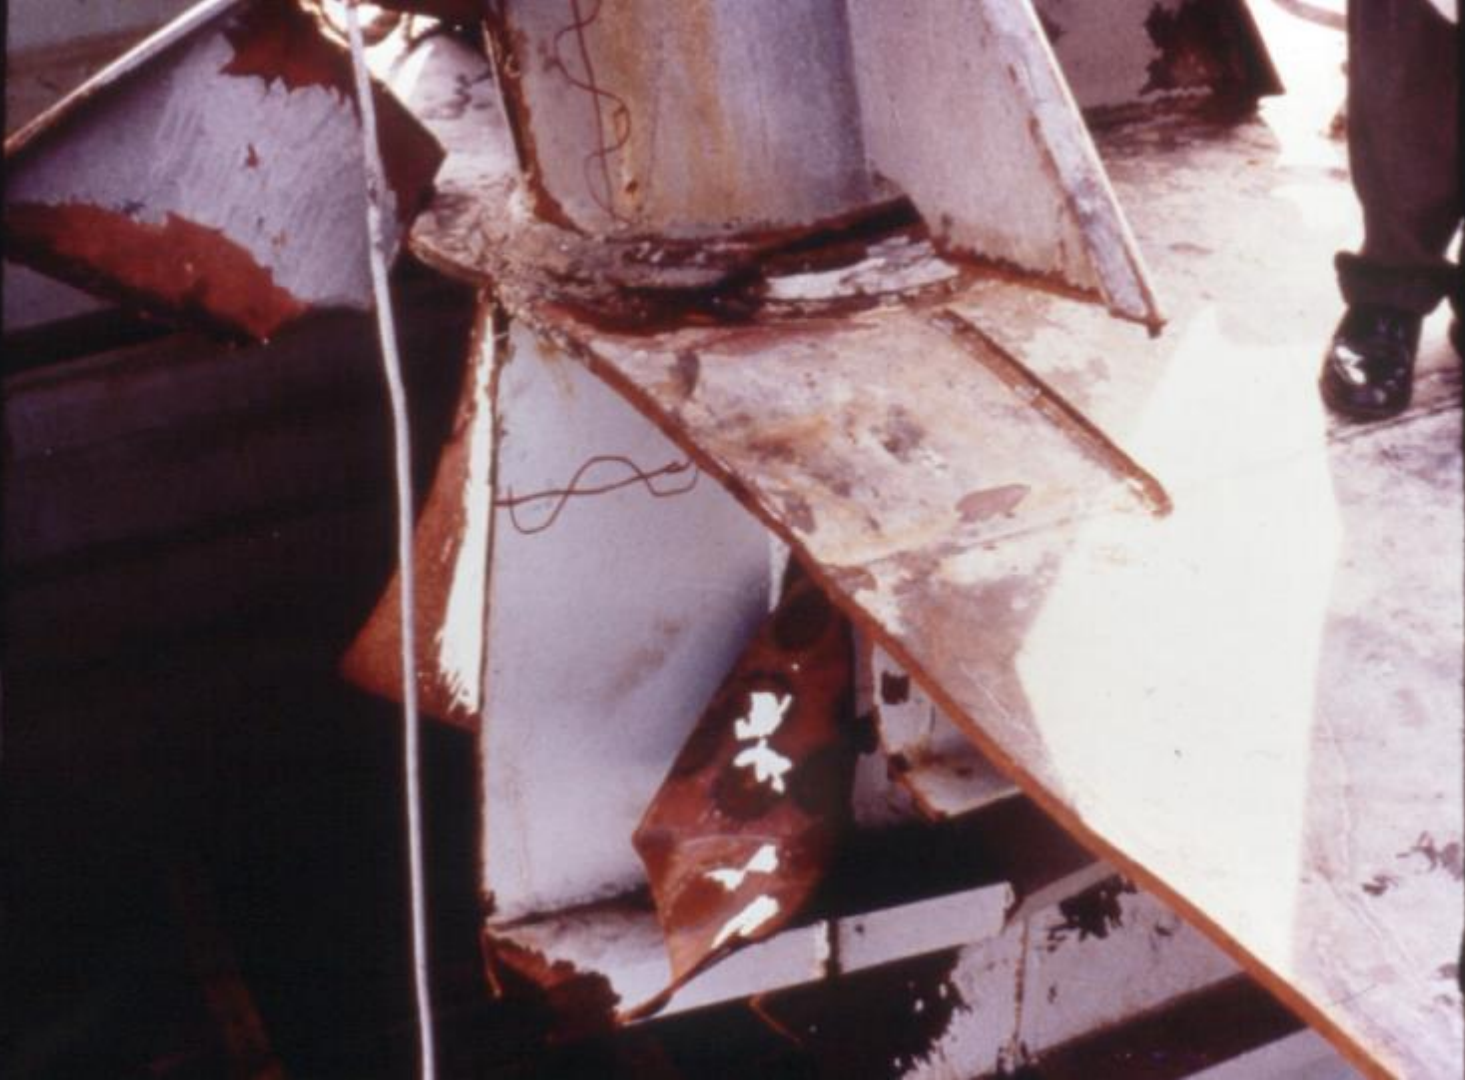
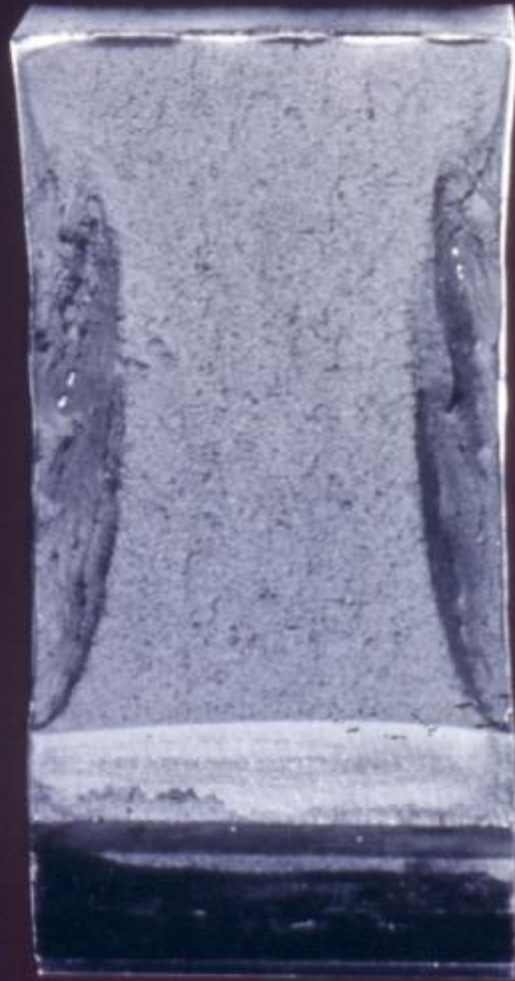
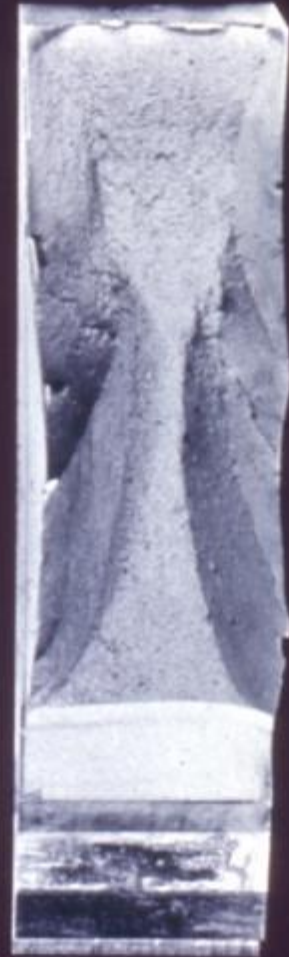
- January 10, 1972
- 584 foot [178 m]
- Air temperature 45 °F [7 °C]
- In service for 9 months
- Unusual loading: 2.5X design load, 24 ksi [165 MPa]
- 55 ft-lbs [74 J] at service temperature
- No pre-existing flaws were observed

...the primary cause of failure was established to be an unusually high loading stress caused by improper ballasting at a highly constrained welded detail.

- January 10, 1972
- 584 foot [178 m]
- Air temperature 45 °F [7 °C]
- In service for 9 months
- Unusual loading: 2.5X design load, 24 ksi [165 MPa]

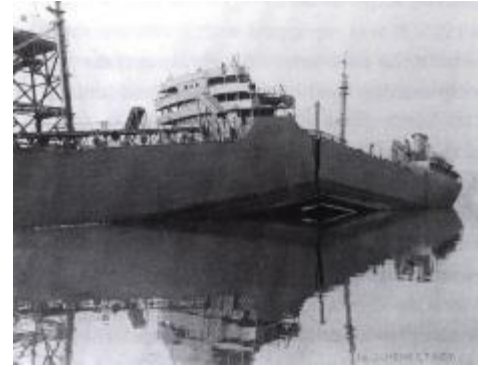
Liberty Ships

- Notches are bad
- Square corners are bad
- Notch sensitive steel is bad
- Good design is important
- Good fabrication is important
- Notch tough steel is helpful

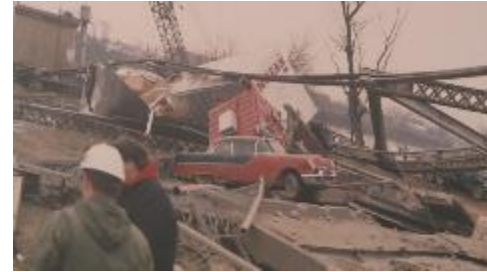
Silver Bridge

- High hardness, subject to SCC, is bad
- High stresses are bad
- Initial fabrication discontinuities are bad
- Cyclic loading can extend initial discontinuities
- Low fracture toughness is bad
- Non-redundant designs can fail catastrophically

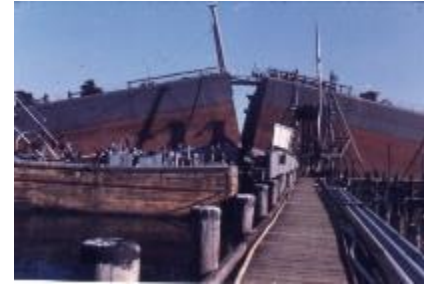
Ingram Barge

- Overloading of barges is bad
- Highly constrained details are bad
- Constraint can induce fracture with no pre-existing cracks
- Good notch toughness does not preclude fracture in highly constrained details

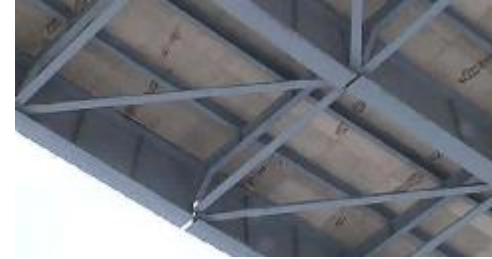
- Highly constrained details are bad
- Constraint can induce fracture with no pre-existing cracks
- Good notch toughness does not preclude fracture in highly constrained details

The cause of the Hoan Bridge fracture as CIF originating in details with high-stress triaxiality, which resulted from:

- A high level of constraint...
- High levels of tensile stress associated with residual stressed induced by welding...
 - crack-like geometry, specifically where the so-called "web gap" (a constraint-relief gap)
- A crack-like geometry...

The steel was found to exhibit reasonable toughness with no evidence of fatigue cracking prior to the CIF event.
