# Assessment and Retrofit of Masonry Structures

## *Case Studies*

College of Continuing and Professional Studies  
Structural Engineering Webinar  
March 7, 2023

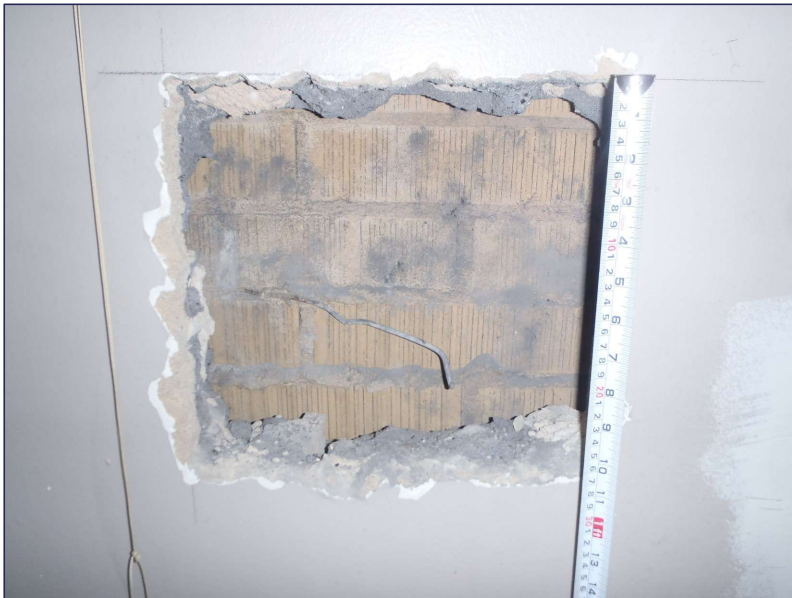
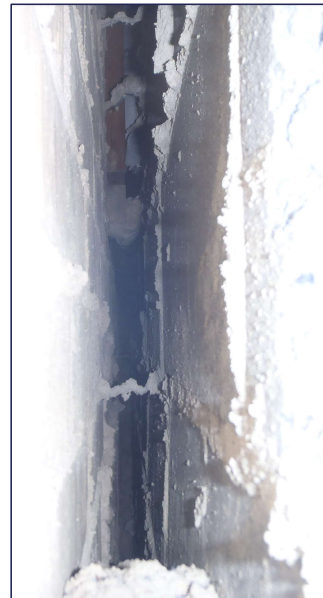
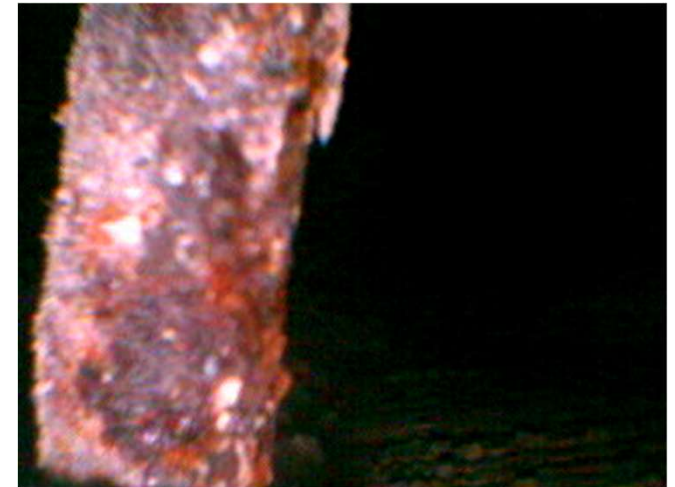
- Document review, interviews
  - Prior reports, repairs
- NDE: anchor location, videoscope

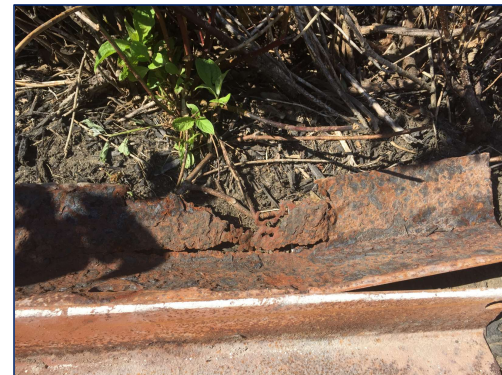
- ▣ Shelf angles

- ▣ Much worse than expected!

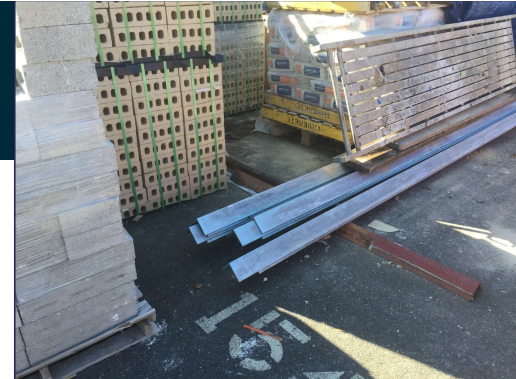
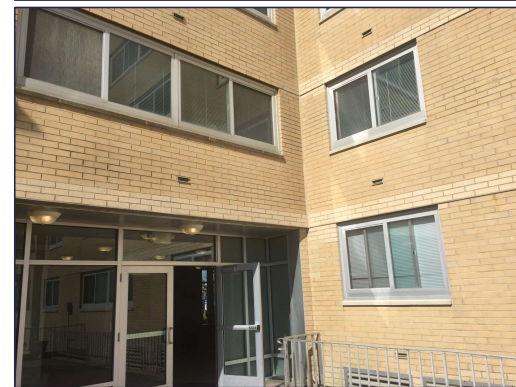
- ❑ Good maintenance records
  - ❑ Nice to have
  - ❑ Saved \$10,000 in diagnostics?
- ❑ Masonry construction needs movement joints
- ❑ What's cheaper?
  - ❑ Localized repairs or re-cladding building
- ❑ Repairs are expensive *and materials are a small part of the total cost*
  - ❑ Long-lasting sealants
  - ❑ Corrosion protection
    - ❑ Hot-dipped galvanizing
    - ❑ Epoxy coating
    - ❑ Stainless steel
- ❑ You can find a replacement brick...
