# Arecibo Observatory Auxiliary Main Cable Socket Failure Investigation

## 2023 Structural Engineering Webinar Series

Jonathan C. McGormley, P.E., S.E.

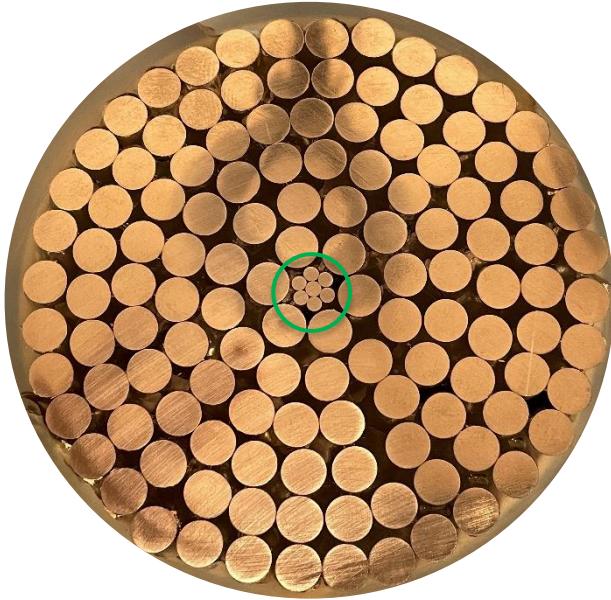
Cross section of 3 1/4-inch diam. M4N AUX cable

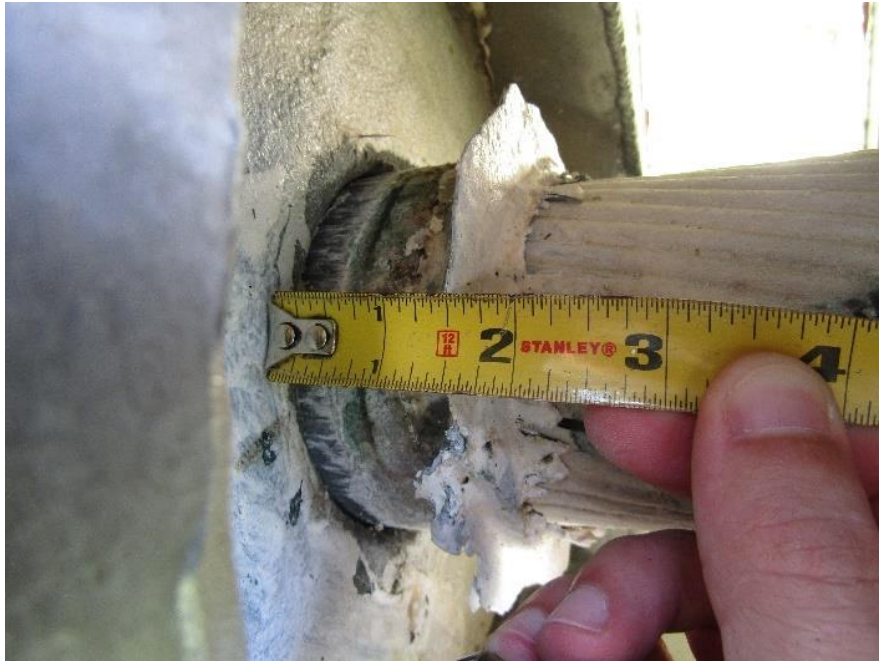
A12W AUX showing about 1 3/8-inch extension (May 2018)

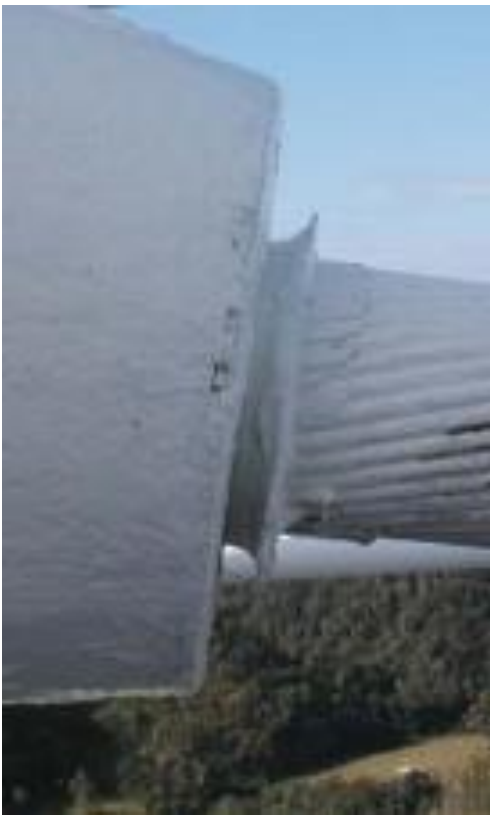
A4N AUX showing 7/8-inch extension (September 2020)

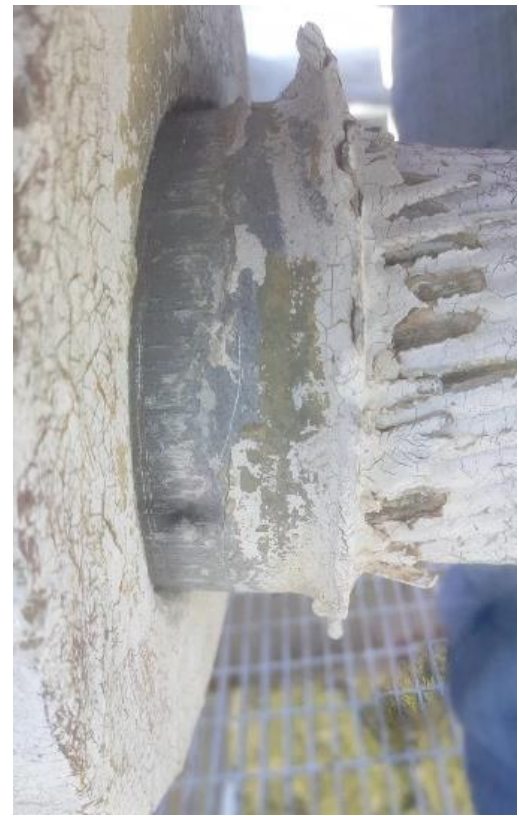
M4S AUX indicating 1/2-inch extension,  
typical all sockets (April 2003)

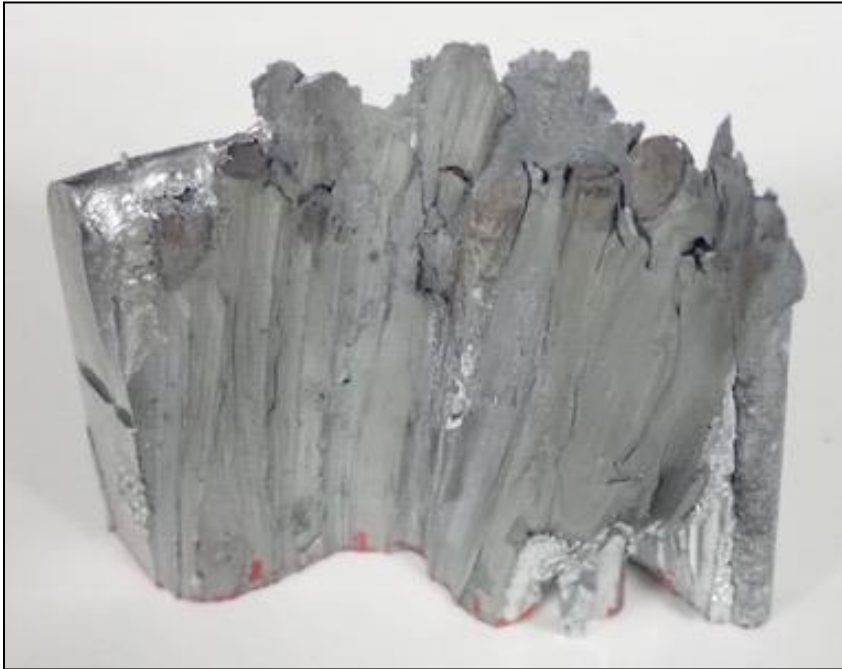
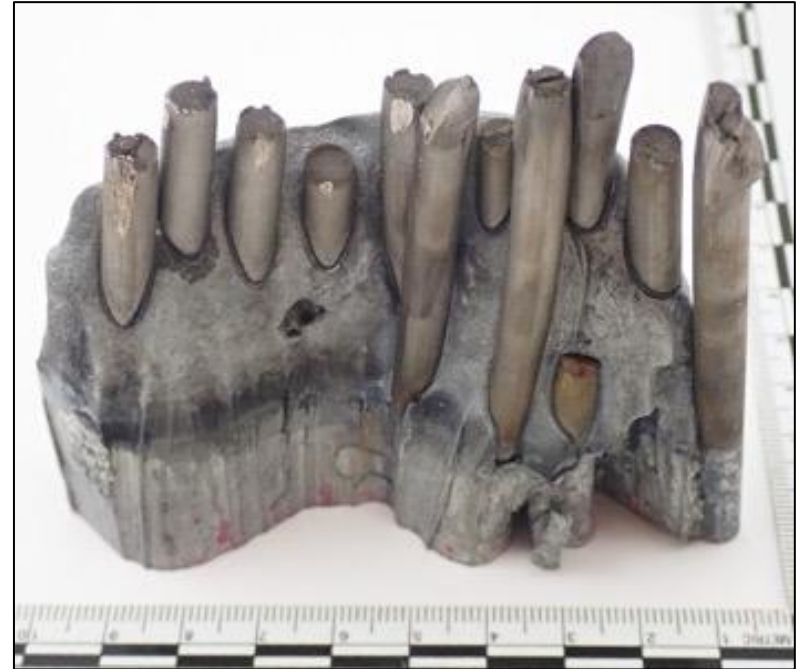
# Wire Fractures

- No evidence of striation-forming high-cycle fatigue crack growth
- Nearly all wires failed as cup-cone or slant shear tensile overload fractures
- Possibility of low-cycle fatigue but similar and nearly indistinguishable from simple overload

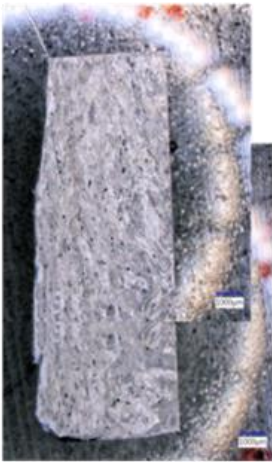
Socket Base Side

- Zinc Metallography and Fractography
  - Overall Grain Structure
  - Cavity Fracture
  - Oxidation of Crack Faces
  - Deformation Effects

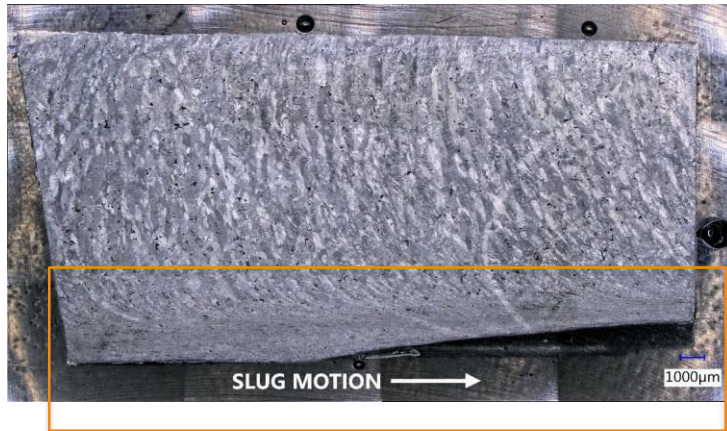
# Deformation Effects
