Champlain Towers South

2023 Structural
Engineering Seminar
Series

February 21, 2023

WJE Collapse Investigation

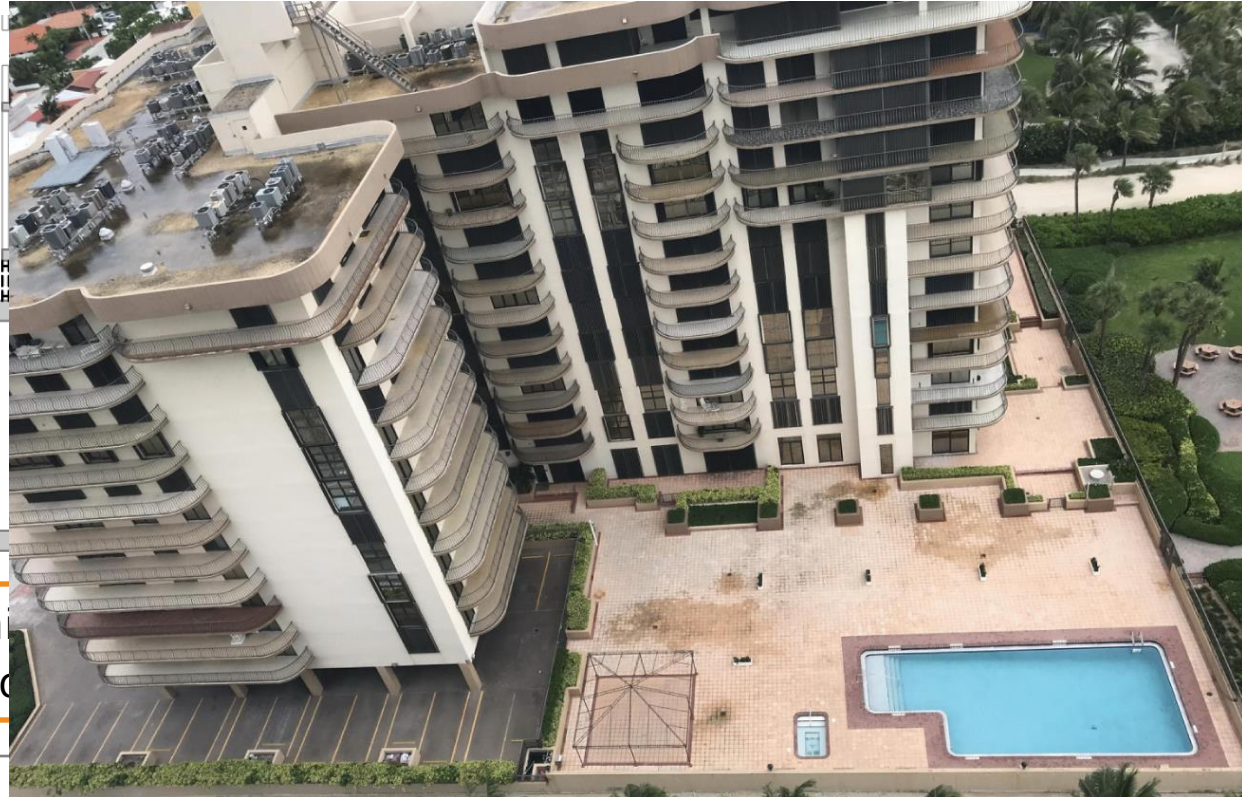
Morabito Investigation – Deck Finish

Deck finish
designed

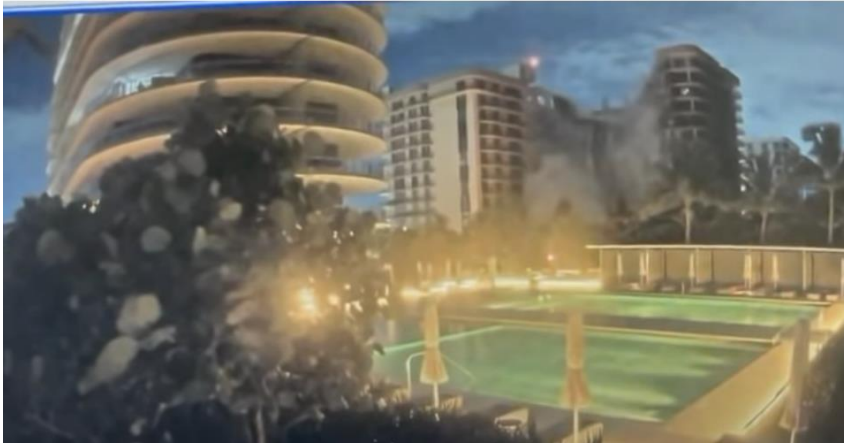
1:22 AM - 8701 Collins Ave Video

1:20 AM	Unit 412 felt the building shaking, saw the pool deck had collapsed	
~1:22 AM	Three columns on the south face of the building appear to fail near their bases. Area 1 immediately collapses	Building Collapse
	Area 2 collapses immediately after Area 1 spreading some debris to the north	
	Area 3 to the east stands briefly and collapses rotating at the base

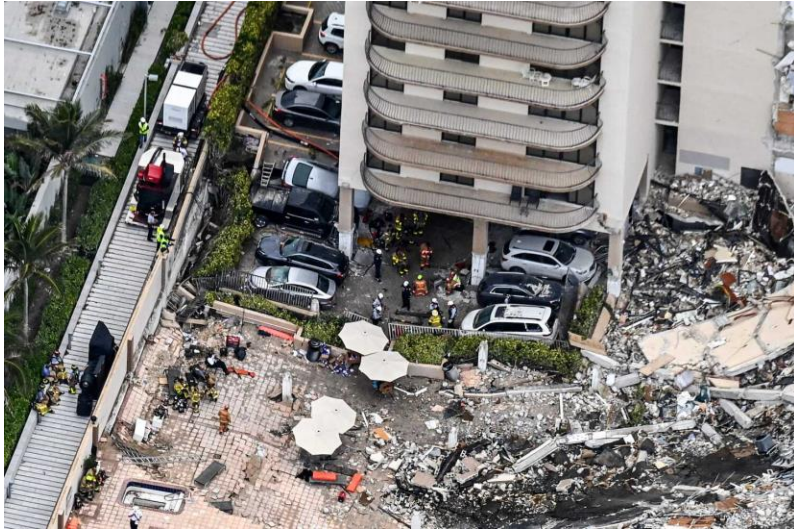
Pool Deck Collapse

Approximate extent of collapsed pool deck
